# Boscobel School District

## *Facility Condition Assessment Report*

Smith Rosenfeld, LLC

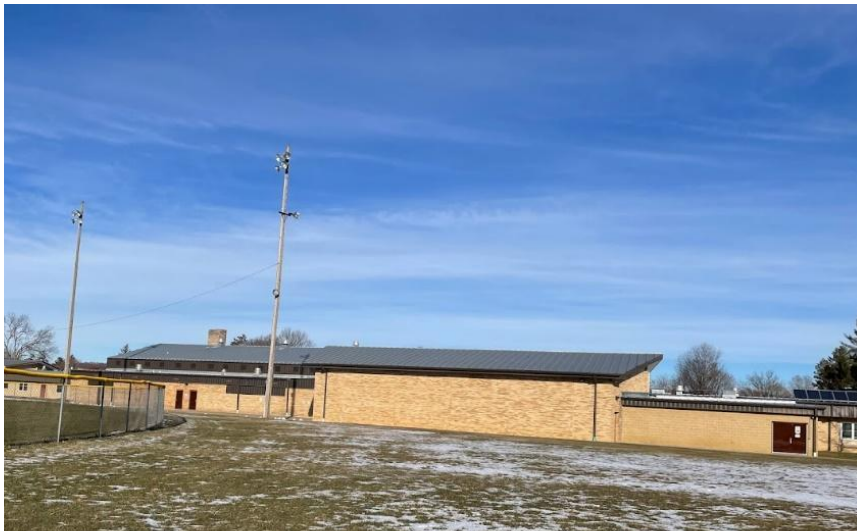
The roofing system is standing seam metal roof with multiple levels and transitions. It slopes to perimeter gutters with some edge runoff. It would be cost prohibitive and difficult to replace in its entirety at the end of its useful service life so the best long terms solution if the facility is planned to be used for the longer term would be to insulate and overlay the area with a membrane roof system. This would allow for modification of the poor details and transitions and would enable the district to increase the R value to help reduce energy costs.

Overall Roof (Left) and Unfinished Roof Edge (Right)

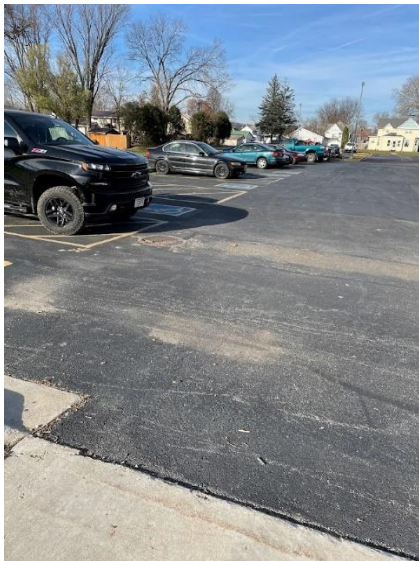
The overall condition of both the asphalt and concrete hardscape areas align with the estimated age and maintenance efforts to date. The asphalt surfaces appear to have been “slurry-coated” to elongate the useful service life of the surface. However, reflective surface cracking has occurred, and limited crack filling has been performed. Select concrete flatwork and curbing areas are in need of replacement. The ADA parking areas are not in compliance and exceed the 2% recommended slope in all directions.

ADA Parking Areas (Left) and  
Asphalt Cracks (Center and Right)

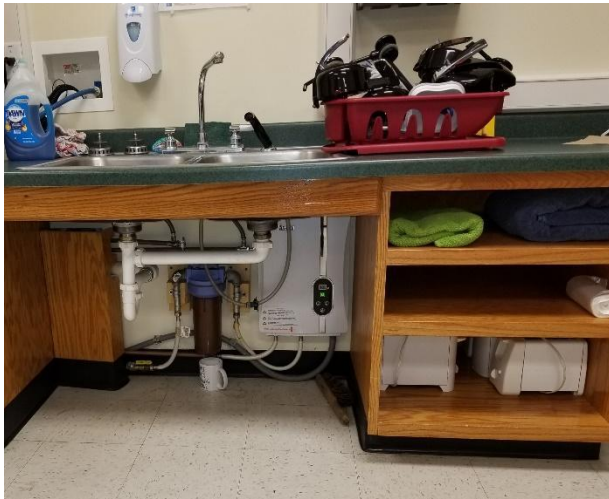
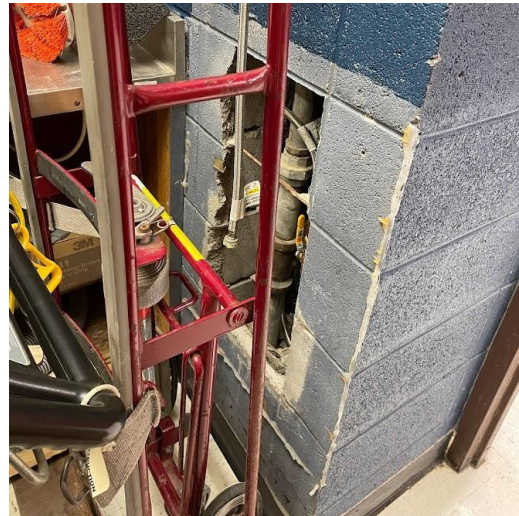
The existing piping at the Middle/High School is at the end of its useful service life. Currently the system has corrosion issues resulting in particles entering the water piping system. Most issues occur in the difficult to access tunnels under the school. This proposed price includes relocating the piping to the ceiling to connect with existing plumbing fixtures.

Below Sink Filter (Left) and Filter Behind Drinking Fountain ( Right)

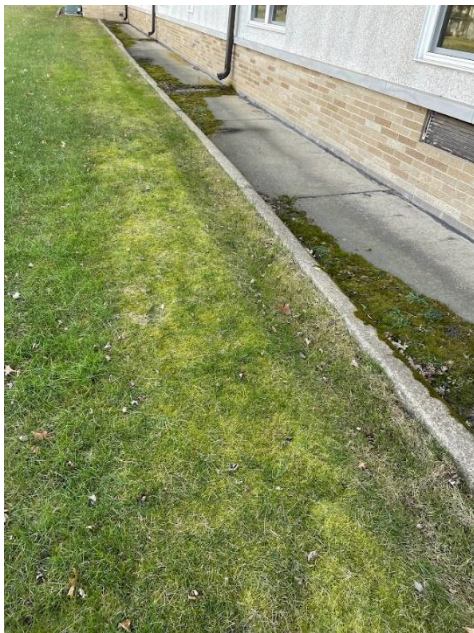
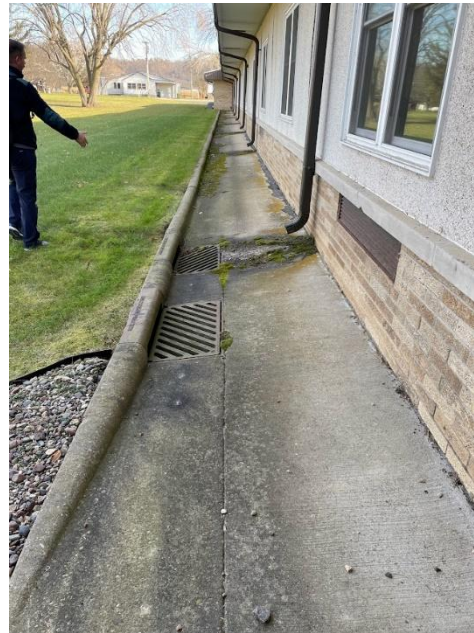
The current drainage near the front of the building requires major repair. The concrete channel for the water draining from the roof to the front of the HS/MS is not graded properly, resulting in stagnant water and pooling. This estimate includes re-grading the existing concrete channel and replacing existing piping to the municipal sewer as required.

Mold Growth and Water Damage in Concrete Channel

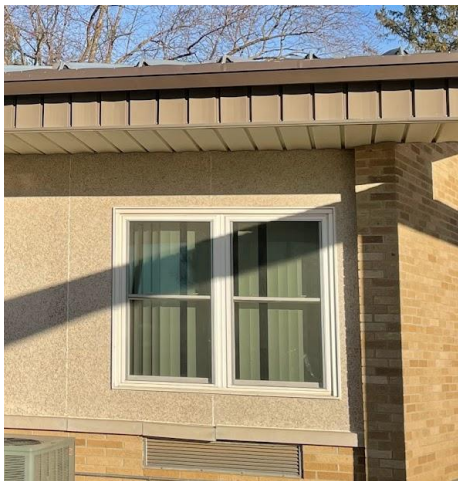
The windows of this facility were installed in 2017 and should be monitored for leaking and the adjacent walls systems should also be addressed including sealants. The windows installed on the high school are residential windows and could possibly be replaced for security and energy savings purposes depending on the school districts goals and priorities. Windows installed in the cafeteria are lower quality windows with high air leak potential and should be replaced as soon as budgets allow.

Residential Style Window on Main School (Left) Cafeteria Window (Right)

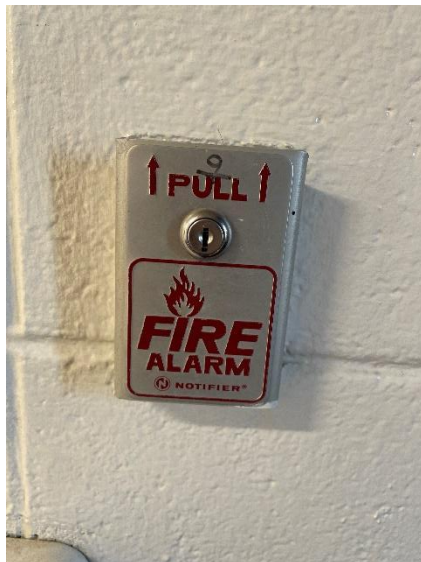
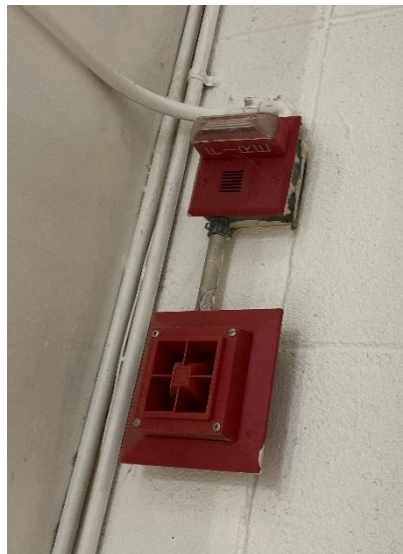
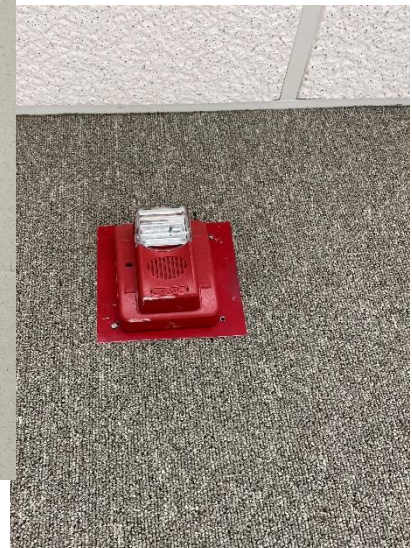
The Fire Alarm system is outdated and needs to be upgraded to be code compliant. The detection devices are currently zones, so the system does not detect the exact alarm pulled. Smoke detectors should also be placed in the hallways which will help detect a fire without have to pull a manual station. New horn and strobe devices should be installed throughout the school.

Existing Horn, Strobe and Pull Devices

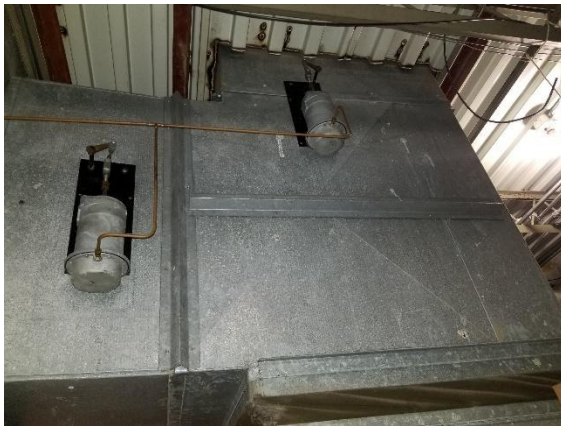
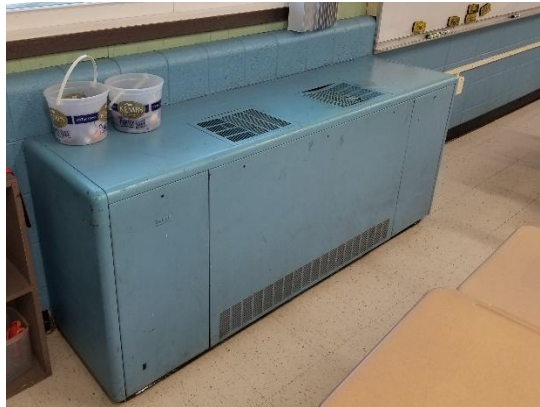
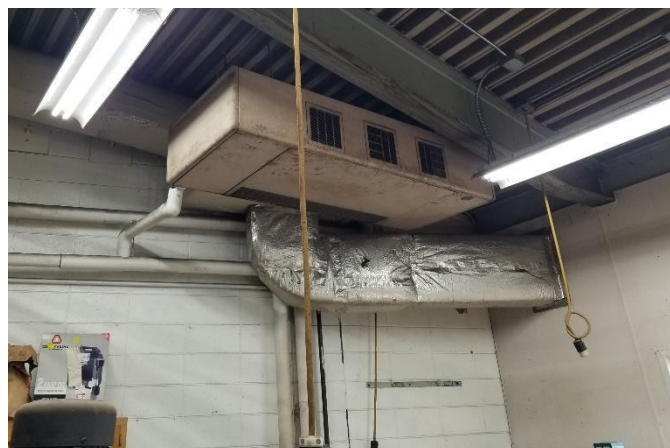
The mechanical systems that serve the High School are a combination of pneumatic and direct digital control. According to ASHRAE standards the following building equipment is near or past it's usable life and should be replaced:

- Trane AHU-Interior Mechanical Storage Room 47A
- Unit Ventilators (Quantity of 8) Unit Ventilators with Steam Reheat
- Exhaust Fans Metal Shop/ Exterior Side wall
- Exhaust Fans Metal Shop- Center finishing Area
- Exhaust Fans Science Room Fume Hood Exhaust Fan
- Air Handling Units -N,S,W,E

Air Handling Unit (Top Right) Unit Ventilator (Top Right) Exhaust Fan (Bottom Center)

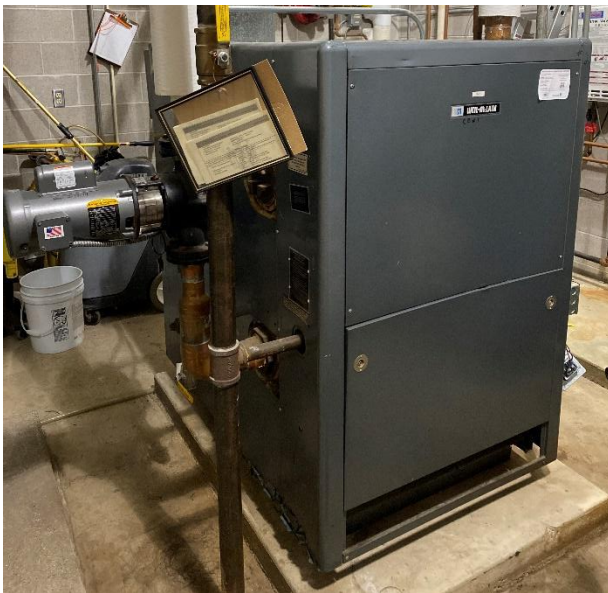
The mechanical systems that serve the High School are a combination of pneumatic and direct digital control. According to ASHRAE standards the following building equipment is near or past it's usable life and should be replaced

- AHU-Interior (Quantity of 3)- Fan Room AHU South/Stage Mezzanine AHU North/Fan Room AHU Gym
- Boiler B-2 Weil-McLain
- Pump P-1 Secondary Hot water System Pump
- Boiler Pump \$1500- Hot Water System Boiler Circulation Pump
- Water Softener \$7000- Water Room/ Rm# 102

Boiler B-2 (Left) Air Handling Unit (Right)

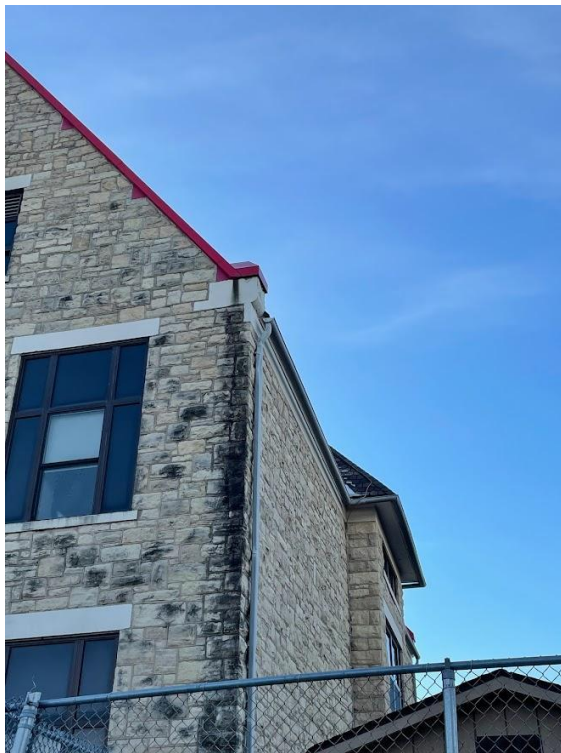
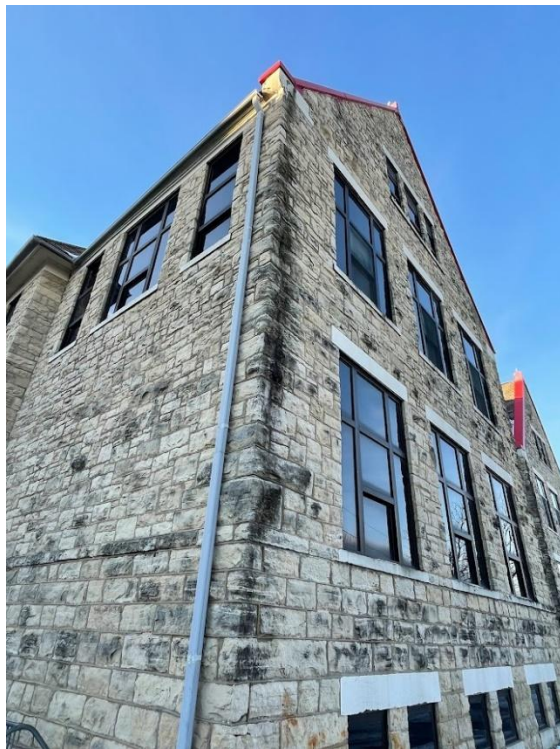
The shingle roof of this facility is in overall good condition. Repairs should be made to the flashings, copings and gutters to address the water infiltration into the stone exterior. Staining from these locations are obvious on the exterior.

Damage and Staining to Stone Exterior
