January 31, 2024

Exterior Asbestos and Lead Paint Survey Report for Repainting

**Cole Elementary School
615 West Stuart Avenue
Clovis, CA 93612**

FACS Project #PJ80246

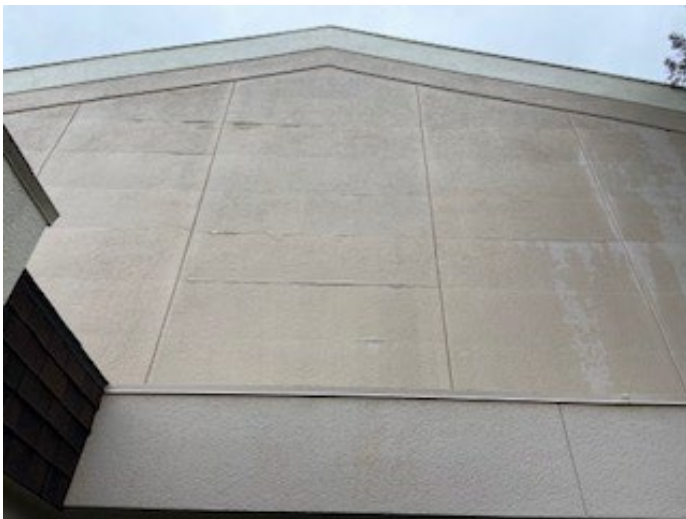
Beige Paint on Stucco – Fair Condition

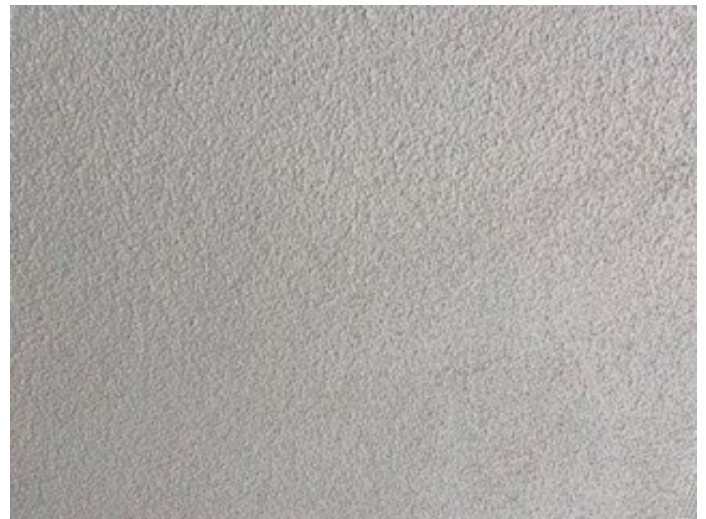
Stucco

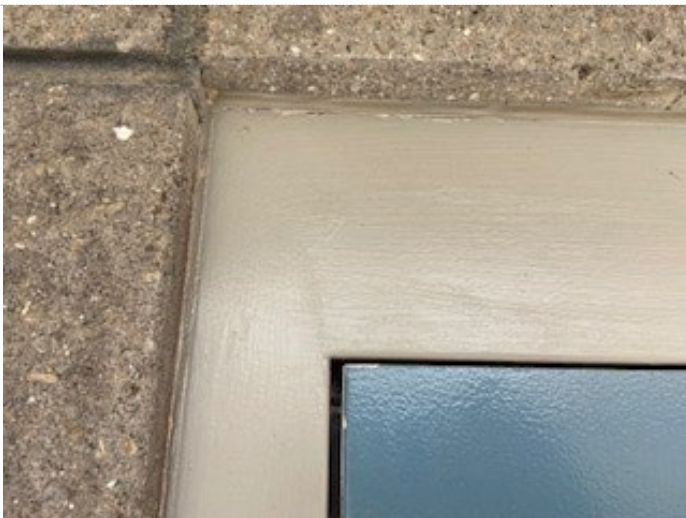
Tan Paint on Metal Door Frame

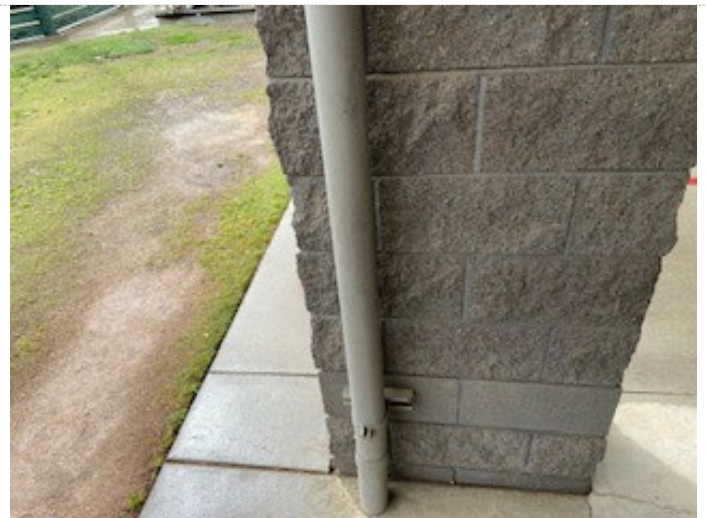
Grey Paint on Metal Downspout
