# **CIVIC STADIUM**

## **ASBESTOS INFORMATION & SURVEY REPORT**

8-22-10

## Civic Stadium-Asbestos Building Identification Summary

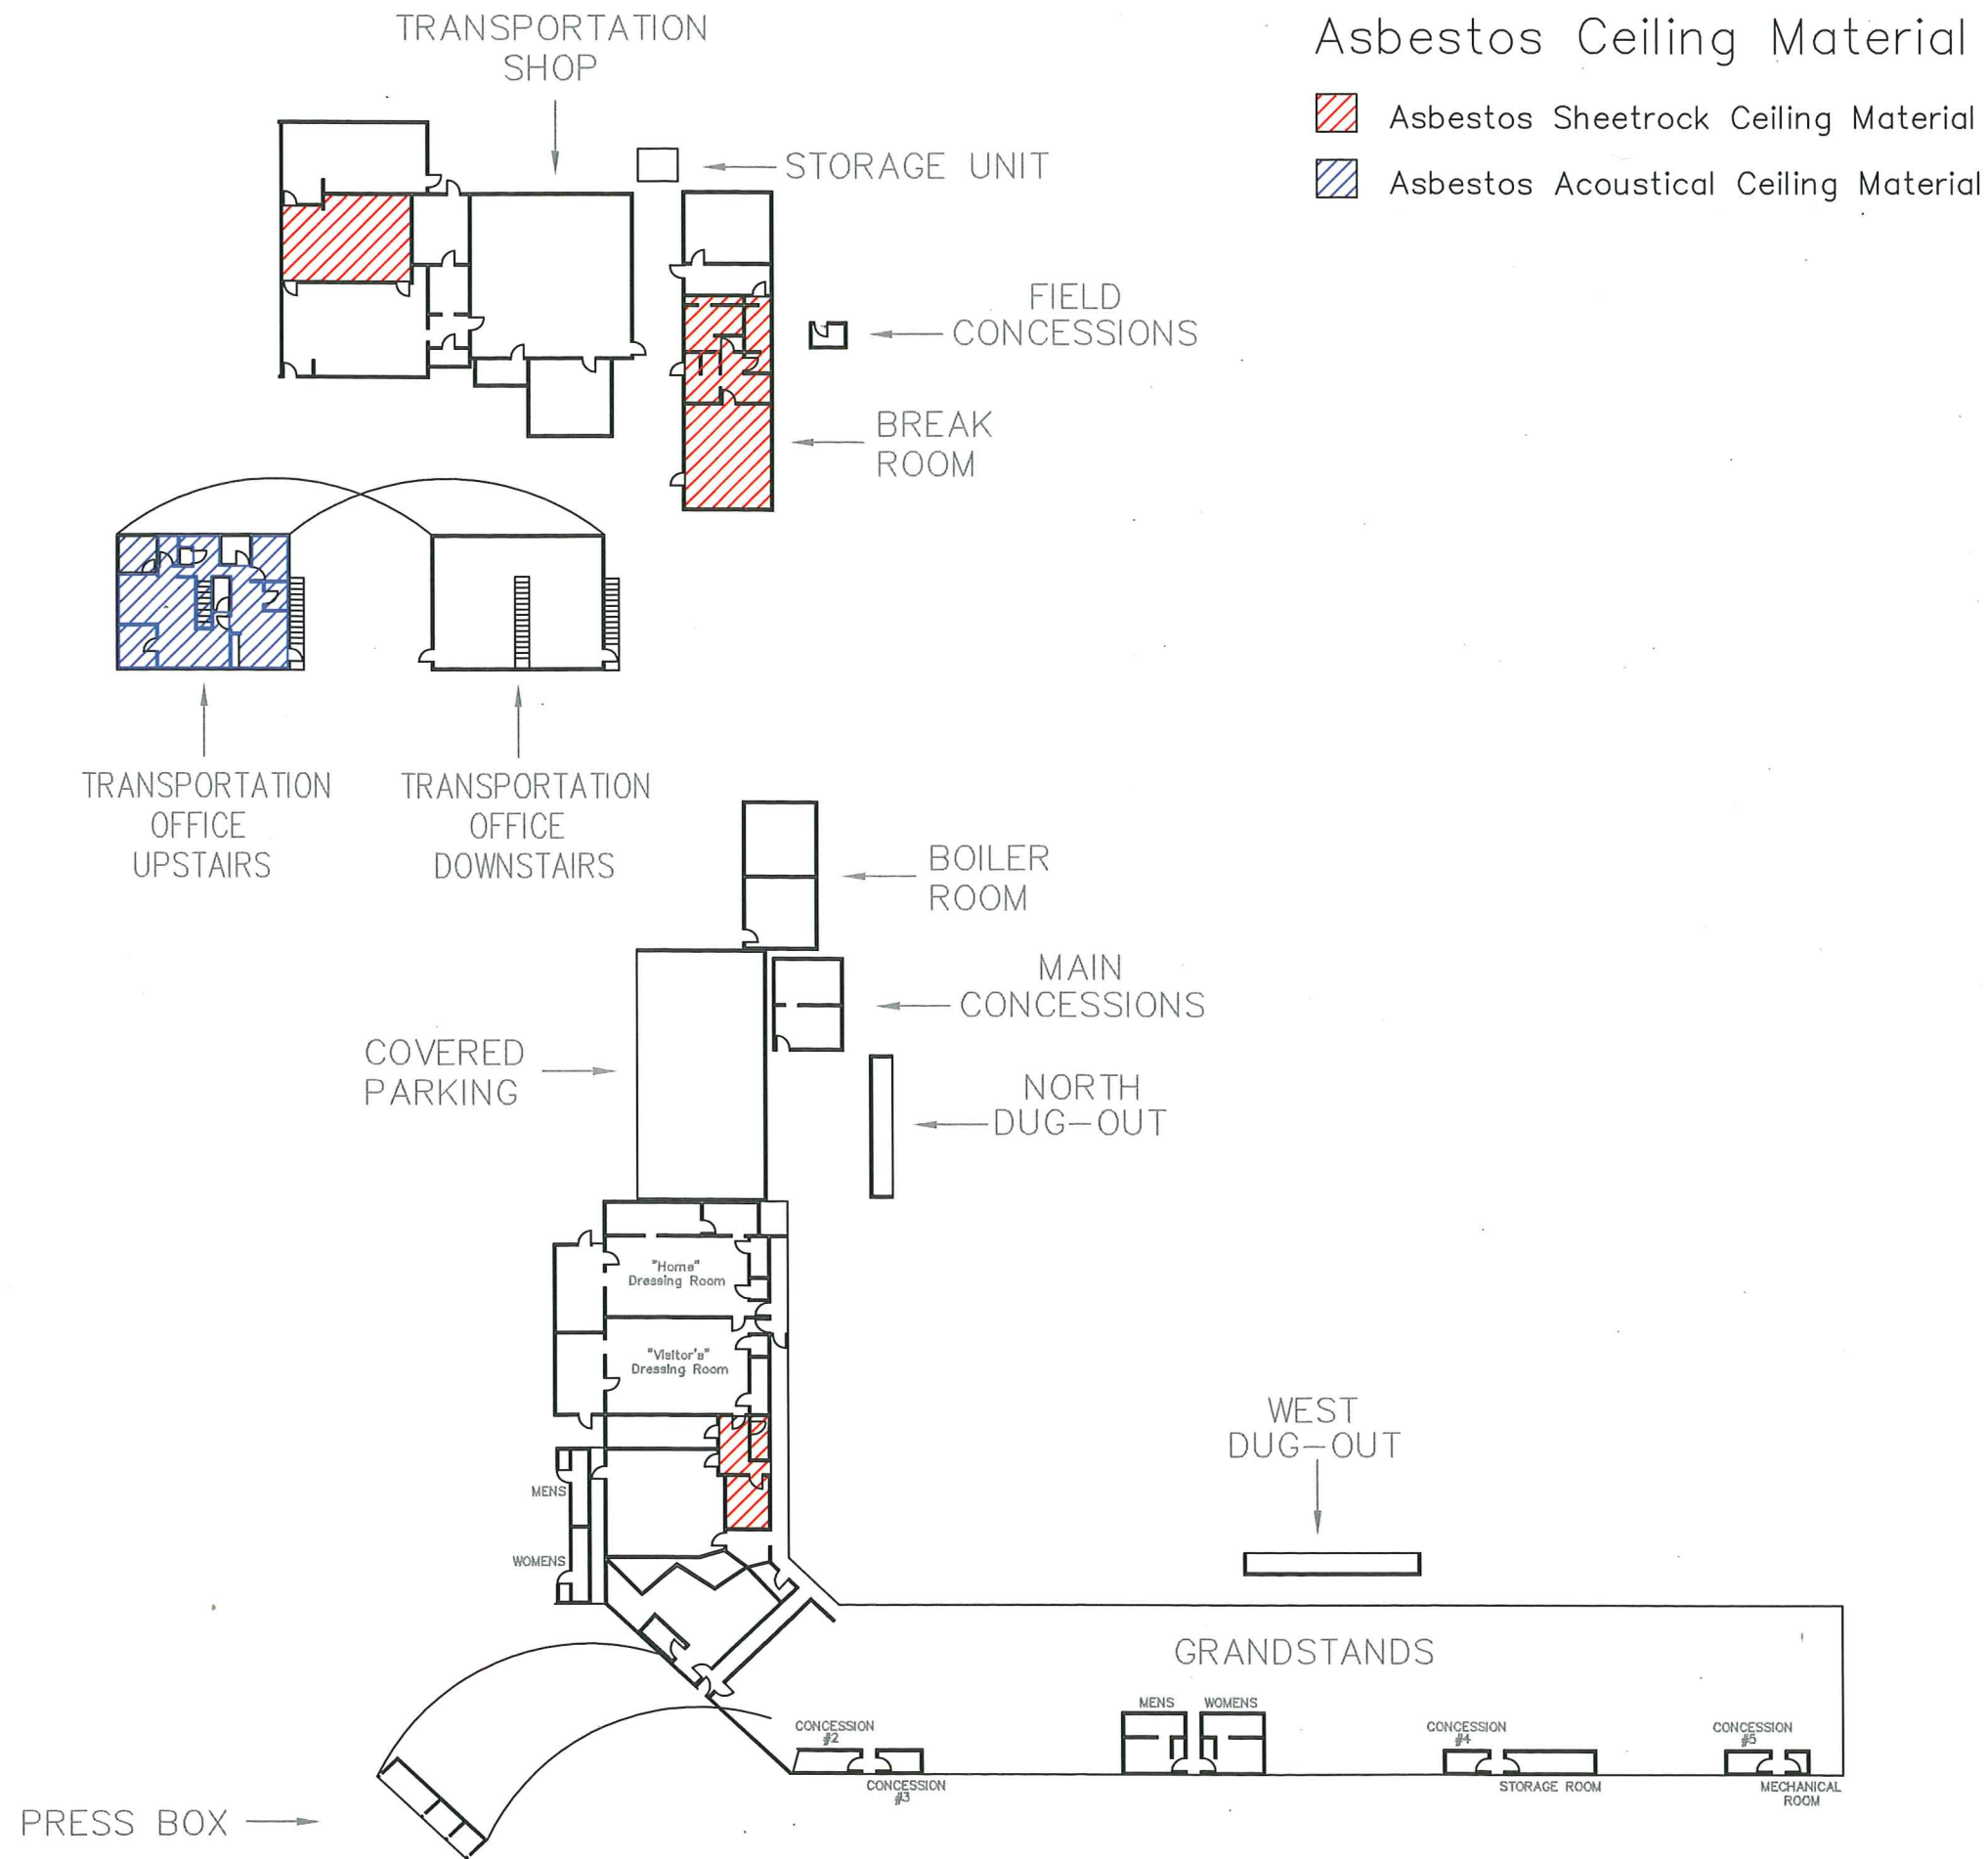
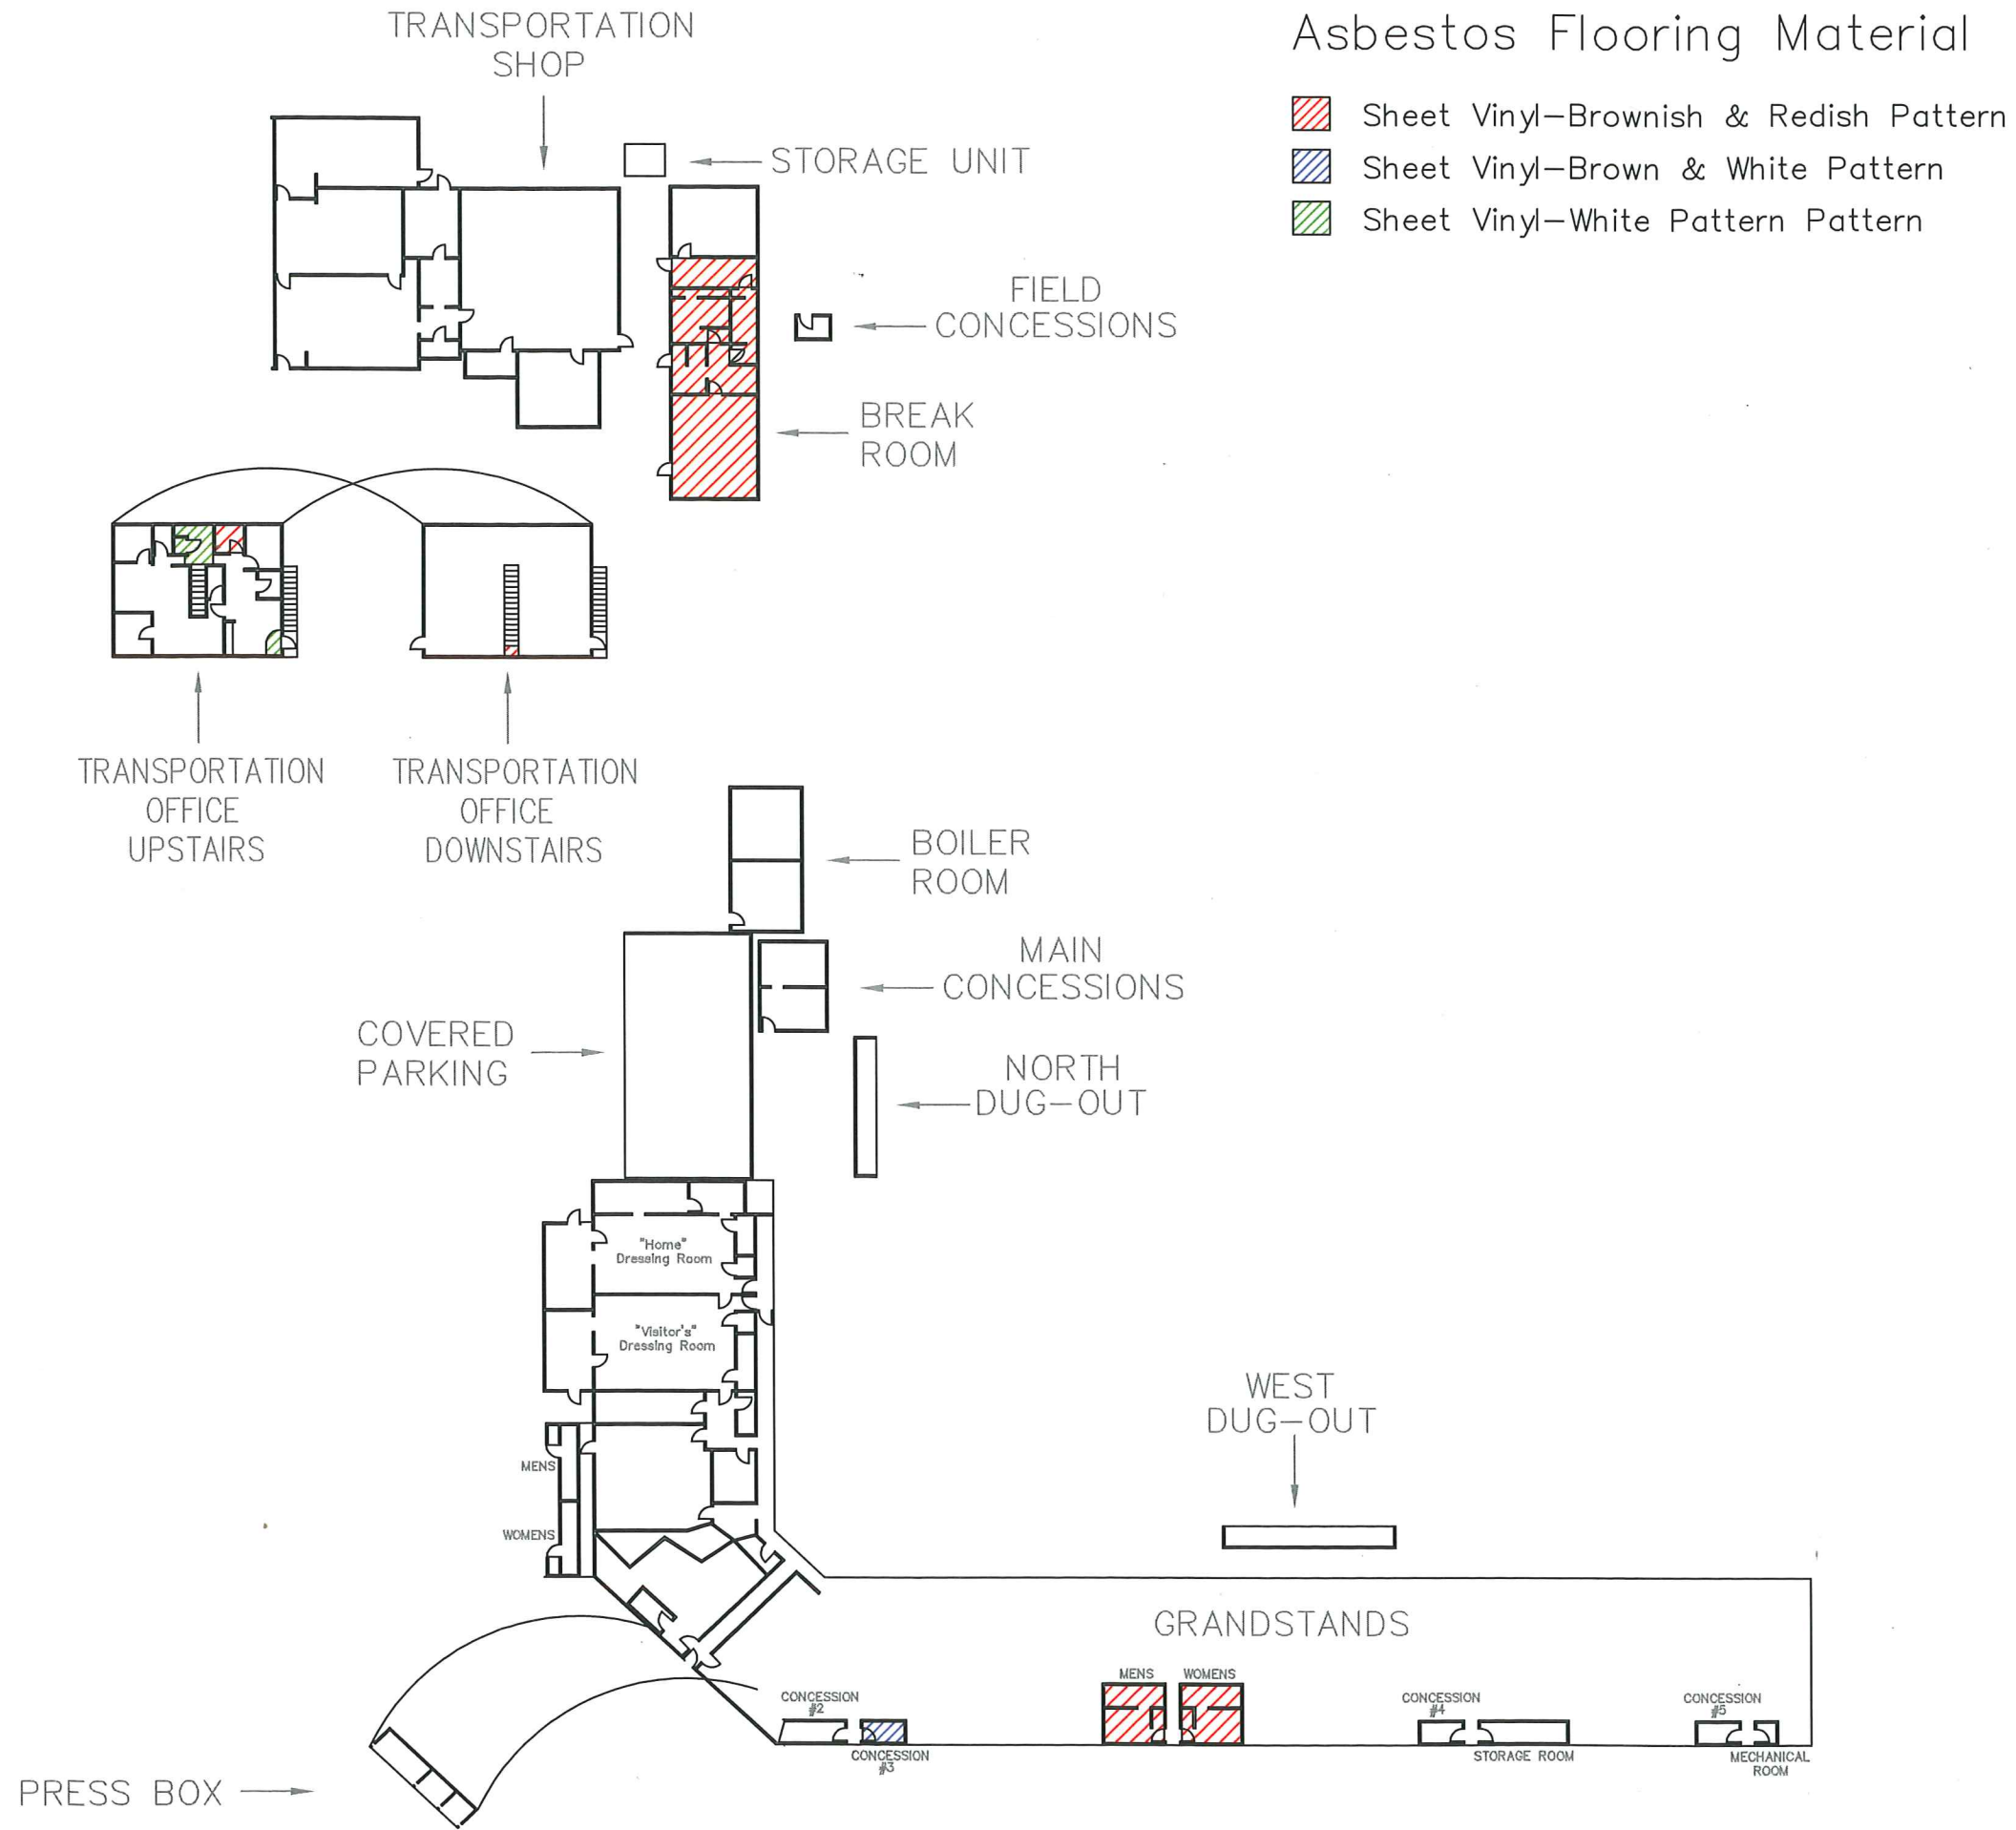
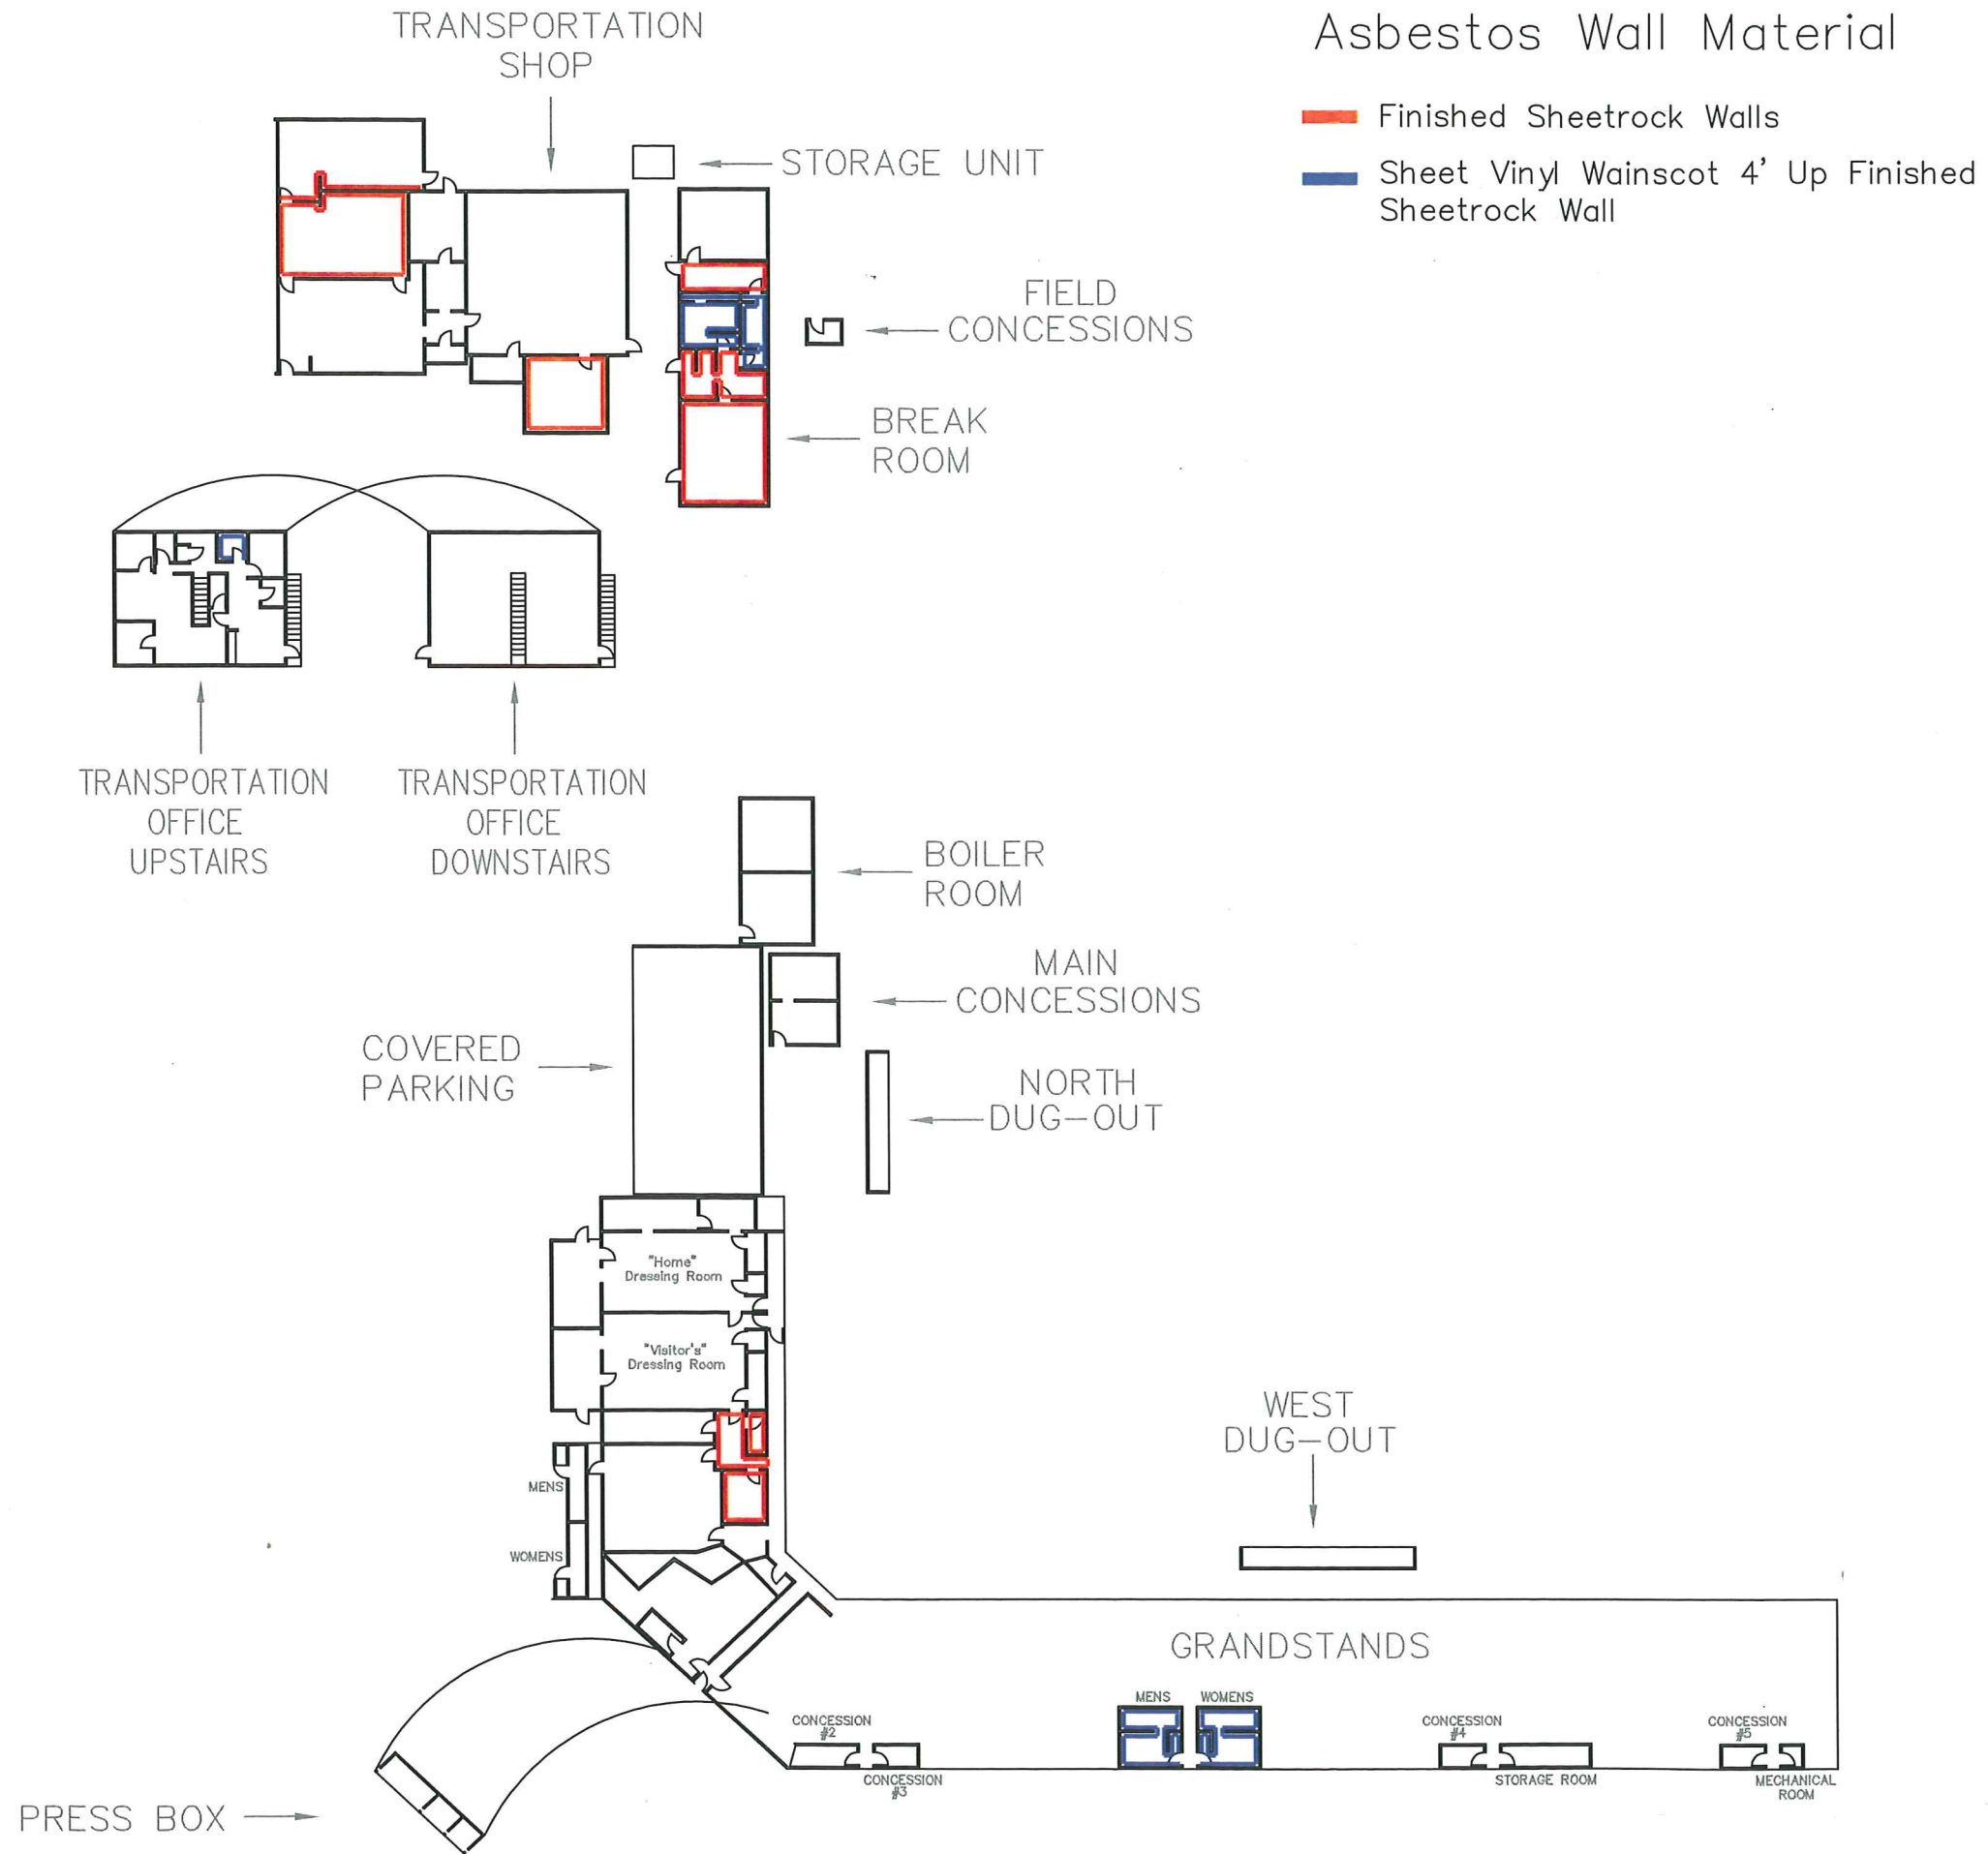
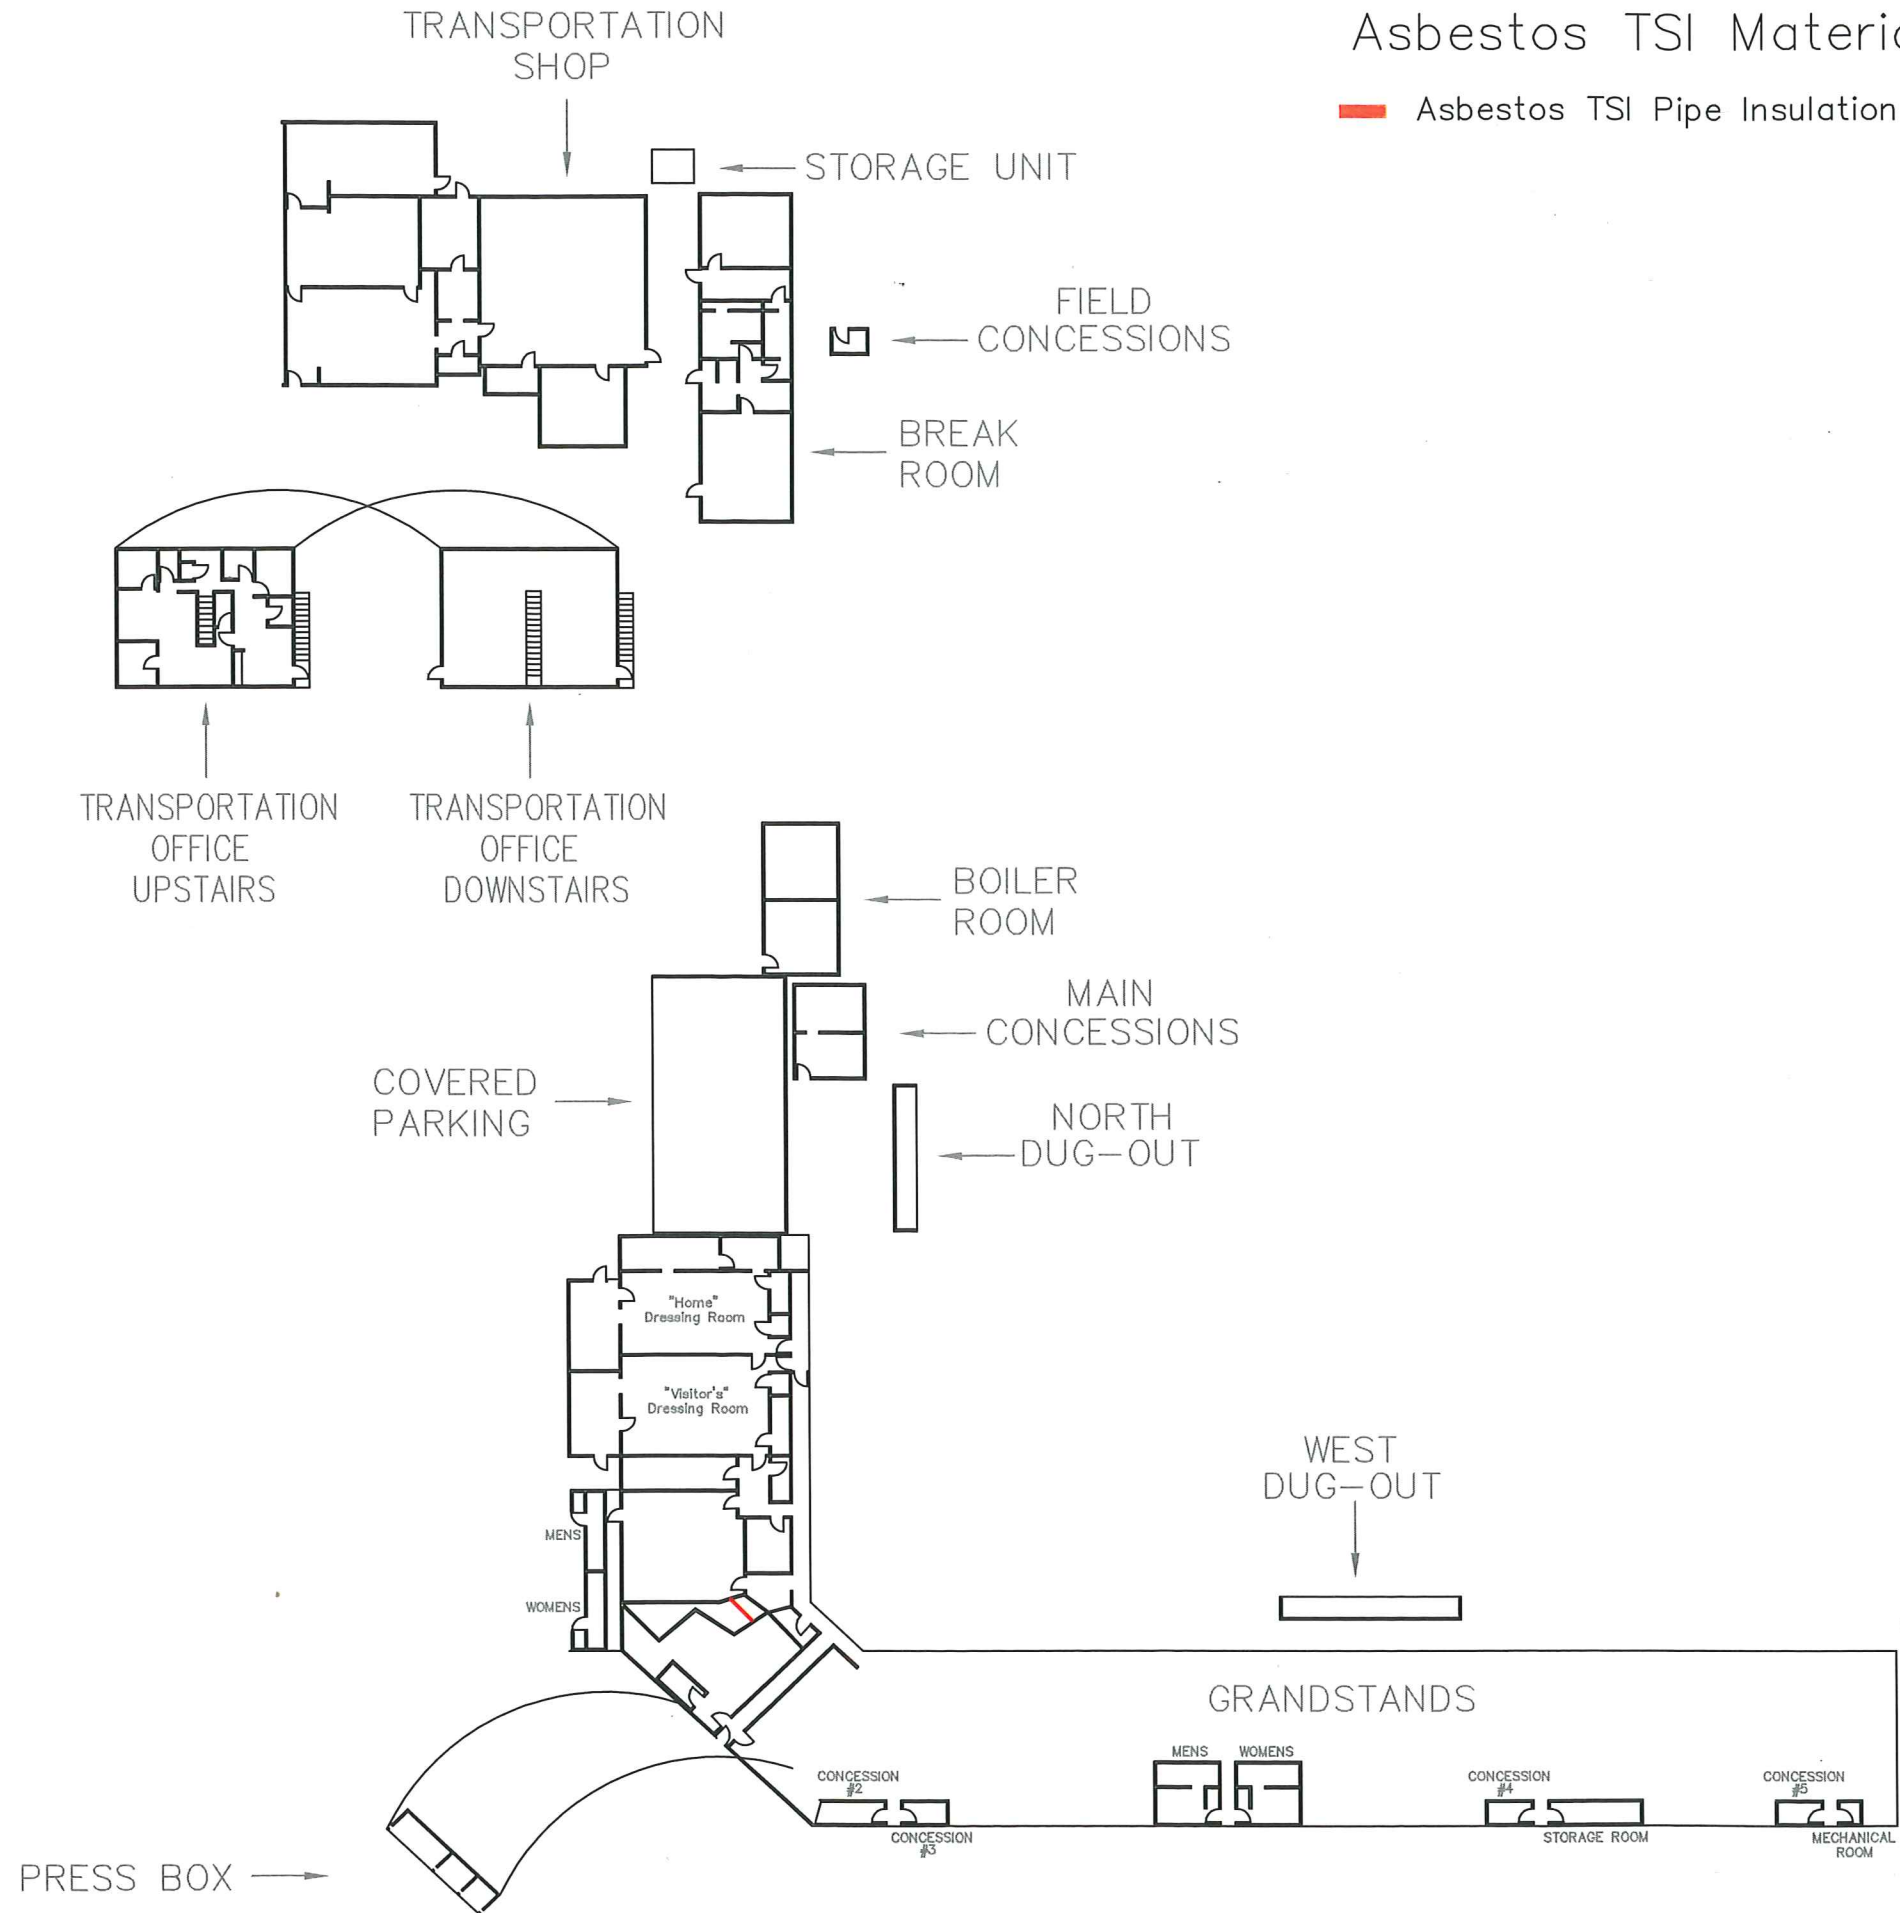
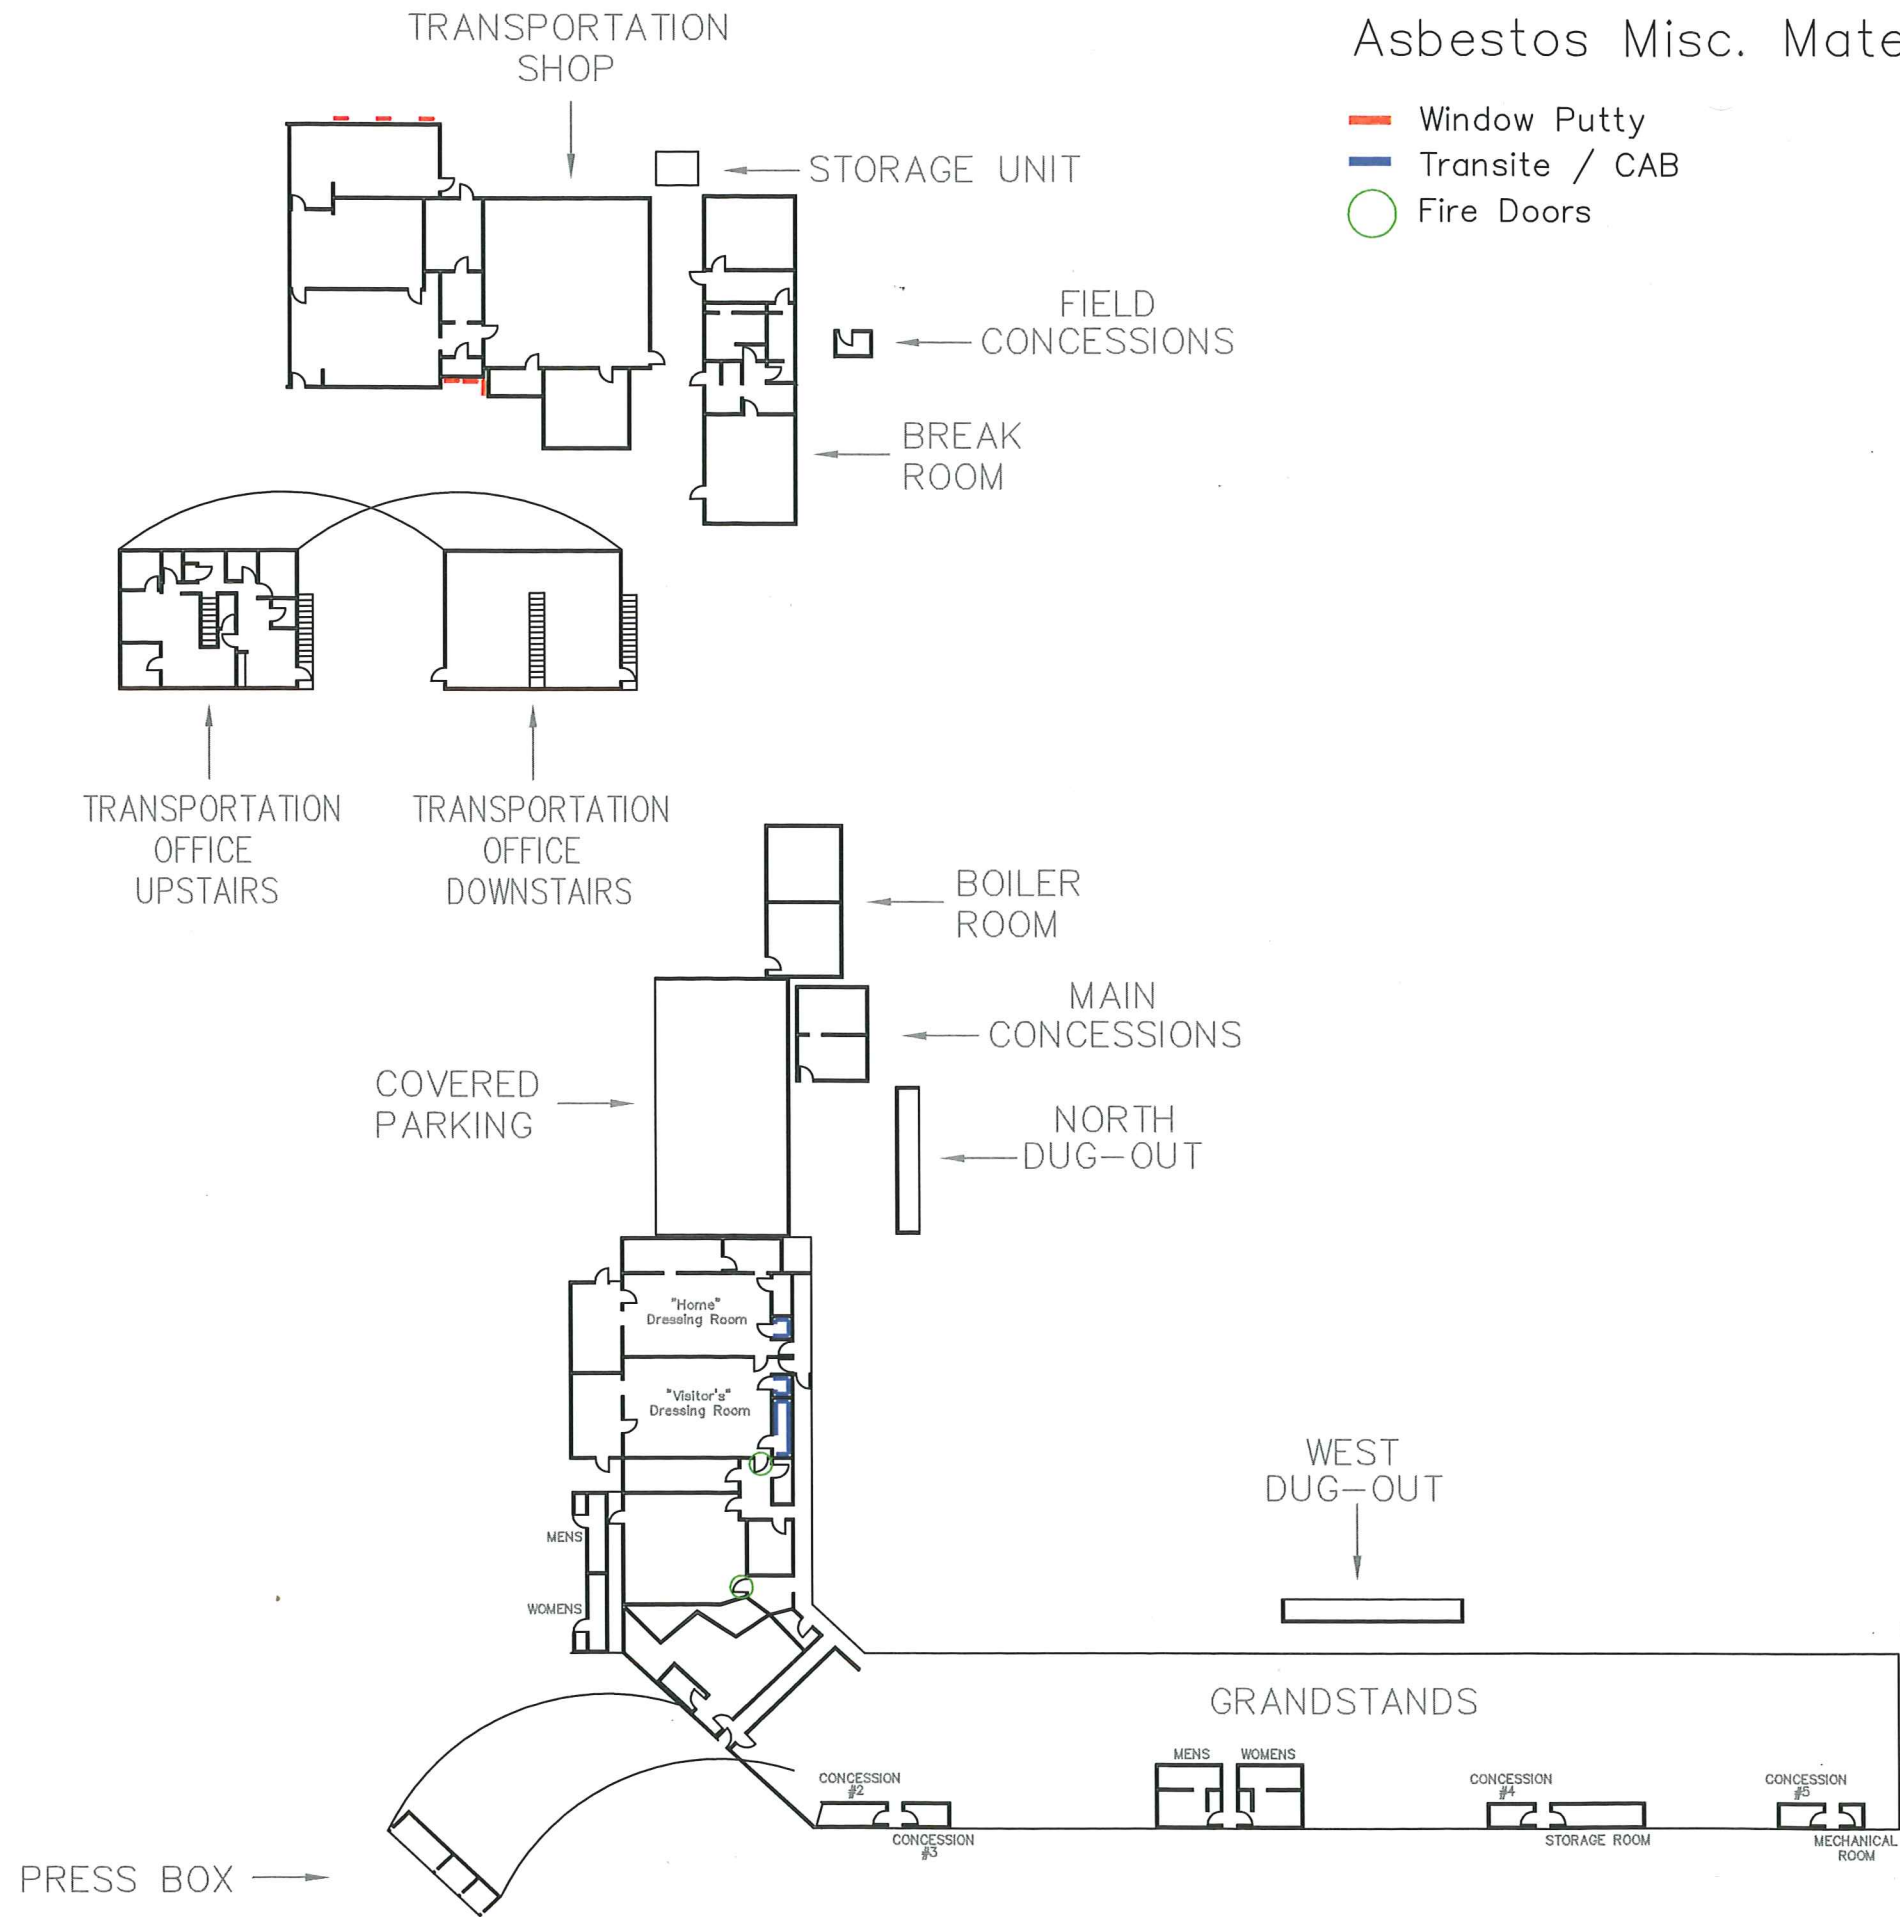
CIVIC STADIUM BULK SAMPLE LOCATIONS  
 2079 OAK STREET  
 EUGENE, OREGON 97401

# Asbestos TSI Material

Asbestos TSI Pipe Insulation

Building Material Bulk Sample Locations:

- Ceiling Material
- Flooring Material
- Misc. Material
- TSI Material
- Wall Material
- Window Putty Material

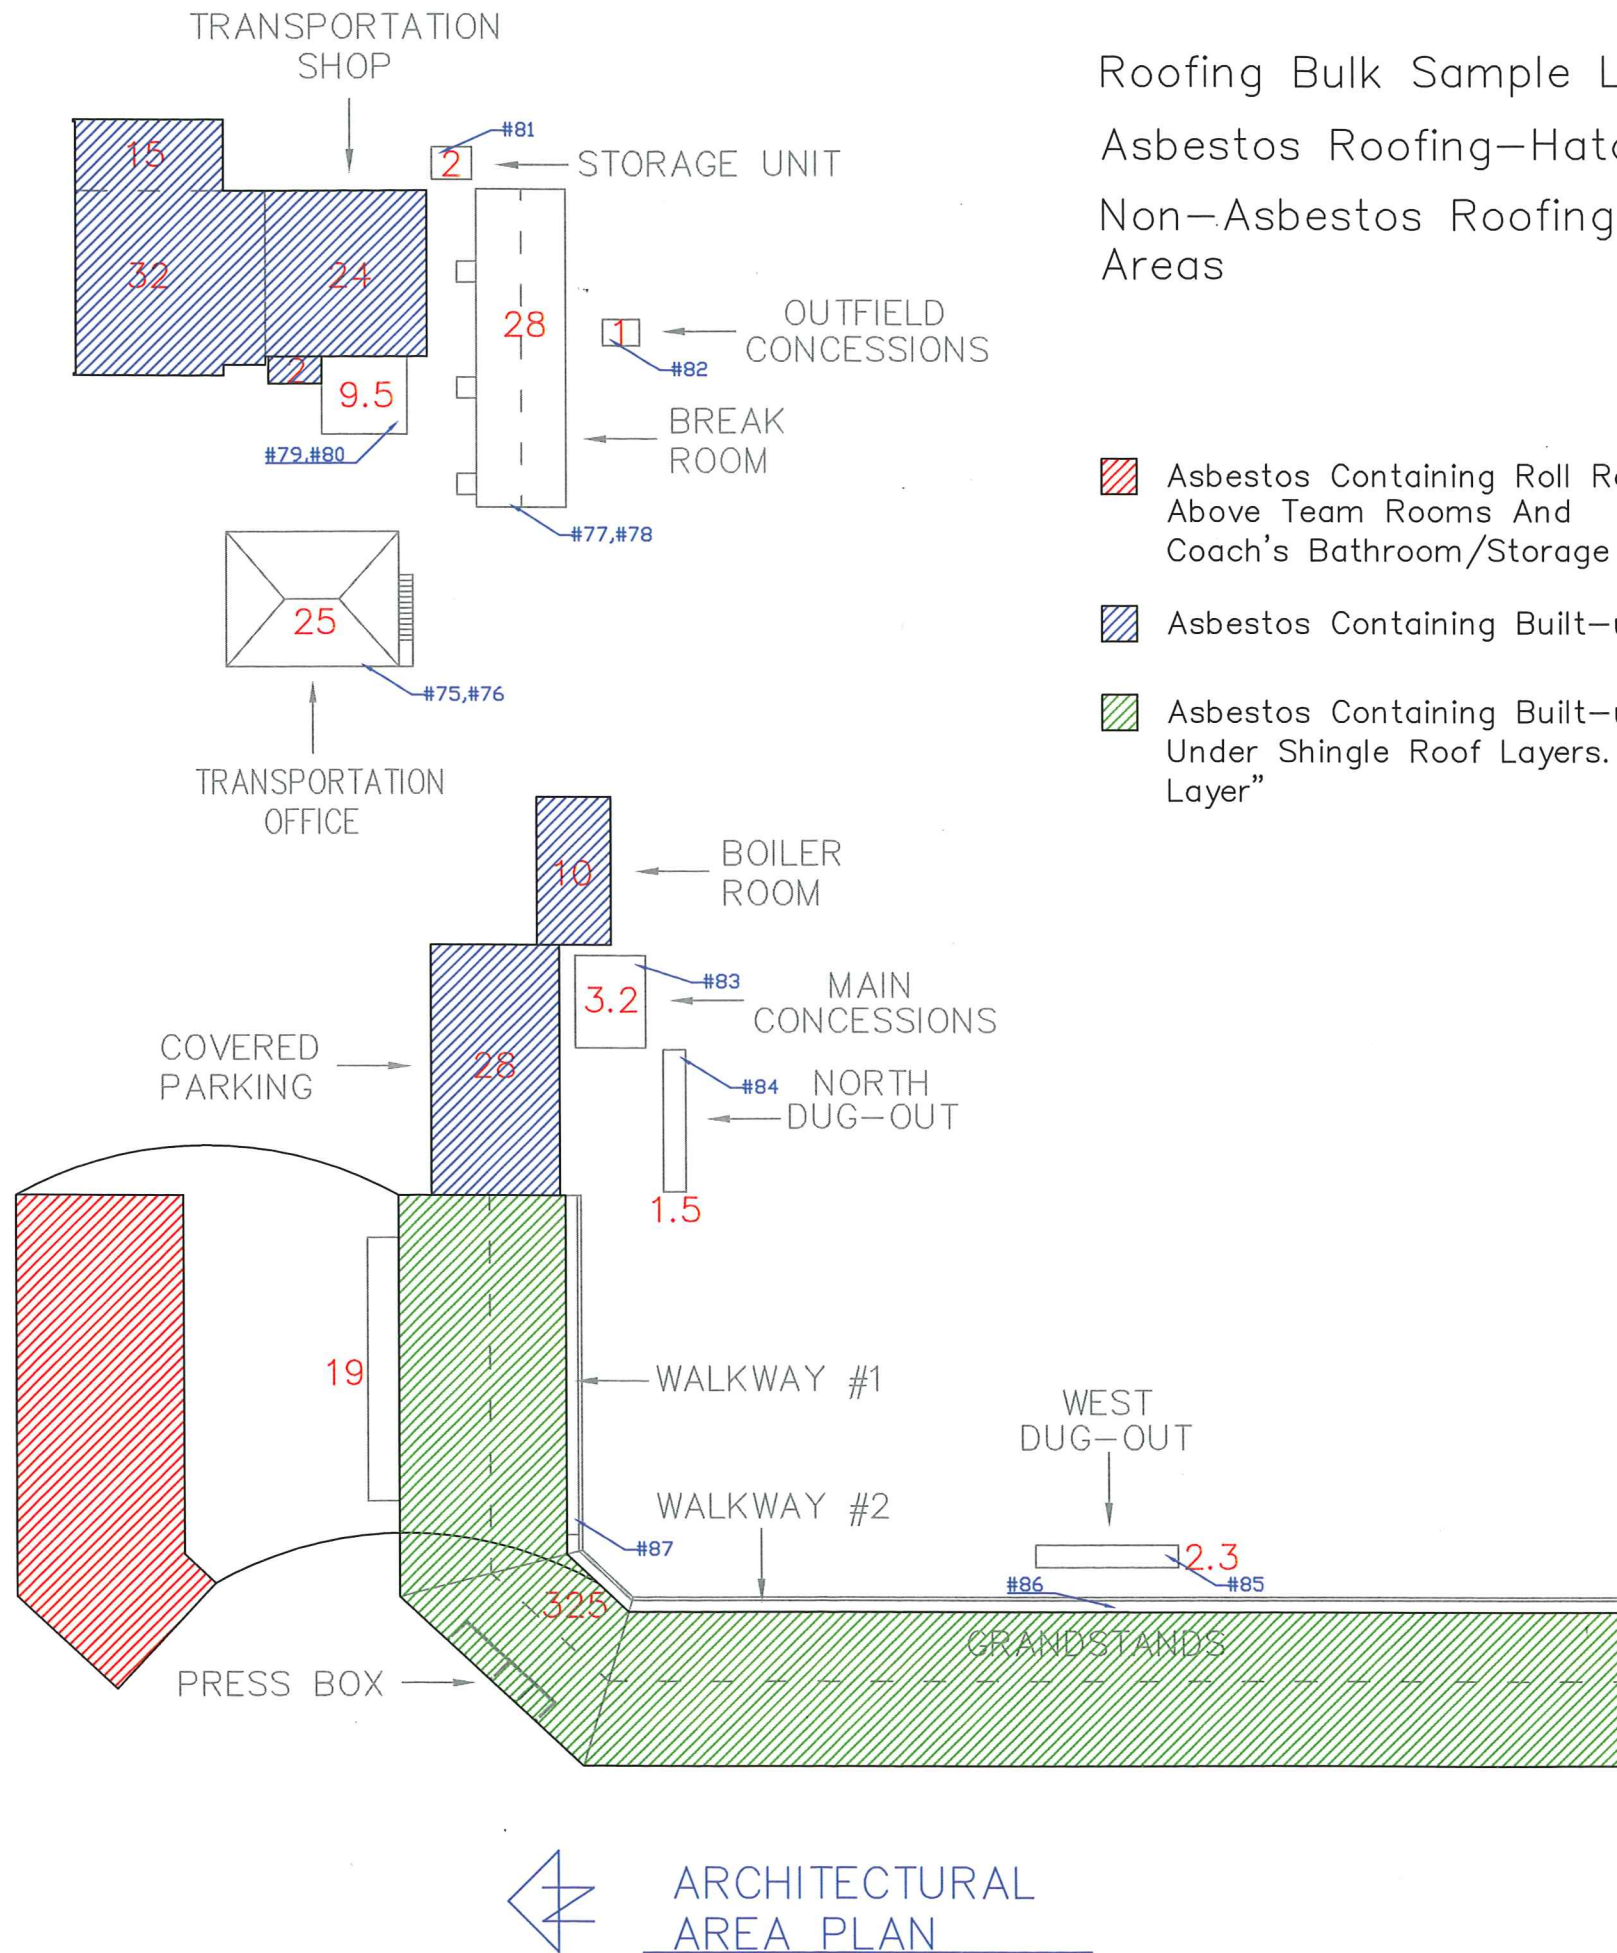
CIVIC STADIUM ROOFING BULK SAMPLE LOCATIONS  
 AND ROOFING SQUARE TOTALS IN RED NUMBERS  
 2079 OAK STREET  
 EUGENE, OREGON 97401

Roofing Bulk Sample Locations  
 Asbestos Roofing—Hatched Areas  
 Non-Asbestos Roofing—Unhatched Areas

- Asbestos Containing Roll Roofing Above Team Rooms And Coach's Bathroom/Storage Rooms
- Asbestos Containing Built-up Roofing
- Asbestos Containing Built-up Roofing Under Shingle Roof Layers. "Bottom Layer"
