Fuller Middle School Feasibility Study
Framingham, MA
Electrical Existing Conditions Systems Report
J#680 015 00.00
L#58621/Page 1/November 1, 2017

ELECTRICAL

Executive Summary:

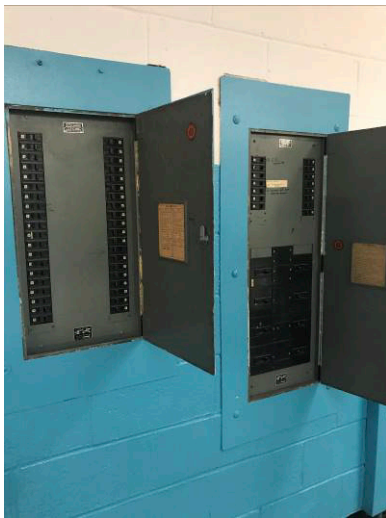
Typical Corridor Panels

Local and remote panels, generally installed flush in Corridors, are of the breaker type, are generally full and in poor condition. Most panelboards are original General Electric panels.

Most switchgear is original to the building and is obsolete. Replacement parts are scarce as switchgear is no longer manufactured. The switchgear, due to its age and condition, should be replaced under a renovation program.

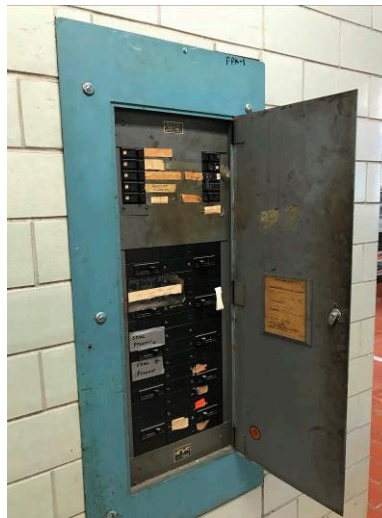
Kitchen Panel

Transformer "K" feeds a 1000 ampere, 277/480V, 3 phase, 4 wire distribution panelboard which services the kitchen complex.

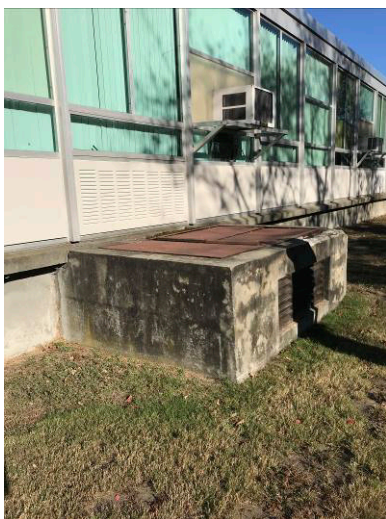
Entryway to Vault

Each vault has access through an areaway from the exterior of the building, available only to the utility company. Secondary services between the vaults and the switchboards consists of General Electric busduct.

The Electric Rooms and vaults are located in the crawl space and have been subjected to moisture and water seepage. Door and door hardware are not in compliance with current codes which require panic hardware.

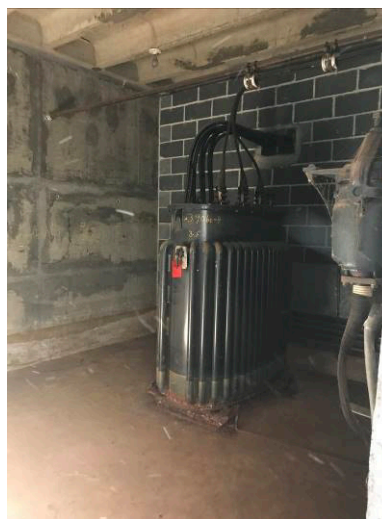
Vault Transformer

The vault mounted transformers are owned by the utility company and due to their age are likely to contain PCBs.

- The existing electrical services should be upgraded with a single 277/480 volt system to provide the required capacity for the building load based on 10 watts per square foot power consumption. A new pad-mounted transformer with new primary and secondary service should be provided. The vault-mounted transformers would be removed when no longer needed.

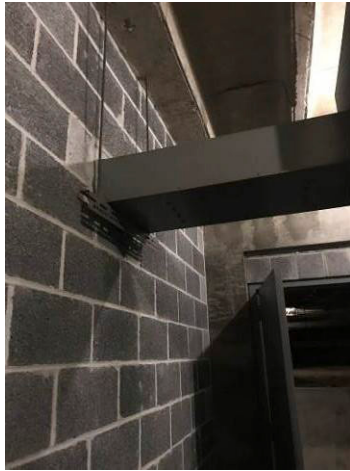
Busduct to Vault

The busduct and switchboards were manufactured by General Electric and are generally in fair to poor condition.

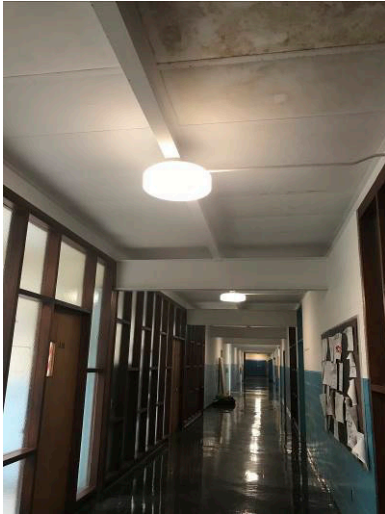
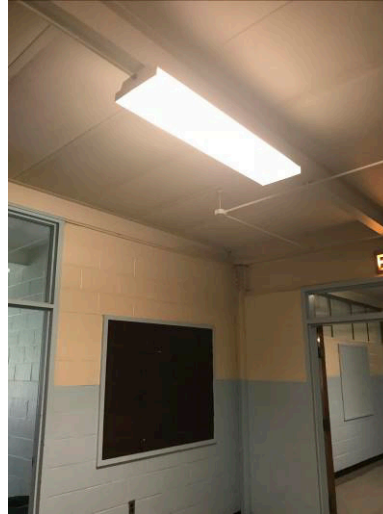
Corridor Lights

The interior lighting has been retrofitted over the years with T8 lamps and electronic ballasts, however most existing fixtures, wiring and switches are original. Corridor lighting generally consists of surface acrylic drums with screw in CFL and LED lamps as well as 1x4 surface acrylic wraparound fixtures with two T8 lamps. Corridor lights are locally switched.

- Corridor lighting will be comprised of recessed acrylic fixtures with LED lamps and electronic drivers. The corridor light level will be designed for approximately 20-foot candles.

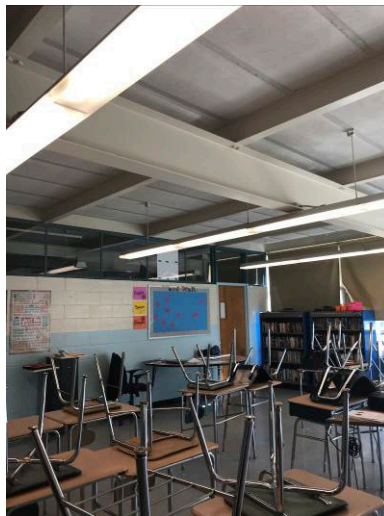
Classroom Lights

Classroom lights consist of three continuous rows of 12” pendant mounted acrylic wraparound fixtures with a single T8 lamp. Fixtures are multi-switched by row. Classrooms do not have occupancy sensors or dimmable photosensors.

- In general, the existing lighting system should be upgraded as required based on the proposed architectural renovations.
- Classroom lighting fixtures will consist of surface or pendant-mounted direct/indirect luminaires with LED lamps and electronic drivers. The fixtures will be pre-wired for automatic dimming control where natural daylight is available and also for multi-level switching. Occupancy sensors and dimming sensors will be provided.

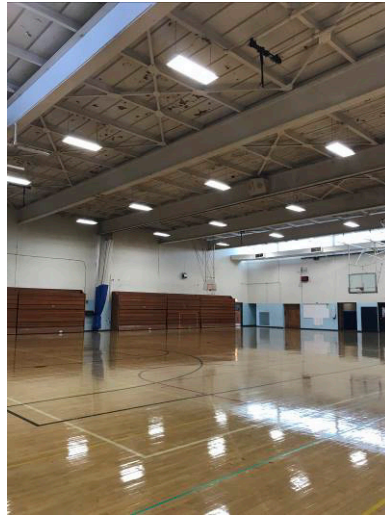
Gymnasium Lights

The Gymnasium and fitness center have 2x4 fluorescent high bays with three T5HO lamps with lens and wireguards. Space is well lit. Lights are breaker controlled.

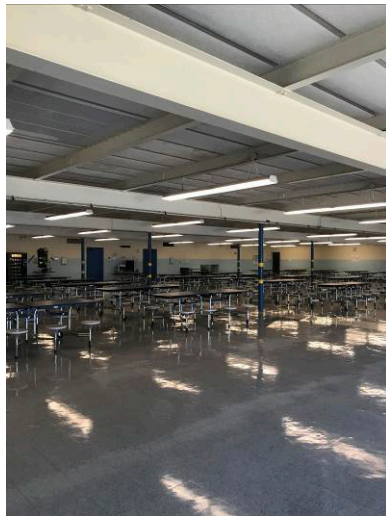
Cafeteria Lights

Cafeteria lighting consists of pendant wraparound fixtures with two T8 lamps.

- Cafeteria and Auditorium lighting will be upgraded with LED sources and electronic drivers. Theatrical lights with a dimming system will be provided for performances. Large Gym lighting could be reused.

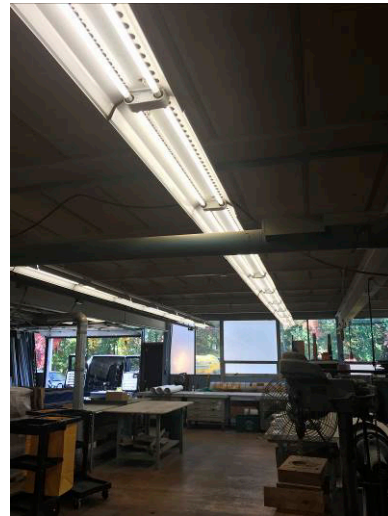
Shop Lights

Shops have pendant industrial strips with (2) T8 lamps locally switched.

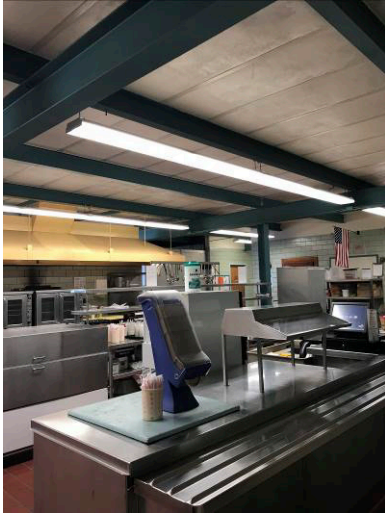
Servery's Fixtures

Kitchen/Servery has pendant wraps with two T8 lamps. Fixtures are not damp/wet location rated. Light switches exceed ADA height. Kitchen hood has globe fixtures with wireguards.

- Kitchen and Served lighting will consist of surface 2'x4' acrylic lensed troffers with aluminum frame doors with LED lamps and electronic drivers. Light levels will be approximately 50-75 foot candles.

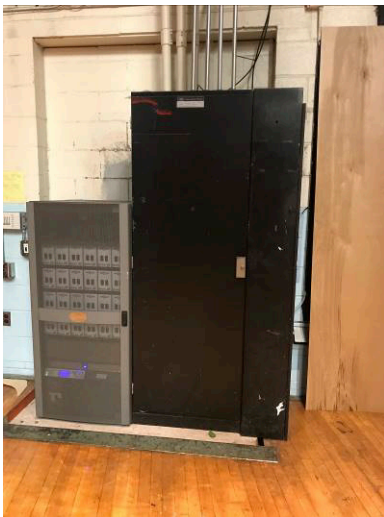
Stage Dimming Rack

The original Major dimming rack is still in place but has been augmented with a newer strand lighting 24 dual dimmer rack and controls.

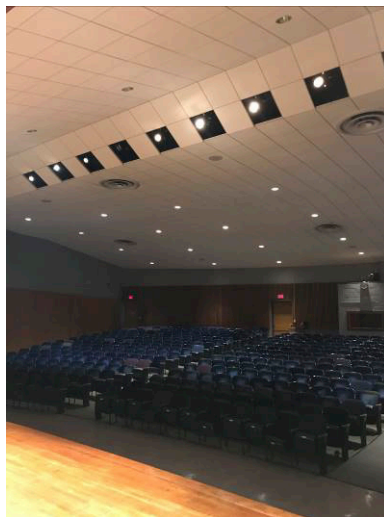
Auditorium Lights

Auditorium has recessed downlights with LED screw-in par lamps for house lighting. Isle lights integral to seat arm rest being used. Lights are controlled with preset dimmable door entry stations.

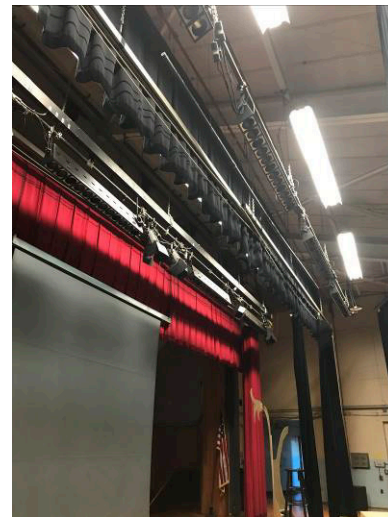
Stage Lights

Stage work lights consists of industrial strips of RLM fixtures.

Performance lighting consist of two wall mounted trims each with four fixtures and front of house fresnels. Stage has two electrics with border lights and fresnels.

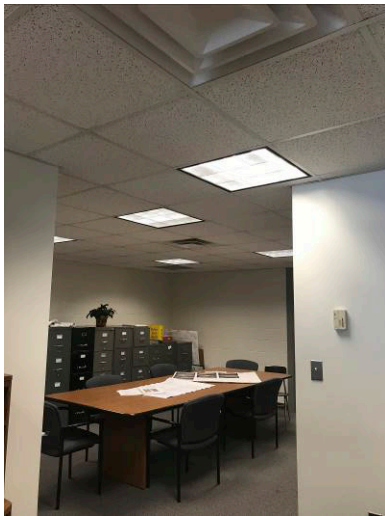
Office Lights

The office areas are lit with recessed 2x2 parabolic fixtures with T8U lamps and wraparound fixtures with T8 lamps.

- Office lighting fixtures will consist of acrylic recessed direct fixtures with LED lamps and electronic drivers for dual-level switching. Fully dimmable drivers will be provided where natural daylight is available. Lighting levels will be approximately 30 foot candles in classrooms and offices.

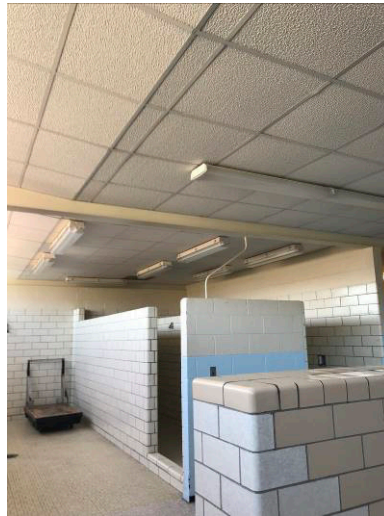
Shower Lights

Locker Rooms have continuous rows of wraparound fixtures with T8 lamps on local switches. Fluorescent vapor tight/wet location exist over showers.

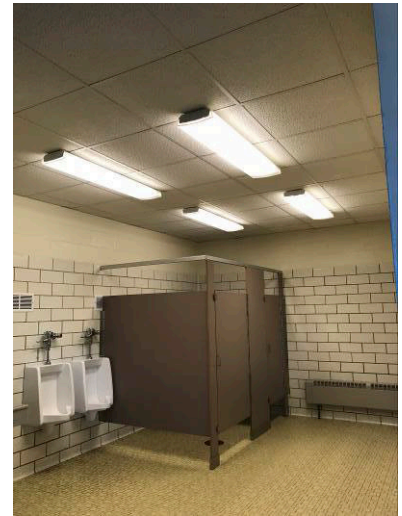
Toilet Room Lights

Typical Toilet Room has wraparound fixture on a local switch.

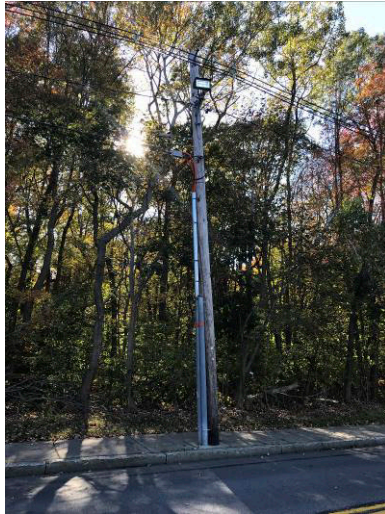
Pole with Mini-Flood

The exterior lighting for the front parking area consists of utility poles with HID floods located across the street. The side parking has (1) utility pole with a cobra head.

The parking areas are inadequately lit.

- Exterior site lighting fixtures for area lighting will be pole mounted long life, energy efficient LED luminaries in the parking areas. Building perimeter fixtures will be wall mounted LED over exterior doors. The exterior lighting will be connected to the automatic lighting control system for photocell on and timed off operation. All exterior lighting will be of the cut-off type.

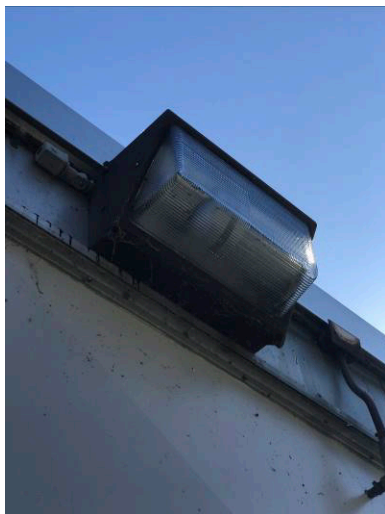
Exterior Wall Pack

HID wall packs are located around building perimeter including over egress doors. Fixtures are not of the cut-off type. Fixtures do not have quartz restrike for instant lighting upon a power loss.

The exterior lighting should be replaced with LED sources of the cut-off type.

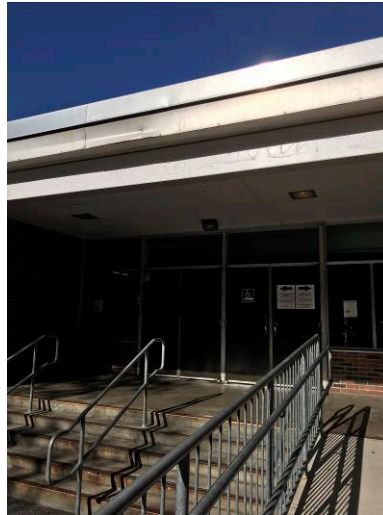
Canopy Fixtures

The Main Entrance canopy has recessed HID fixtures with acrylic lens and ceiling mounted wall packs.

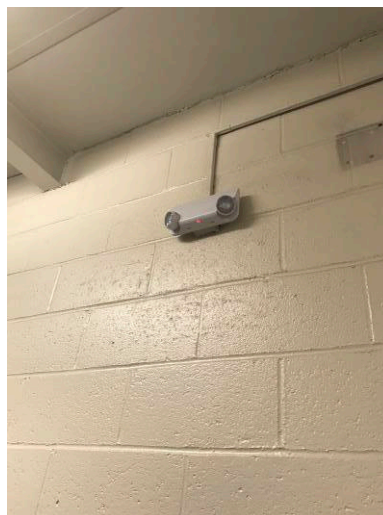
Battery Unit

Emergency lighting consists of battery units with integral heads. Emergency lighting coverage is generally inadequate.

The life safety systems are original and no longer code compliant. These systems should be replaced under a renovation program.

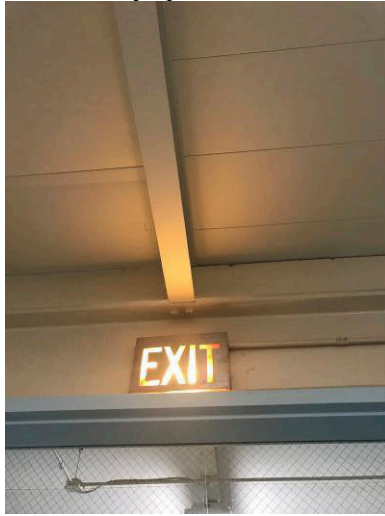
Old Functional Exit

Exit signs range from newer functional internally lit with battery back-up to original exit signs without battery back-up. Coverage is inadequate in many spaces.

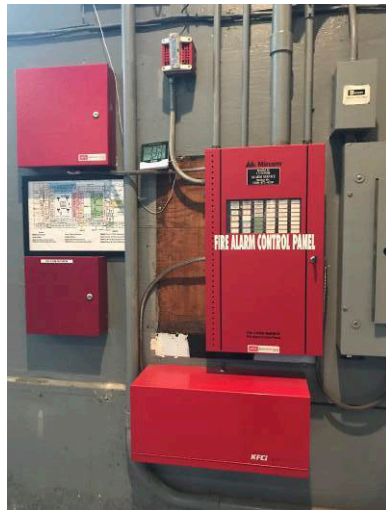
Fire Alarm Control Panel

The fire alarm system for the facility consists of a newer replacement zoned (non-addressable) Mircom FA-1000 series fire alarm control panel located in the Boiler Room. A remote LED annunciator is located outside the Main Lobby. The newer panel replaced the former FACP now used as a splice box. The existing zones were extended and monitored with addressable modules. The existing horn circuits were reconnected to the new panel.

Although a newer control panel was installed, existing wiring and devices were generally reused.

The existing fire alarm system does not meet current codes and should be replaced under a renovation program.

- A fire alarm and detection system in compliance with ADA should be provided with battery back-up. The system will be of the addressable type where each device will be identified at the control panel and remote annunciator by device type and location to facilitate search for origin of alarms. Smoke detectors will be provided in open areas, corridors, and other egress ways. The sprinkler system will be supervised for water flow and tampering with valves. Voice evacuation speaker/strobes will be provided in egress ways, classrooms, assembly spaces, open areas and other large spaces.
- Strobe only units will be provided in single toilets and conference rooms.
- Manual pull stations will be provided at exit discharge doors.
- The system will be remotely connected to automatically report alarms to fire department via the master box.

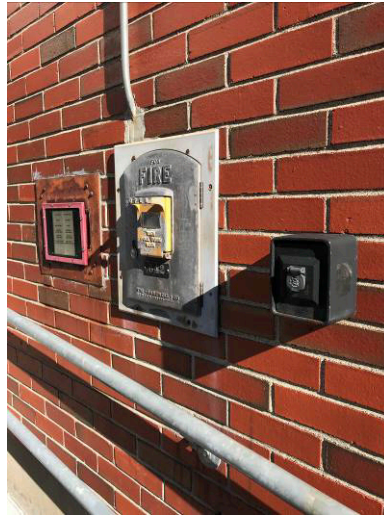
Master Box, Annunciator, & Key Box

The form of alarm transmission is via a local energy master box connected with IMSA Cable located outside the main lobby.

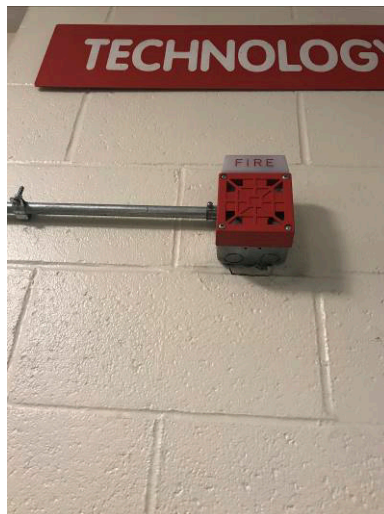
Horn/Strobe

Horn/strobes exist but are not ADA compliant and generally offer inadequate coverage, some exceed ADA mounting height. Classrooms do not have horn/strobes.

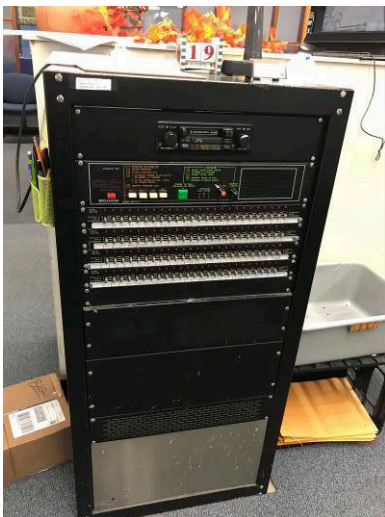
Paging Console

The paging system console, located within the Administration Area, is a Bogen Model MCP-3A. Paging is through a desktop digital telephone handset. Paging speakers exist throughout the school.

- The existing classroom intercom system should be replaced with a state of the art intercom system with web based software. Each classroom should be wired back as an individual home run for private conversations. New speakers should be located throughout the facility to ensure adequate coverage and capable of flexible selective zone paging. The existing master clock system should be replaced with a new GPS based wireless master clock system with repeaters in the IDF closets and 120V wireless secondary clocks located in each classroom, office and large space as needed.

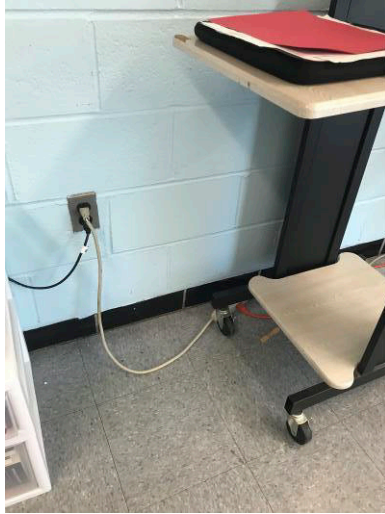
Classroom Extension Cord Use

The receptacle coverage is inadequate in most spaces. Typical classroom has one duplex receptacle per wall. Extension cords were noted being used throughout Classrooms and Labs. The use of extension cords for permanent wiring is a code violation.

- Additional duplex receptacle for general purpose power should be provided throughout the facility as required. Additional duplex receptacles for computer workstations in classrooms/labs should be installed and circuited to the computer grade panelboards outlined above.

- Each classroom should have a minimum of 2 duplex receptacles per teaching wall and 2 double duplex receptacles on dedicated circuits at classroom computer workstations. The Teacher's workstation should have a double duplex receptacle also on a dedicated circuit.

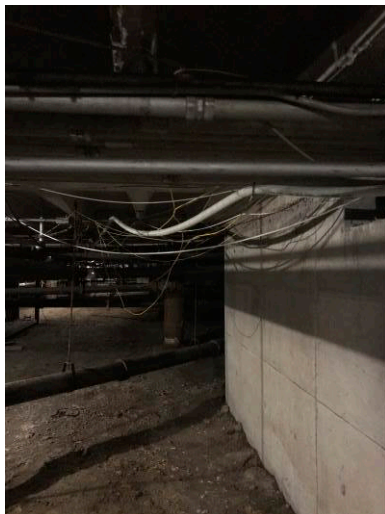
Crawl Space Wiring

Most wiring runs within crawl space.
