**FULLER MIDDLE SCHOOL
FRAMINGHAM, MASSACHUSETTS
STRUCTURAL EXISTING CONDITIONS REPORT
NOVEMBER 1, 2017**

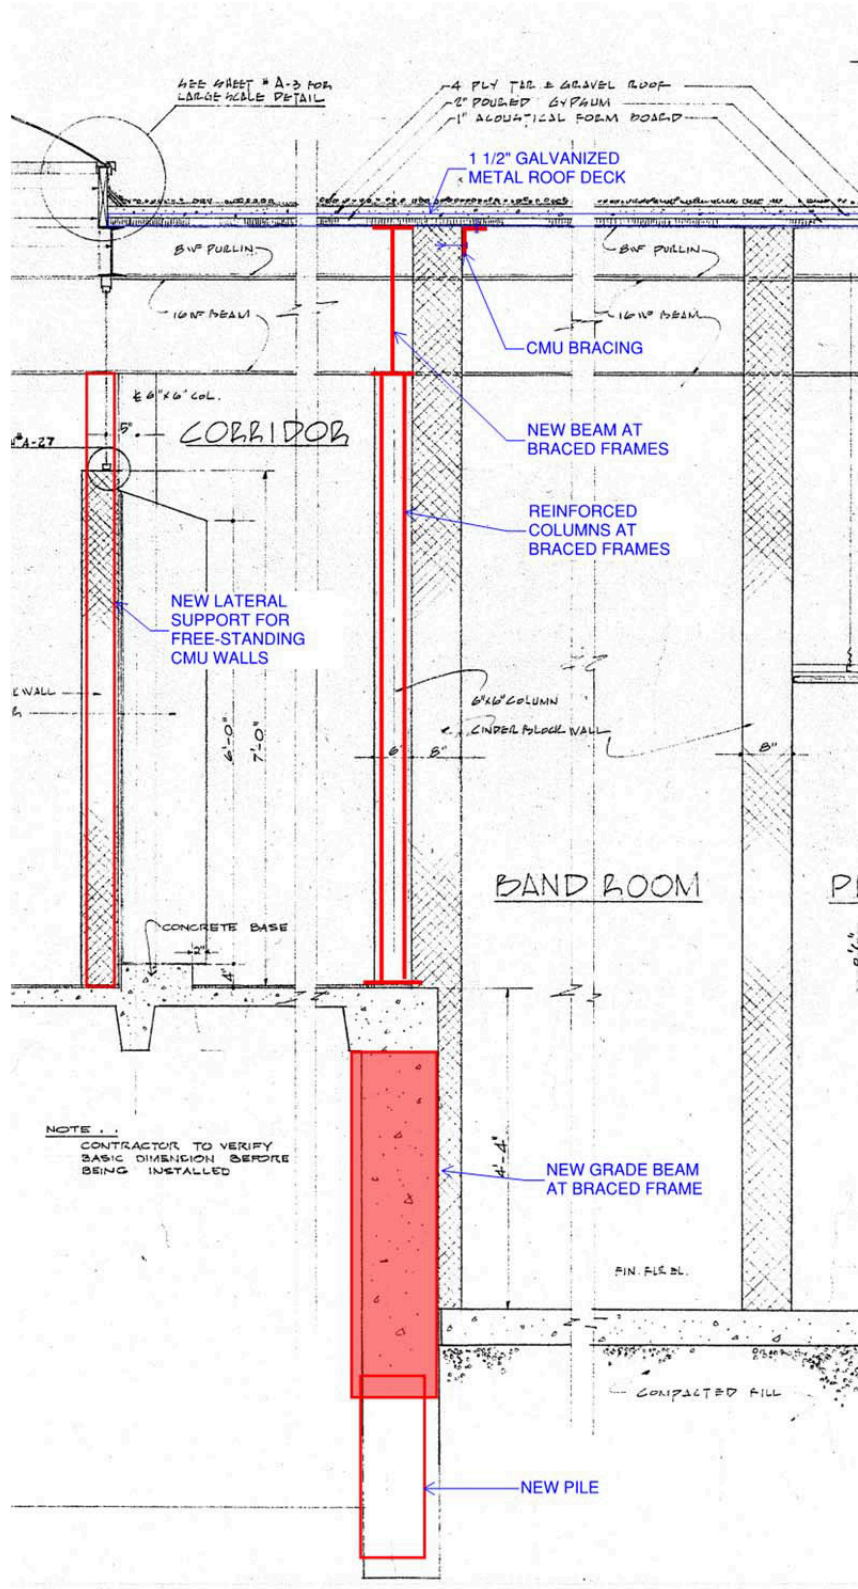
Seismic Upgrade Sketch

The original design of the building did not consider lateral loads. By default, the lateral stiffness is provided by the unreinforced CMU partitions. A renovation of the building will likely result in removed or relocated CMU partitions, and therefore a lateral design will be required based on the current code. If the CMU walls are not removed, RSE still recommends a seismic upgrade due to the significant financial investment and prolonged life expectancy of the building.

- i. Replace the entire gypsum roof deck with a metal deck that can distribute diaphragm loads. Gypsum is a brittle material that by nature does not have sufficient ductility to transfer diaphragm loads to the lateral system. Add supplemental steel framing (such as 8" steel beams) at the diaphragm edges that don't have existing steel beams. These are required because the 8" purlins sit above the girders and the load path is broken at the diaphragm edges.

- ii. Add a lateral system for the entire building, such as steel braced frames. Add grade beams or braced frames in the crawl space to transfer lateral loads to the ground. Reinforce brace frame columns as required. New piles might be required depending on location of braced frames, which will be difficult to install given the low clearance in the crawl space for the pile rig.

- iii. Brace CMU partitions to the roof diaphragm. If the gypsum roof is not replaced, supplemental steel will be required above the CMU partitions where the gypsum has been affected by roof leaks since fastening to saturated gypsum is not reliable.

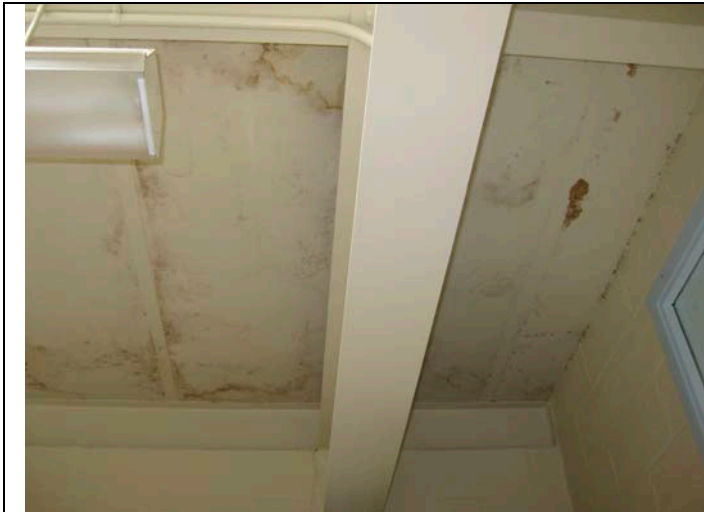
The steel roof framing appears to be in good condition and well maintained. There is widespread evidence of roof leaks, which causes the gypsum to be saturated with water. Prolonged exposure to entrapped water will compromise all properties of gypsum. Gypsum roof decks are a composite system that derives its strength from the sum of the parts (gypsum, wire reinforcement and steel tees), so a reduction in gypsum strength reduces the overall capacity of the roof deck system. Also, any mechanical fasteners that are screwed into the gypsum will see a reduced embedment capacity from the water-logged material.

Roof leaks causing rusted steel tees and water-logged gypsum slab.

- i. Address roof leaks and drainage. Replace areas of gypsum roof decks that are saturated with metal roof deck.
- ii. Repair or replace damaged first floor slab. Address cause of rusted rebar, such as adding a vapor barrier and slab in the crawl space and better ventilation.
- iii. Patch exterior concrete and repair rusted rebar.

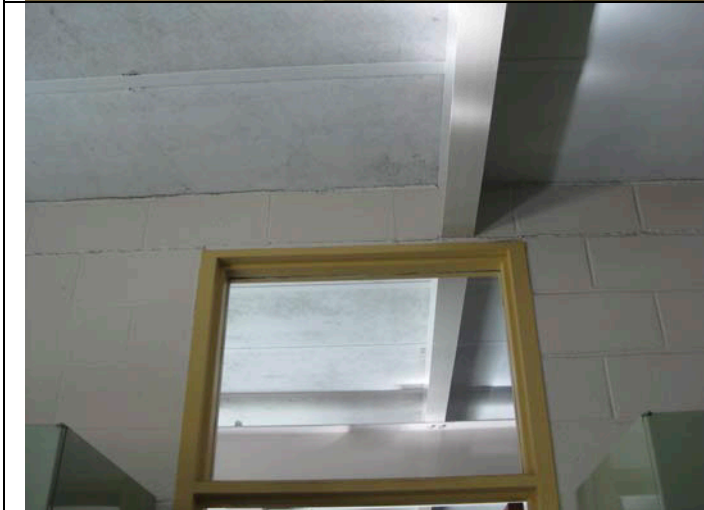
The existing partitions in the building are constructed from unreinforced CMU. Although customary in 1950's construction, these non-load bearing partitions are not up to current code since there is no positive attachment to the floor or roof diaphragms. Also, it is not obvious that every masonry opening has a lintel or bond beam to span over the opening. Some of the interior

No lintel observed.
Top of CMU is tight up against gypsum roof deck but not positively attached.

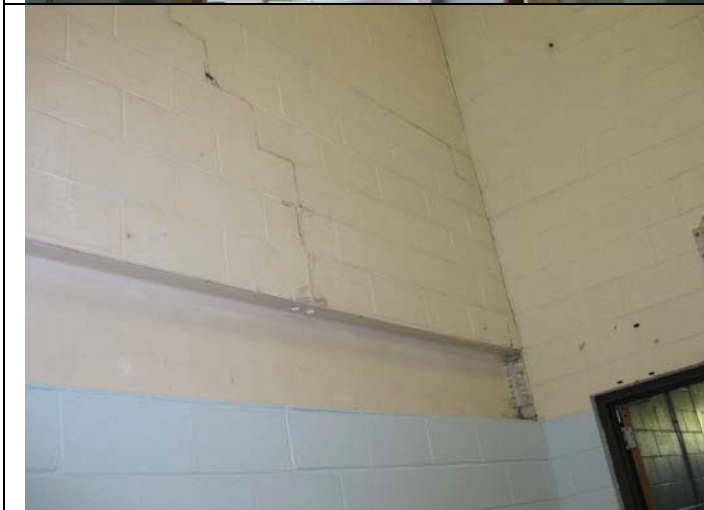
CMU walls exhibit cracking, which is not necessarily a structural concern, but could be remedied by some well-placed masonry joints.

CMU cracking at irregularities

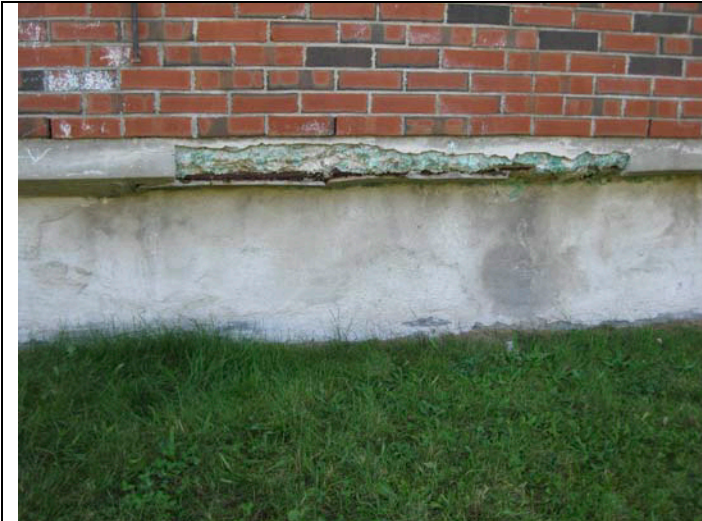
The first floor slab cantilevers over the concrete grade beam to support the exterior façade. There are some isolated areas of exposed rusted rebar and spalled concrete that can be repaired locally. The concrete exposed on the exterior is a thermal bridge to the interior conditioned space, which is a challenge to remedy if the building was renovated.

Exterior concrete rebar rusted and spalling

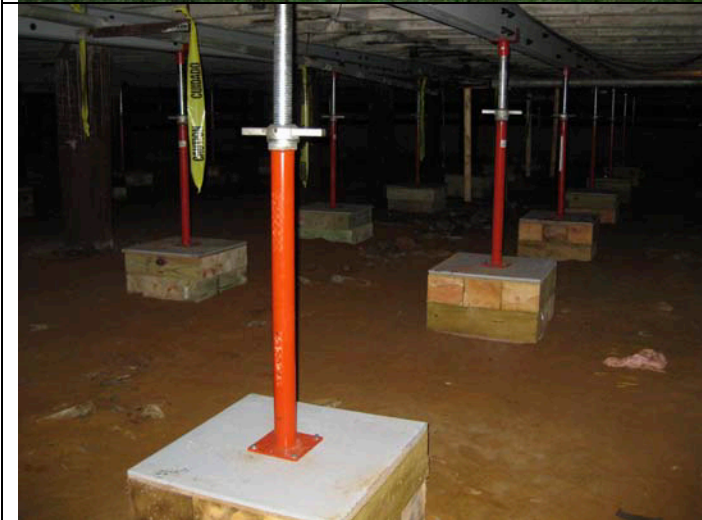
There is a significant area of the first floor that exhibits rusted and delaminated rebar on the concrete joists and girders. The worst area, under the garage space bound by grids N-T-0-5 is currently shored to grade. This should be considered a temporary fix considering no repair to the existing rebar was performed. The area of reduced structural capacity extends along the south wing (under classrooms B36-B48) in a similar fashion. The bottom rebar in the concrete joists have rusted, delaminated, and caused the concrete cover to spall and fall off. The current condition of the rebar is worse than noted in the 2013 Feasibility report since there is now rebar section loss rather than just concrete cover removal. Furthermore, it was noted from the maintenance workers that the spalled concrete damages the pipes underneath when the heavy concrete pieces fall.

Temporary shores in crawl space

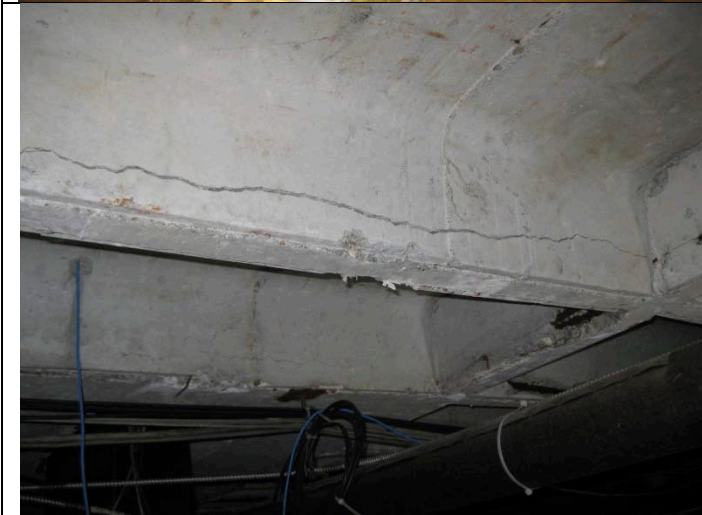
Additional concrete joists with spalling concrete (unshored)
