CHAPTER 34 NARRITIVE

FRAMINGHAM FULLER SCHOOL
FRAMINGHAM, MA

SUBMITTED: NOVEMBER 8, 2017

**FULLER MIDDLE SCHOOL
FRAMINGHAM, MASSACHUSETTS
STRUCTURAL EXISTING CONDITIONS REPORT
NOVEMBER 1, 2017**

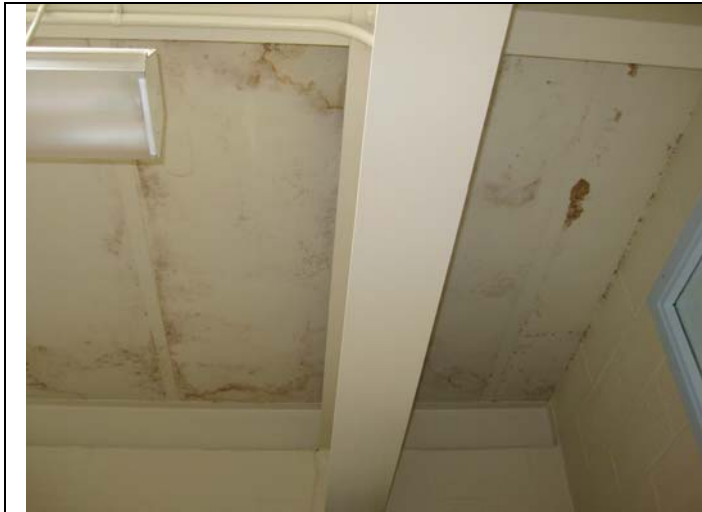
The steel roof framing appears to be in good condition and well maintained. There is widespread evidence of roof leaks, which causes the gypsum to be saturated with water. Prolonged exposure to entrapped water will compromise all properties of gypsum. Gypsum roof decks are a composite system that derives its strength from the sum of the parts (gypsum, wire reinforcement and steel tees), so a reduction in gypsum strength reduces the overall capacity of the roof deck system. Also, any mechanical fasteners that are screwed into the gypsum will see a reduced embedment capacity from the water-logged material.

Roof leaks causing rusted steel tees and water-logged gypsum slab.

- i. Address roof leaks and drainage. Replace areas of gypsum roof decks that are saturated with metal roof deck.
- ii. Repair or replace damaged first floor slab. Address cause of rusted rebar, such as adding a vapor barrier and slab in the crawl space and better ventilation.
- iii. Patch exterior concrete and repair rusted rebar.

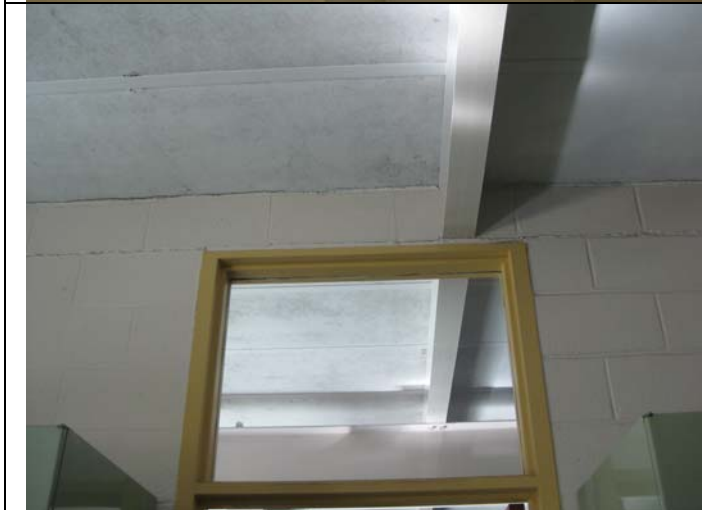
No lintel observed.
Top of CMU is tight up against gypsum roof deck but not positively attached.

- iii. Brace CMU partitions to the roof diaphragm. If the gypsum roof is not replaced, supplemental steel will be required above the CMU partitions where the gypsum has been affected by roof leaks since fastening to saturated gypsum is not reliable.

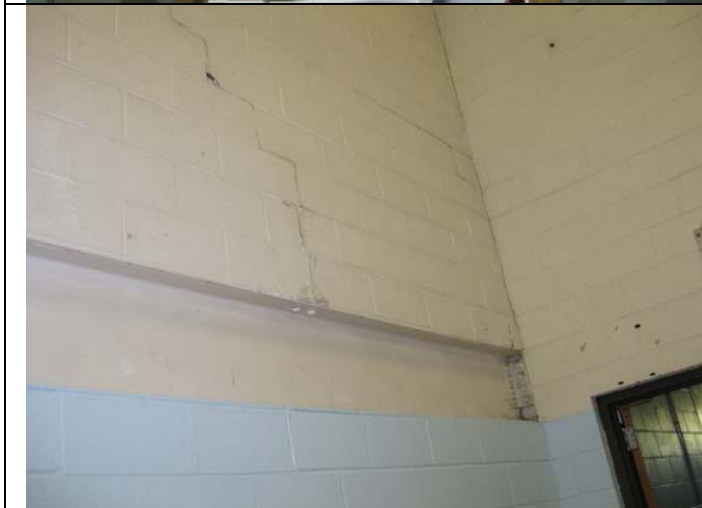
CMU walls exhibit cracking, which is not necessarily a structural concern, but could be remedied by some well-placed masonry joints.

CMU cracking at irregularities

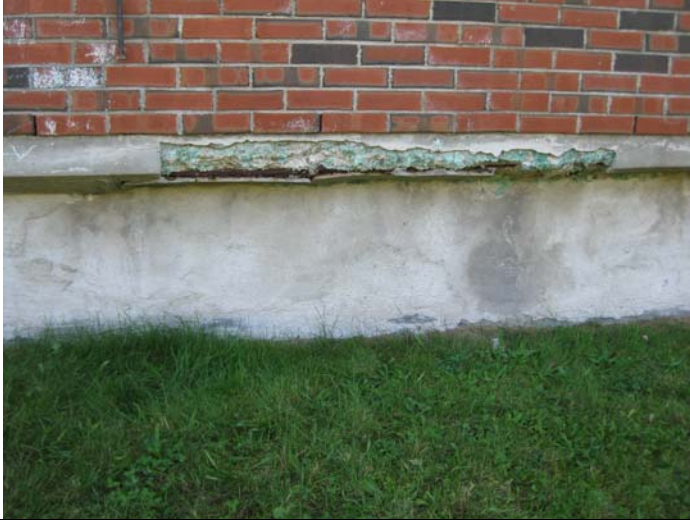
The first floor slab cantilevers over the concrete grade beam to support the exterior façade. There are some isolated areas of exposed rusted rebar and spalled concrete that can be repaired locally. The concrete exposed on the exterior is a thermal bridge to the interior conditioned space, which is a challenge to remedy if the building was renovated.

Exterior concrete rebar rusted and spalling

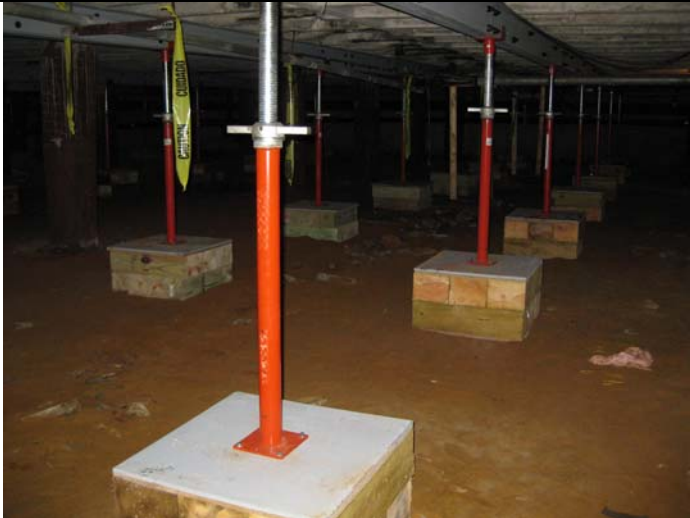
There is a significant area of the first floor that exhibits rusted and delaminated rebar on the concrete joists and girders. The worst area, under the garage space bound by grids N-T-0-5 is currently shored to grade. This should be considered a temporary fix considering no repair to the existing rebar was performed. The area of reduced structural capacity extends along the south wing (under classrooms B36-B48) in a similar fashion. The bottom rebar in the concrete joists have rusted, delaminated, and caused the concrete cover to spall and fall off. The current condition of the rebar is worse than noted in the 2013 Feasibility report since there is now rebar section loss rather than just concrete cover removal. Furthermore, it was noted from the maintenance workers that the spalled concrete damages the pipes underneath when the heavy concrete pieces fall.

Temporary shores in crawl space

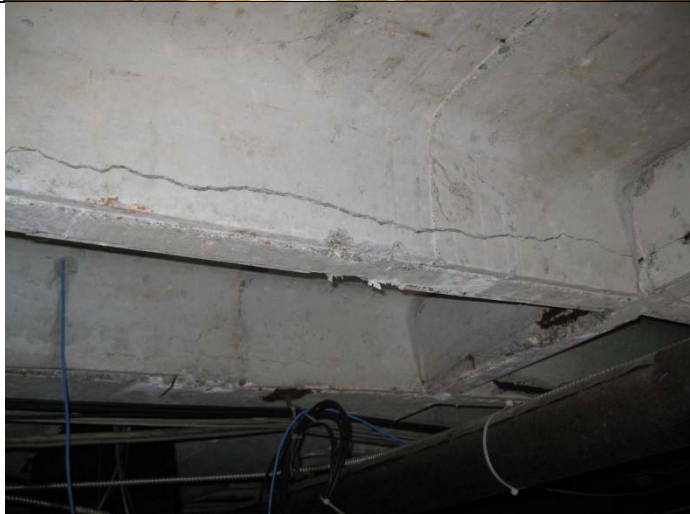
Additional concrete joists with spalling concrete (unshored)

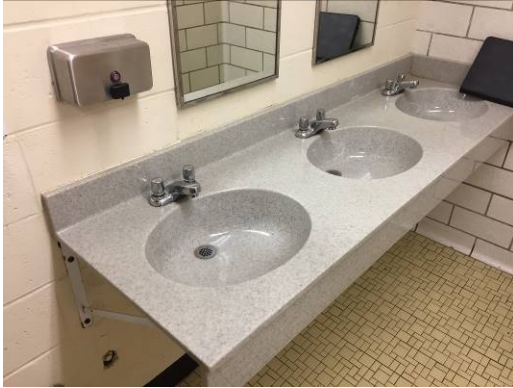
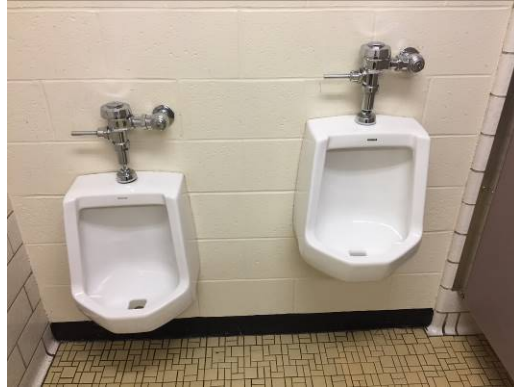
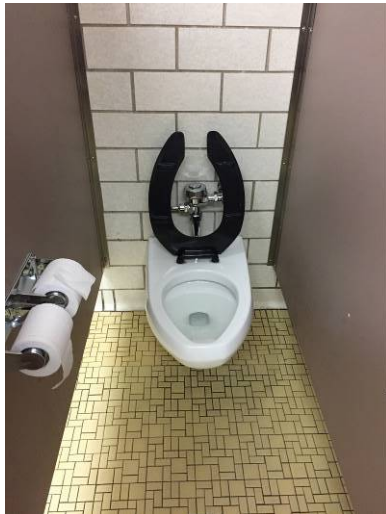
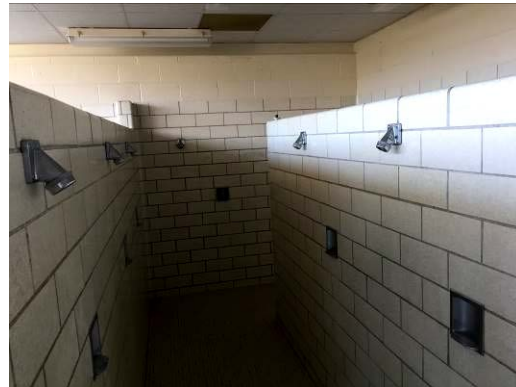
Typical Bathroom Fixtures & Showers

The plumbing fixtures are in fair condition. The gang toilet rooms have had the lavatories up graded to one piece countertop with integral sinks. In general, the fixtures appear to have served their useful life. Current Access Code requires accessible fixtures wherever plumbing is provided. In terms of the water conservation fixtures, their use is governed by the provisions of the Plumbing and Building Code. Essentially, the code does not require these fixtures to be upgraded, but where new fixtures are installed, as may be required by other codes or concerns, the new fixtures need to be water conserving type fixtures. All new fixtures are recommended.

- Replace all domestic water piping.
- Provide all new plumbing fixtures and science room equipment.
- Replace all natural gas piping.

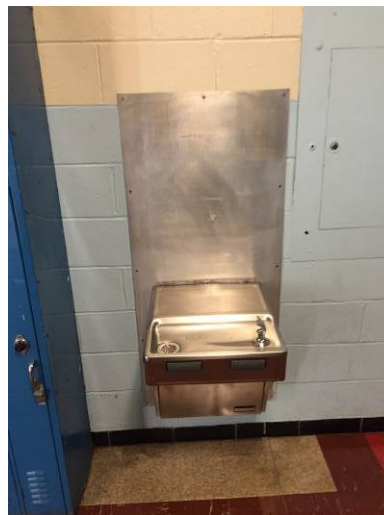
Drinking Fountain

Drinking fountains consist of wall hung stainless steel, non-accessible.

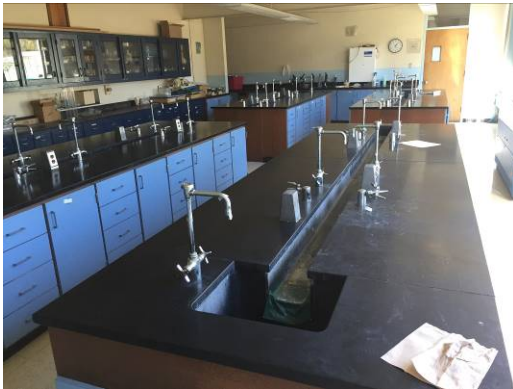
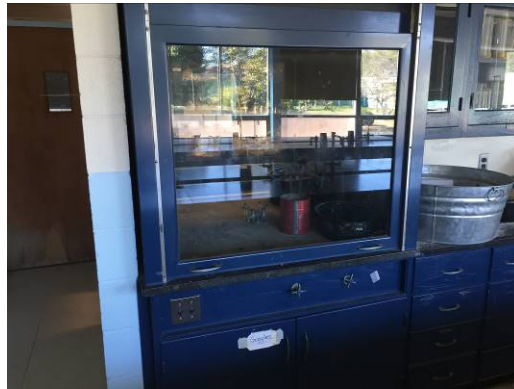
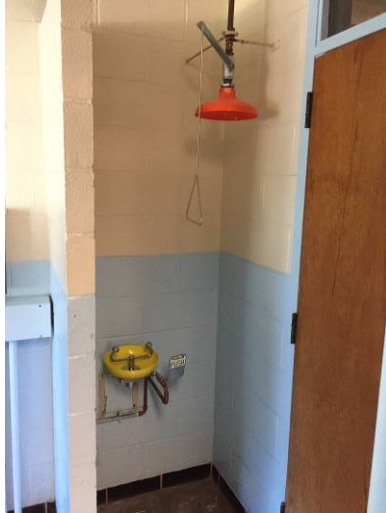
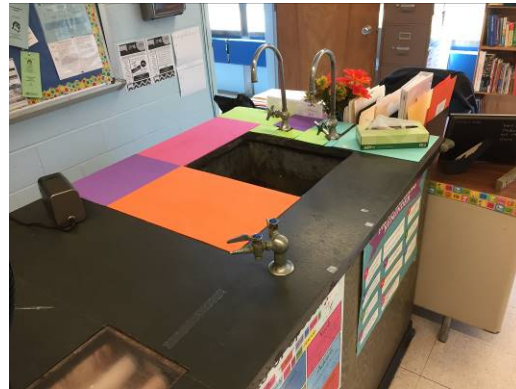
Typical Science Classroom

Science classroom sinks are resin type with cold and hot water faucets. Faucets are equipped with vacuum breakers. Classrooms contain an emergency shower fixture fed by the cold water system. Sinks are piped to an interior lime stone chip acid neutralization system located in the crawl space that ultimately discharges to the municipal sewer. The benches are provided with gas turrets, the gas is not turned on to the benches. No master gas valve shut off was provided.

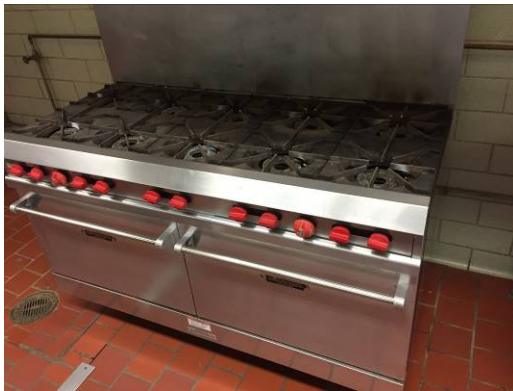
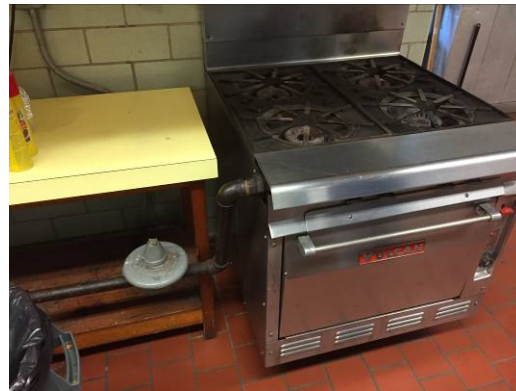
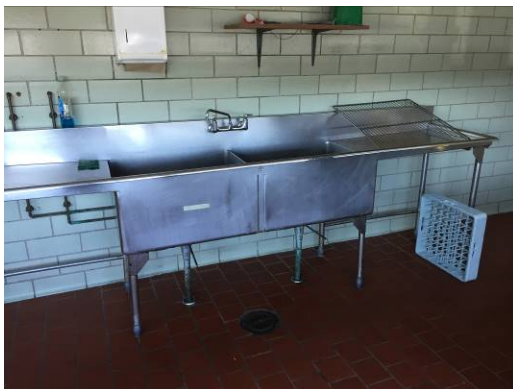
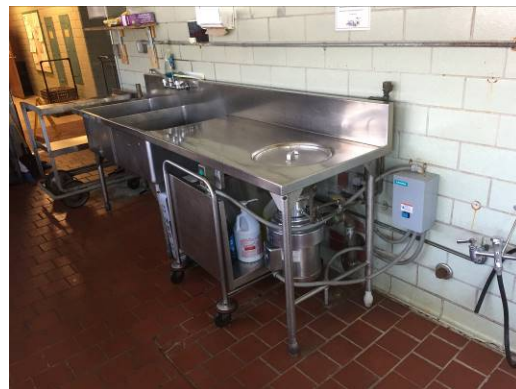
Typical Kitchen Equipment

Kitchen area fixtures are in poor condition. The pot washing sinks are fitted with grease interceptor located in the crawl space. The gas fired equipment is not provided with master gas shut off valve.

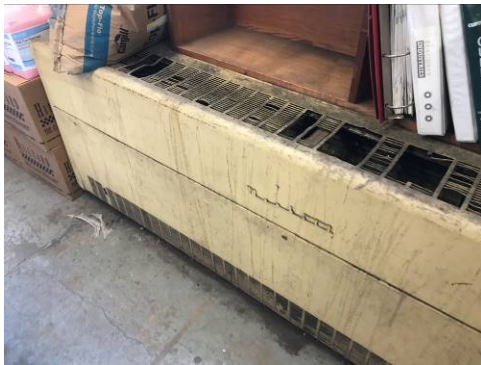
Shop area Unit Ventilator

The Shop areas are typically heated and ventilated by a combination of wall mounted unit ventilators, fin tube radiation and unit heaters. The majority of equipment is originally installed equipment, circa 1957, and in need of replacement. The unit ventilators were noted to have a source of outside ventilation air, supply fans, filters, and a heating hot water coil with valve control. The general condition of the unit ventilators, unit heaters and radiation heating equipment observed were in poor condition.

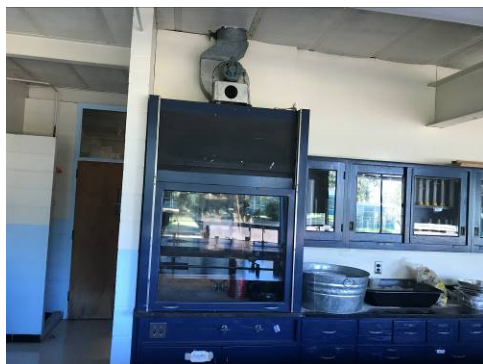
Science Classroom Fume Hood

The Science Classroom has an old fume hood and exhaust air fan system which appears to have been originally installed equipment and in poor physical condition. Many of the Classrooms observed appear to have window air conditioners installed

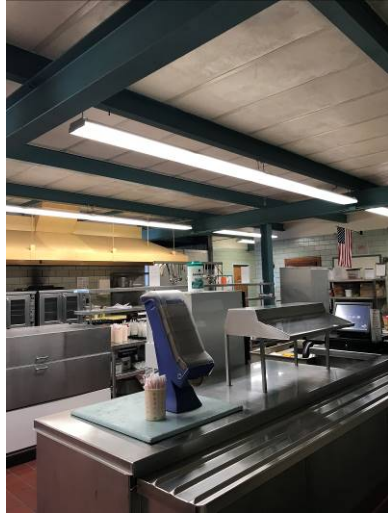
Servery's Fixtures

Kitchen/Servery has pendant wraps with two T8 lamps. Fixtures are not damp/wet location rated. Light switches exceed ADA height. Kitchen hood has globe fixtures with wireguards.

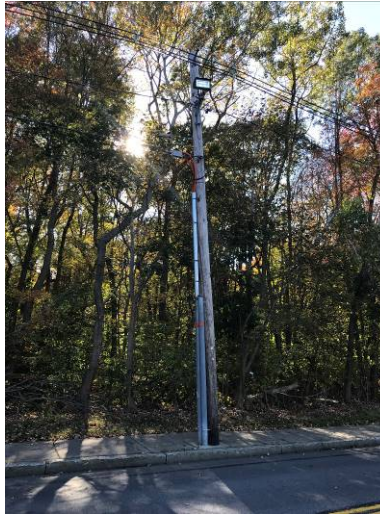
Pole with Mini-Flood

The exterior lighting for the front parking area consists of utility poles with HID floods located across the street. The side parking has (1) utility pole with a cobra head.

The parking areas are inadequately lit.

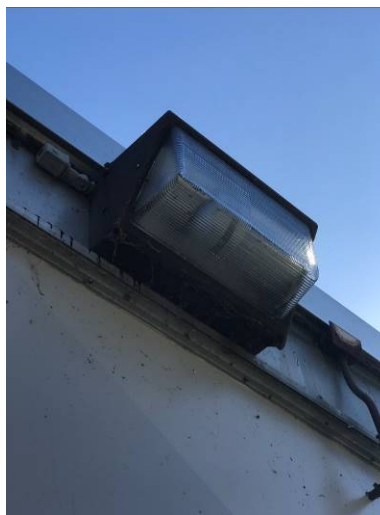
Exterior Wall Pack

HID wall packs are located around building perimeter including over egress doors. Fixtures are not of the cut-off type. Fixtures do not have quartz restrike for instant lighting upon a power loss.

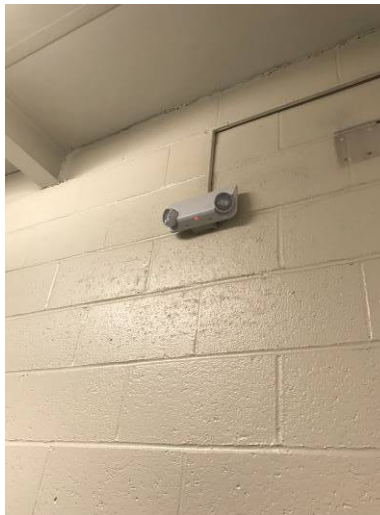
Battery Unit

Emergency lighting consists of battery units with integral heads. Emergency lighting coverage is generally inadequate.

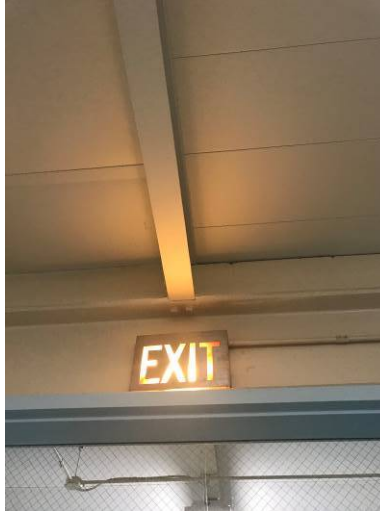
Old Functional Exit

Exit signs range from newer functional internally lit with battery back-up to original exit signs without battery back-up. Coverage is inadequate in many spaces.

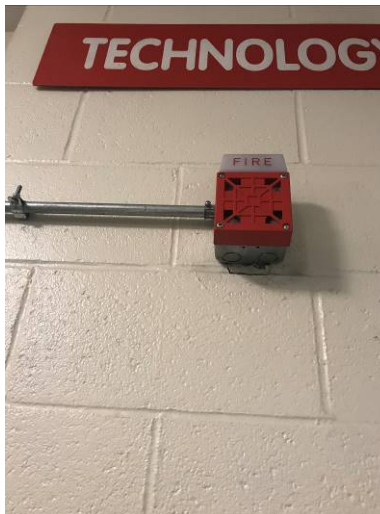
Horn/Strobe

Horn/strobes exist but are not ADA compliant and generally offer inadequate coverage, some exceed ADA mounting height. Classrooms do not have horn/strobes.

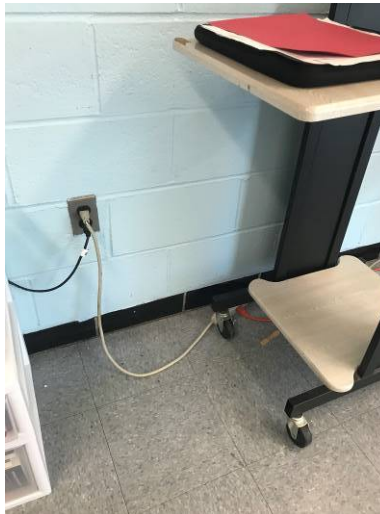
Classroom Extension Cord Use

The receptacle coverage is inadequate in most spaces. Typical classroom has one duplex receptacle per wall. Extension cords were noted being used throughout Classrooms and Labs. The use of extension cords for permanent wiring is a code violation.
