Pre-Feasibility Study

Fuller Middle School and Farley Building
Framingham Public Schools

Framingham, Massachusetts

February 27, 2013

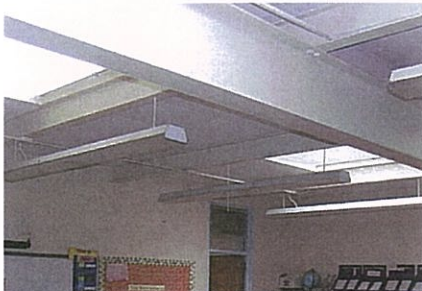
Typical steel framing at classroom

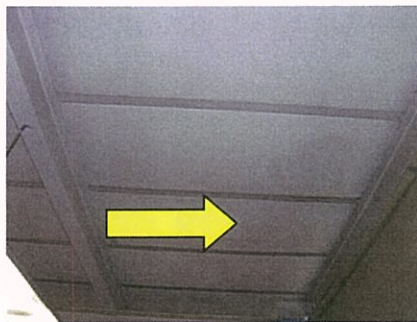
Typical ceiling panel on tees (discoloration from moisture)

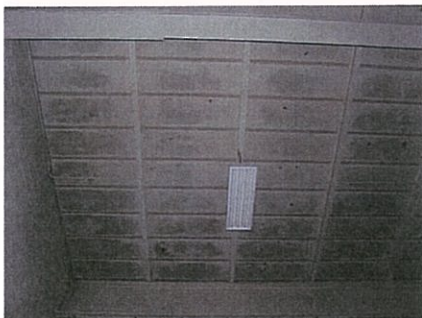
Gym ceiling (discoloration from moisture)

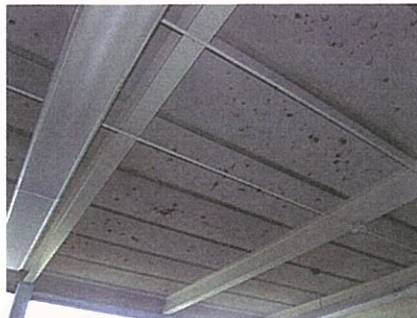
Impact damage in corridor ceiling

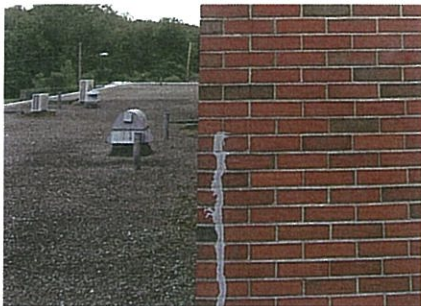
The upper gymnasium walls have no control joints; stepped cracking from thermal movement was observed at the corners.

Cracking at upper gym walls

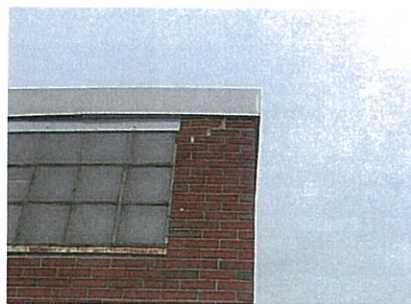
Stepped cracking at top of gym wall

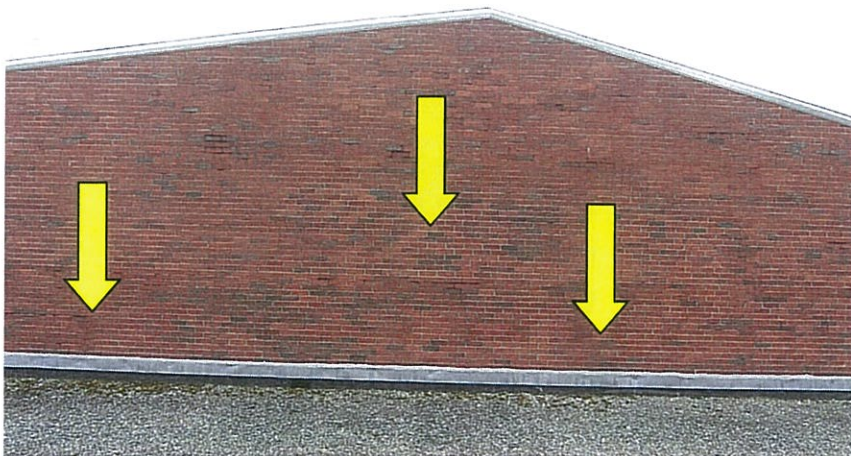
Moisture passing through auditorium north wall

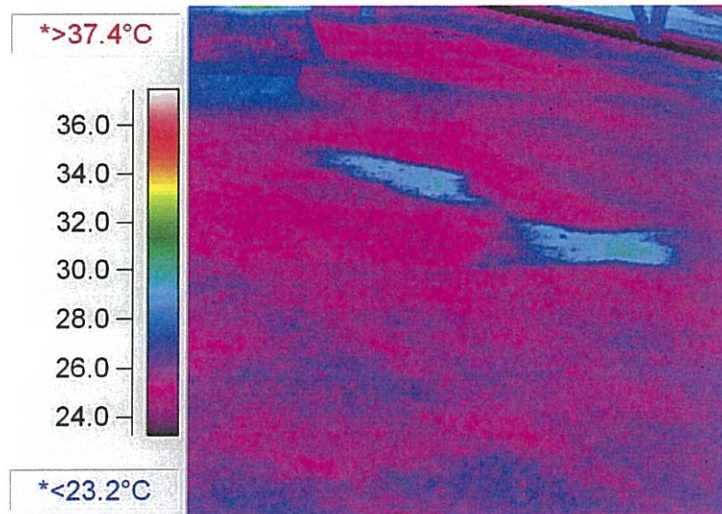
Infra-red thermogram shows areas with moisture below surface

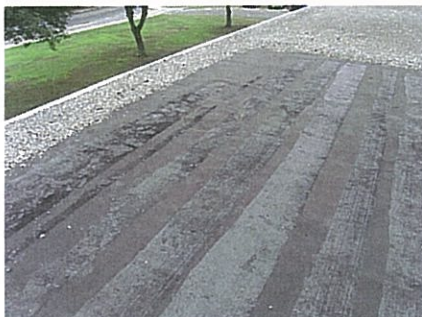
Repair areas along south side of building

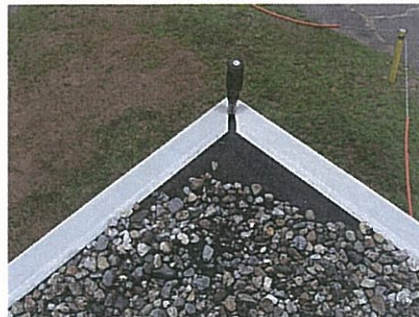
Open joint in coping, southeast corner

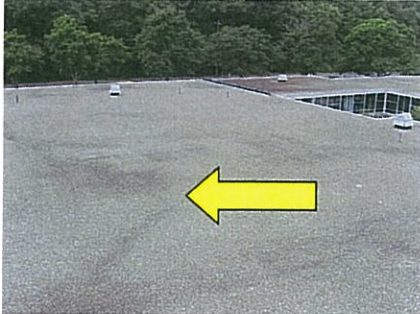
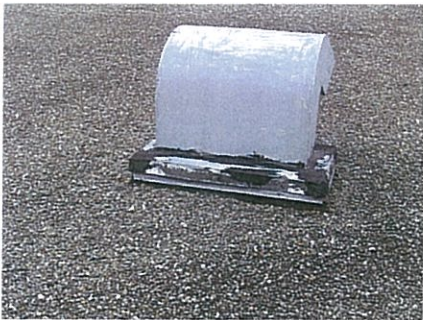
Hood flashing repaired with mastic

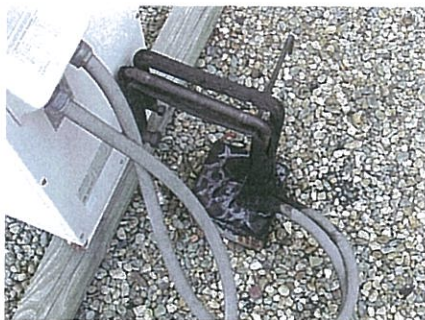
Piping insulation on condensing units has deteriorated and missing. The insulation is closed cell foam; exposed roof insulation should be fiberglass with a weather-proof PVC jacket.

Failing pitch pocket/missing insulation at piping

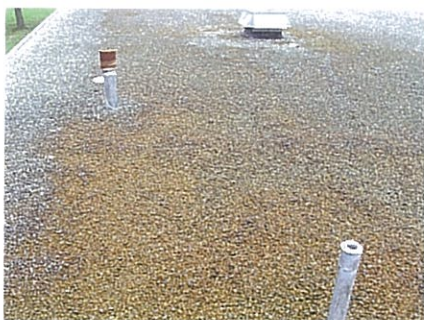
Discoloration from ponding water

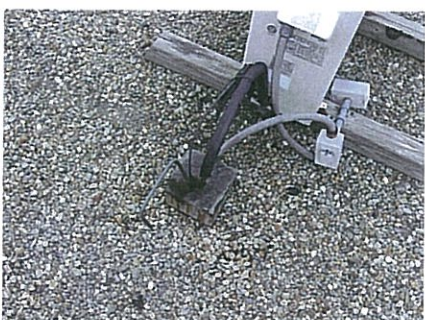
Pitch pocket/loose electrical connections

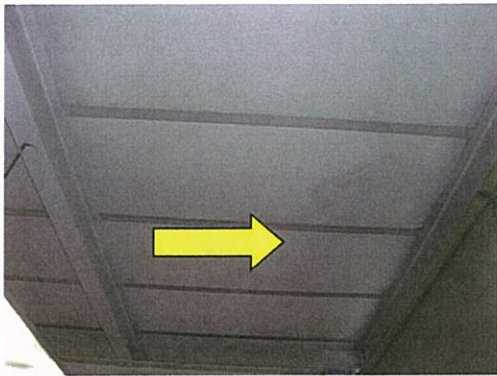
Typical ceiling/roof panels with staining

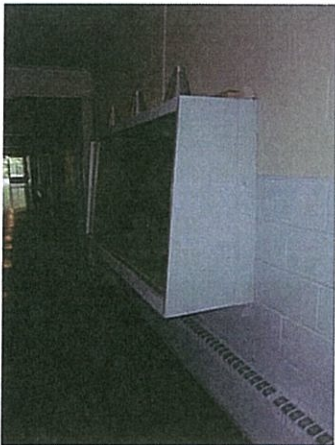
A number of the existing display cases project more than 4" into the egress path and do not meet the requirements of the Massachusetts Architectural Access Board (MAAB) or ADA. Cases would need to be replaced or provisions to protect the projection would be needed as part of a major renovation.

Display case

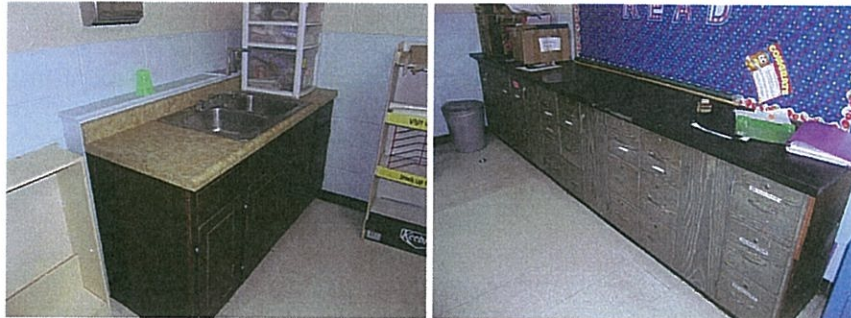
Classroom Wing: Casework has been replaced with non-commercial grade cabinets with post-formed plastic laminate tops. Other casework in this area appears to be refinished/repaired existing casework. Casework is not accessible.

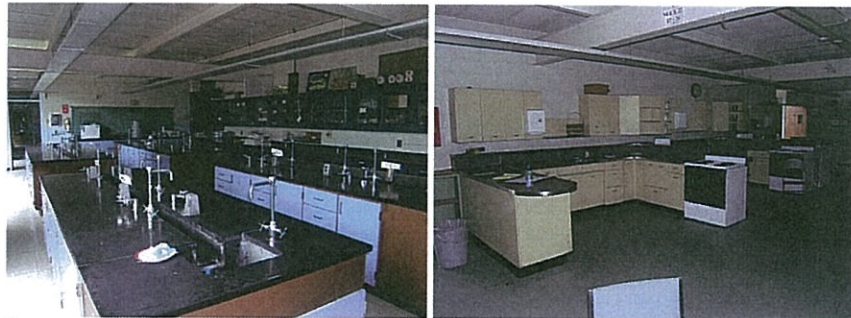
Science Classrooms: Casework appears original. Fittings have been replaced; doors and hardware repaired. Casework does not provide accessible stations.

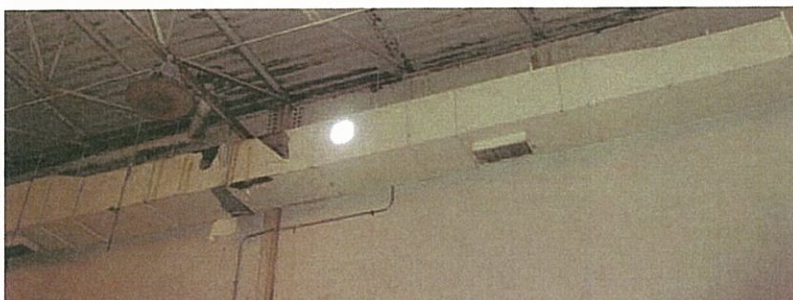
Similar to the main building, the design snow loads for the school are noted to be 40 pounds per square foot on the original construction drawings. Current flat roof snow loads for a new school in Framingham would be 42 pounds per square foot, which is marginally above the original design load. If the roof is renovated and the roof structure altered, the existing members in the areas of the alteration will need to be reviewed with modified current snow loads, including drifting snow, to verify their adequacy. Based on the site visit, it is expected that the existing pool roof framing would be fully inspected and likely require replacement of the deck and possibly roof framing if the joists are determined to be deteriorated and deficient.

Rusting at metal joists and deck

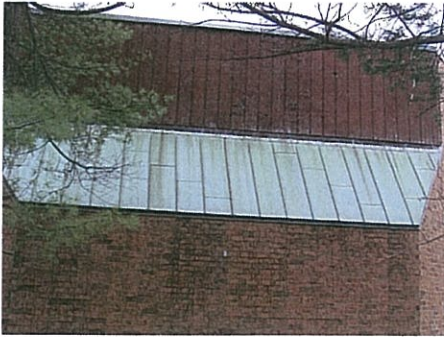
The exterior walls of the pool building are stained with efflorescence, indicating moisture is leeching outward through the brick. The moisture could be caused by water entering the wall cavity at the roof level or being pulled out of the abandoned pool building.

Corner of pool building deterioration

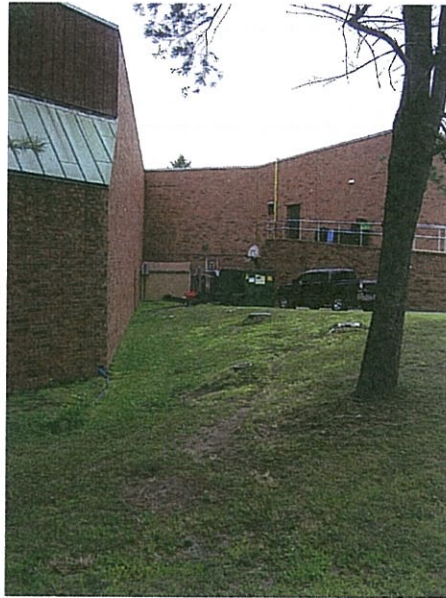
Pool water pumped and daylighted at grade

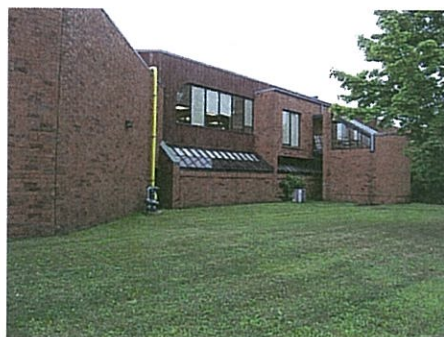
The windows are well maintained and in good working order. Some glass units have deteriorated surfaces; no active leaks were reported.

Sloped glazing at first-floor classrooms

Glass units with deteriorated surfaces should be replaced.

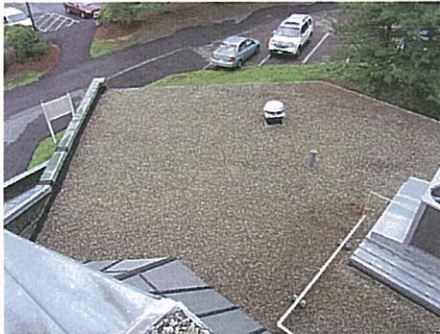
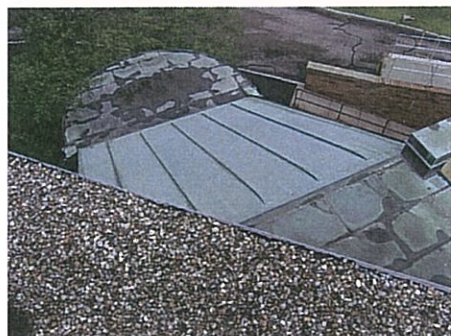
Standing water on flat copper roofing

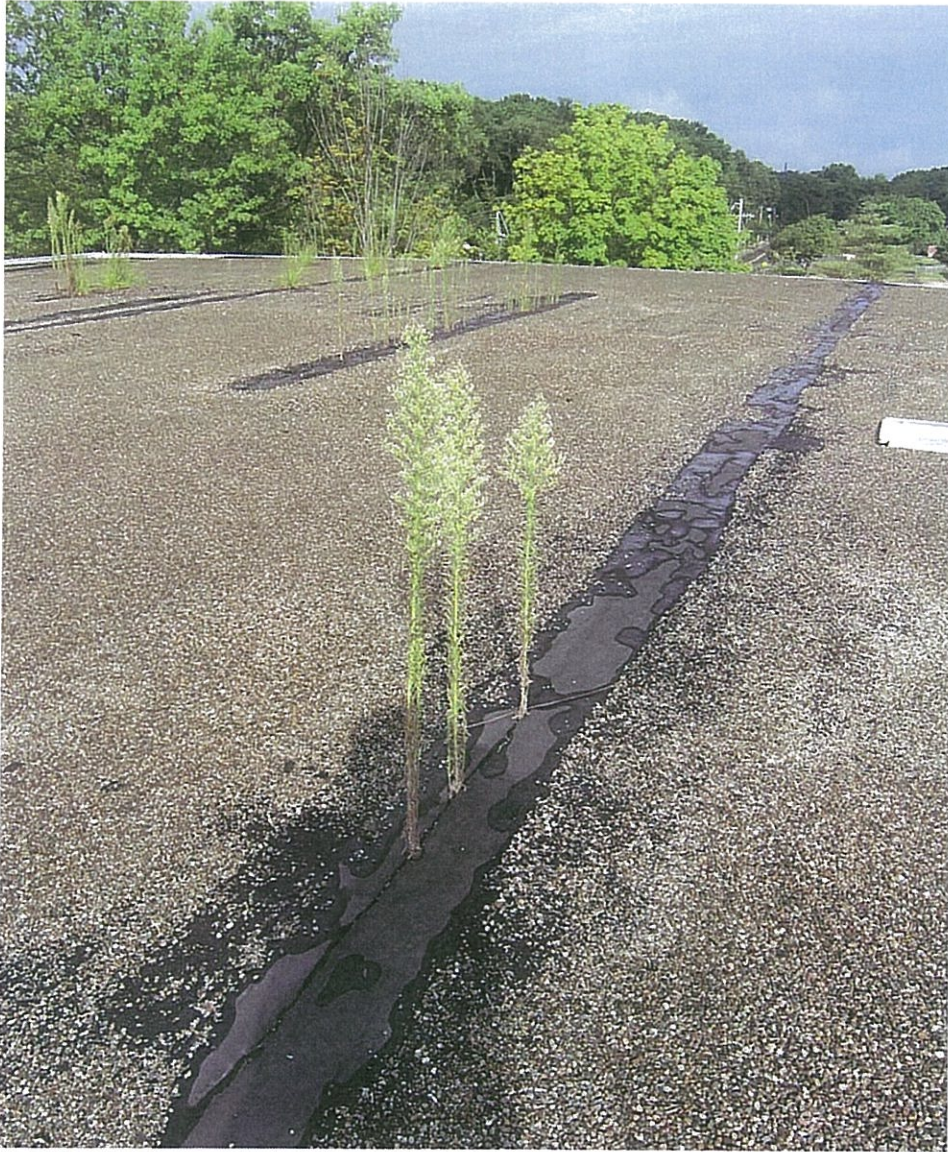
Condition of pool area roof – typical

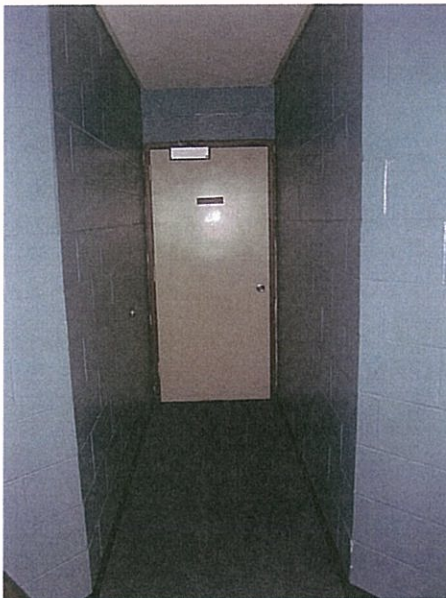
Typical non-accessible corridors and door configurations
