Mineola Union Free School District
121 Jackson Avenue, Mineola, NY 11501

BUILDING CONDITION SURVEY 2015

JANUARY 21, 2016

Michael Mark, AIA
Principal
Mark Design Studios Architecture, PC

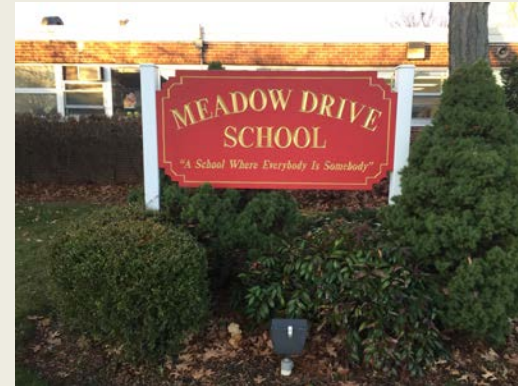
MEADOW DRIVE SCHOOL

- Kitchen/Cafeteria is in need of renovation.
- Classroom Doors/hardware and glass transoms do not meet current code and replacement should be replaced to improve building safety.
- Renovate toilets to comply with ADA requirements.
- Replace VAT floor tile where necessary.
- District will conduct roof moisture scans and require manufacturer to honor warranty for any issues.
- The building is in the process of undergoing masonry restoration and window replacement.
- Asphalt walkways at building rear are in poor condition and in need of replacement.
- Playground surfacing recommended with ADA play components.

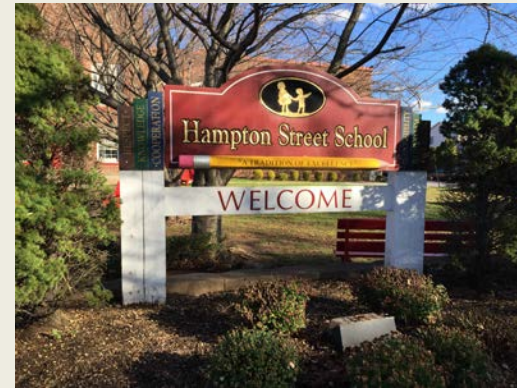
HAMPTON STREET SCHOOL

- Classroom Doors/hardware do not meet current code and replacement should continue on an ongoing basis until complete.
- Glass partitions at corridors must be 1-hour fire rated.
- Replacement of one boiler recommended.
- District will conduct roof moisture scans and require manufacturer to honor warranty for any issues.
- The building is in the process of undergoing masonry restoration and window replacement.
- Asphalt parking lot is in poor condition and in need of replacement.
- Playground surfacing recommended with ADA play components.

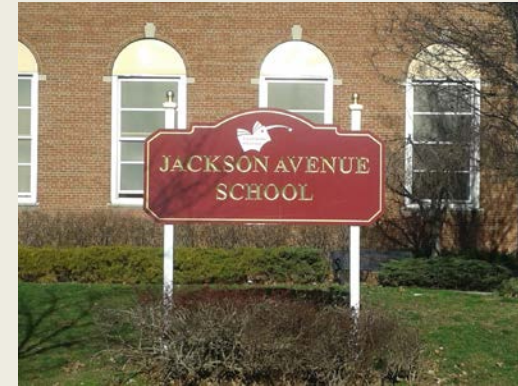
JACKSON AVENUE SCHOOL

- Classroom Doors/hardware do not meet current code and replacement should continue on an ongoing basis until complete.
- Existing heating plant, cast iron radiators and unit vents recommended for replacement.
- Replace existing ceiling and lights at cafeteria lobby.
- District will conduct roof moisture scans and require manufacturer to honor warranty for any issues.
- Exterior entrance doors and hardware to be replaced in Masonry contract.
- Concrete walks are in need of repair.
- Playground surfacing recommended with ADA play components.

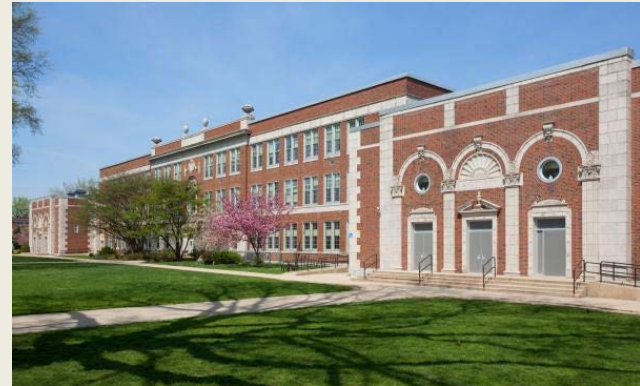
MINEOLA MIDDLE SCHOOL

- Classroom Doors/hardware do not meet current code and replacement should continue on an ongoing basis until complete.
- Replace existing ceiling and lights through out the second and third floor along with the first floor music wing.
- Improve controls for the heating system.
- Replace existing where required and provide additional fire alarm devices per fire code.
- District will conduct roof moisture scans and require manufacturer to honor warranty for any issues.
- The building is in the process of undergoing masonry restoration. Concrete walks are in need of repair.

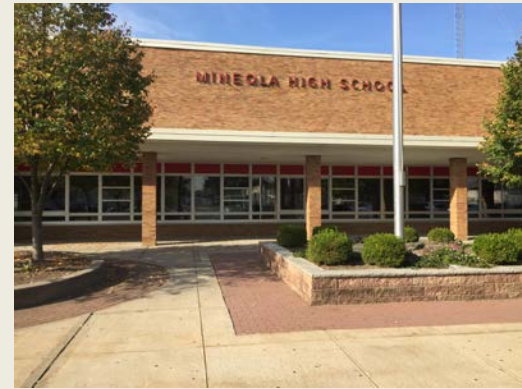
MINEOLA HIGH SCHOOL

- Classroom Doors/hardware do not meet current code and replacement should continue on an ongoing basis until complete.
- Replace VAT floor tile where necessary & Fitness Room rubber flooring.
- Student Locker Replacement / Removal recommended.
- Replacement of main boilers recommended.
- District will conduct roof moisture scans and require manufacturer to honor warranty for any issues.
- The building is in the process of undergoing masonry restoration project.
- Asphalt parking lots are in poor condition and in need of replacement.

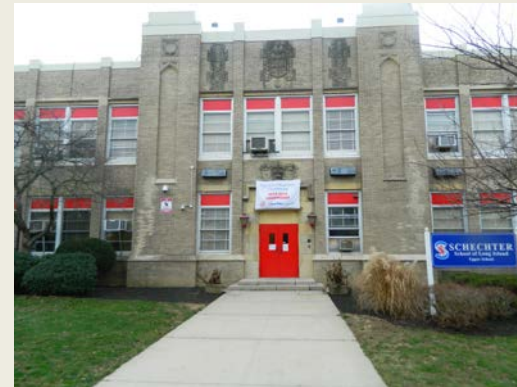
CROSS STREET SCHOOL

- Classroom Doors/hardware do not meet current code and replacement should continue on an ongoing basis until complete.
- Replace corridor ceiling and grid along with existing light fixtures.
- Toilets do not fully comply with ADA.
- Refinish gymnasium floor.
- Replace existing boiler along with boiler feed pumping system
- District will conduct roof moisture scans and require manufacturer to honor warranty for any issues.
- Asphalt pavement and concrete walks need repair work. Replace chain link fence.
- Playground surfacing recommended with ADA play components.

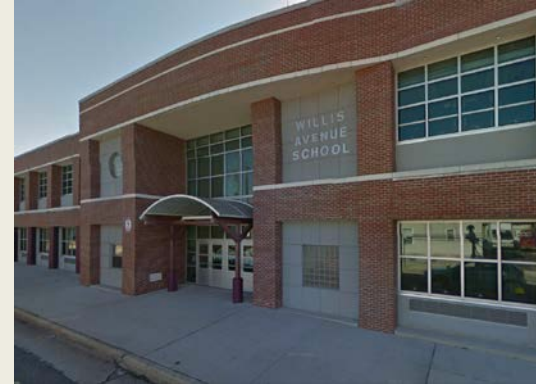
WILLIS AVENUE SCHOOL

- Remove existing playground safety surface tiles. Provide new pourable safety surface and ADA accessible equipment.
- Carpeting needs repair throughout the building.
- Concrete walks need repair work.
- Repairs required to the EIFS on the building exterior in several locations.
- Address window leaks at second floor curtain wall.
- Exterior fresh air louvers need to be sealed properly.

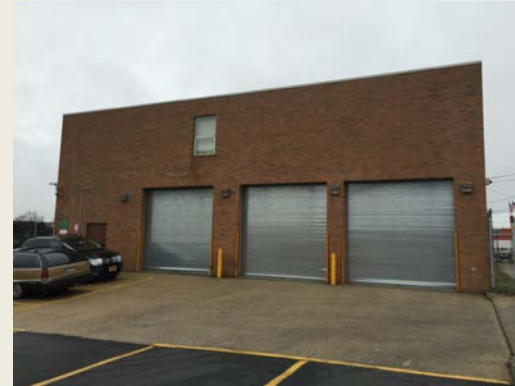
BUS GARAGE

- Roof/skylights have reached the end of their useful life and requires replacement.
- Skylights & South windows require guards to protect from baseball impact damage.
- Window replacement in progress.
- Repair masonry expansion joints on all except north wall.
- Toilets do not fully comply with ADA.
- Replace wall ladder at scuttle to fully extend to roof for maintenance.
- Replacement should be planned for two oil-fired unit ventilators in Bus Garage area.

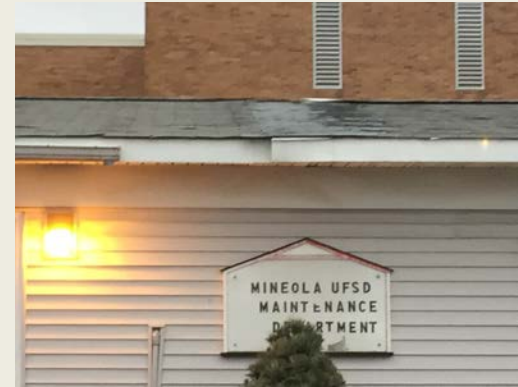
BUILDINGS AND GROUNDS

- Repair roof along center core of structure. Plan for eventual roof recovery.
- Patching of CMU foundation required at several locations.
- Replacement of rear exterior doors is recommended.
