MILL VALLEY SCHOOL DISTRICT FACILITIES ASSESSMENT 2018

MILL VALLEY MIDDLE SCHOOL

FACILITY CONDITION ASSESSMENT

Mill Valley Middle School
425 Sycamore Avenue
Mill Valley, California 94941

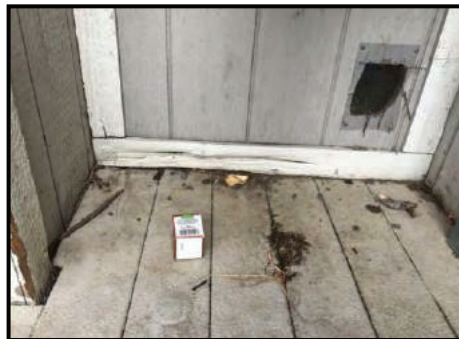
**PHOTO - 6
PORTABLE**

There are significant areas of dry rot on the exterior siding of the Gym, Main Building, and portables 78 - 82. The Gym also shows considerable evidence of clamshell fungus. Both conditions indicate that the exterior finish needs to be replaced in the near future. Furthermore, the Gym and Main Building roofs are deteriorating and roof replacement is recommended within the next few years. The Gym's steel window frames are rusting and are also due for replacement. Replacing the Main Building's single glazed windows is recommended as an energy saving investment. The interior finishes have been periodically replaced as-needed over the years, and regular on-going replacement is budgeted.

Exterior siding on portables 78 - 82 show significant areas of dry rot

All of the buildings have T-111 exterior siding. This product is wood and thus is susceptible to rot and deterioration. The Gym, Main Building and portables 78 - 82 show significant areas of dryrot. The Gym also shows considerable clamshell fungus. These conditions indicate that the exterior finish needs to be replaced. The portables have metal roofs and the other two buildings have modified bitumen roofs. The modified bitumen is very near the end of its life. The fiberglass fibers are showing, several areas are blistering and cracking. Replacement is recommended in the next few years. The Gym has steel window frames that are rusting, replacement is recommended. Modernizing the Main Building by replacing the single glazed windows is also recommended as an energy saving investment.

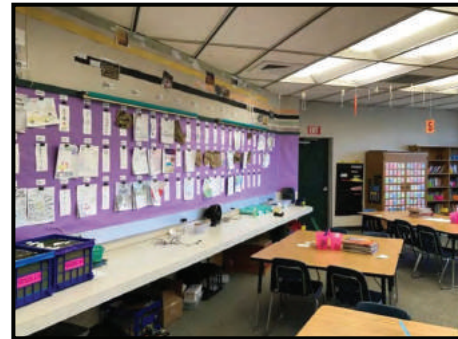
**PHOTO - 7
CLASSROOM**

Classroom pods need more breakout spaces, storage, and sinks

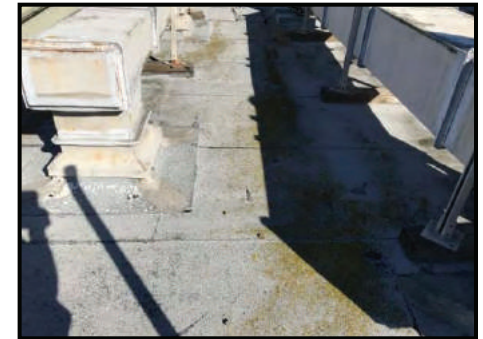
**PHOTO - 8
GYM ROOF**

The Gym roof is deteriorating

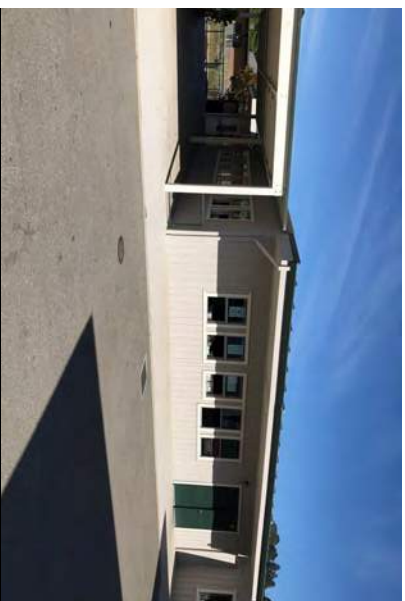
#20	PORTABLES 78 - 82
-----	-------------------

Portables 78-82 Information	
HVAC	Individual heat pump Supplemental components: Unit heater Fair
Fire Suppression	Hydrants, fire extinguishers Fair
Electrical	Source and Distribution: Main panel with copper wiring Interior Lighting: LED Emergency: None Fair
Fire Alarm	Alarm panel, smoke detectors, alarms, strobes, pull stations, back-up emergency lights, and exit signs Fair
Equipment/Special	None --
Key Issues and Findings	Dry rotted and warped siding, it needs replacement

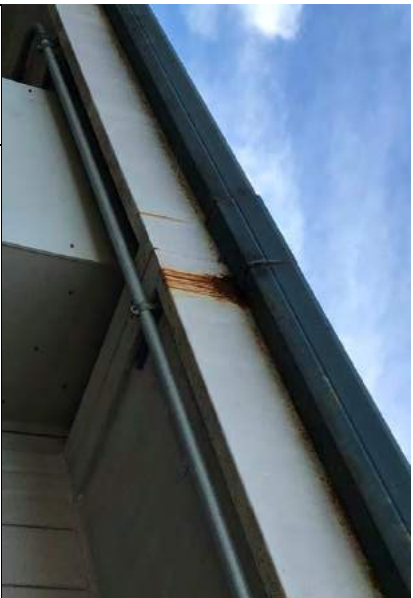
#63 LEAK AT GUTTER

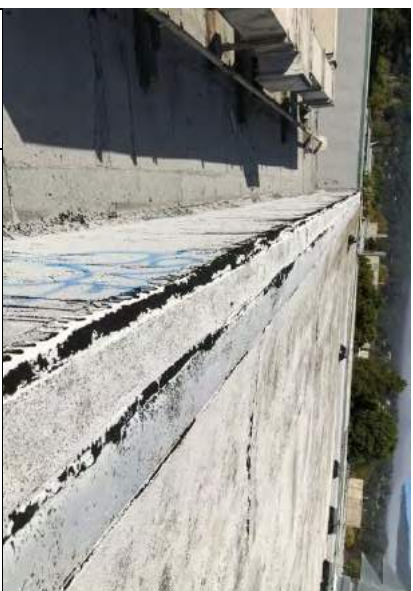
#64 ROOFING DETERIORATION
