MILL VALLEY  
SCHOOL DISTRICT  
FACILITIES  
ASSESSMENT  
2018

# OLD MILL ELEMENTARY SCHOOL

# FACILITY CONDITION ASSESSMENT

Old Mill Elementary School  
352 Throckmorton Avenue  
Mill Valley, California 94941

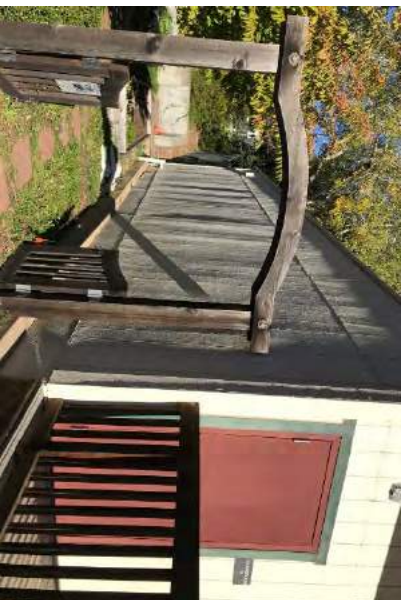
#8  
FRONT ELEVATION, PORTABLES

Portables Information		
HVAC	Individual package units	Fair
Fire Suppression	Dry-pipe / Wet-pipe sprinkler system; hydrants, fire extinguishers, hose cabinets, kitchen hood system	--
Electrical	Source and Distribution: Main panel with copper wiring Interior Lighting: LED Emergency: None	Fair
Fire Alarm	Alarm panel, smoke detectors, alarms, strobes, pull stations, back-up emergency lights, and exit signs	Good
Equipment/Special	None	--
Key Issues and Findings	The exterior T-111 is warping and beginning to deteriorating

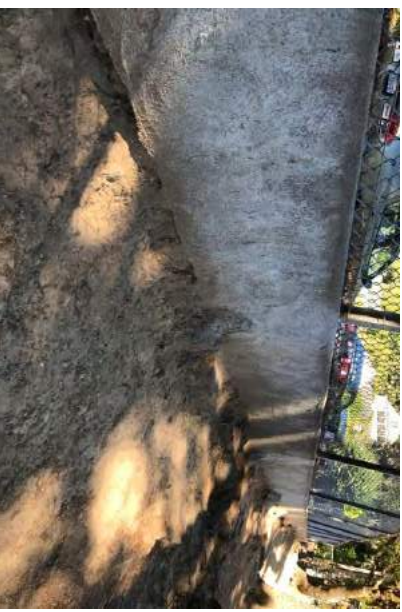
#14

No off street parking is provided at Old Mill Elementary. Play areas, play structures and exterior lighting are in good condition. The retaining walls on the west and north sides of the property are slowly being undermined by rain and tree roots. Regular attention to the condition of the retaining walls is recommended.

RETAINING WALL - UNDERMINED

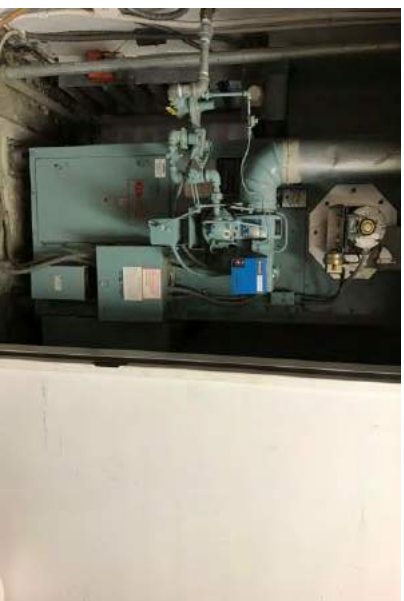
#33

Most of the mechanical equipment in the Main building and Multipurpose Building (MPR) was not replaced in 2010. The package units at the Portables are original. Average age of the furnaces in the classrooms is 20 years. The two furnaces in the MPR appear to be more than 20 years old; one is completely non-functioning. Neither of these buildings is air-conditioned.

FURNACE, GAS AT CLASSROOMS

Classrooms have no air conditioning and it is reported that many of them get uncomfortably warm. Providing air conditioning is highly recommended. A professional engineer must be retained to analyze the existing condition, provide recommendations and, if necessary, estimate the scope and cost of any required repairs. The cost of this study is included in the cost tables. A budgetary cost allowance to reconfigure the HVAC system is also included.
