MILL VALLEY SCHOOL DISTRICT FACILITIES ASSESSMENT 2018

PARK ELEMENTARY SCHOOL

FACILITY CONDITION ASSESSMENT

Park Elementary School
360 East Blithedale Avenue
Mill Valley, California 94941

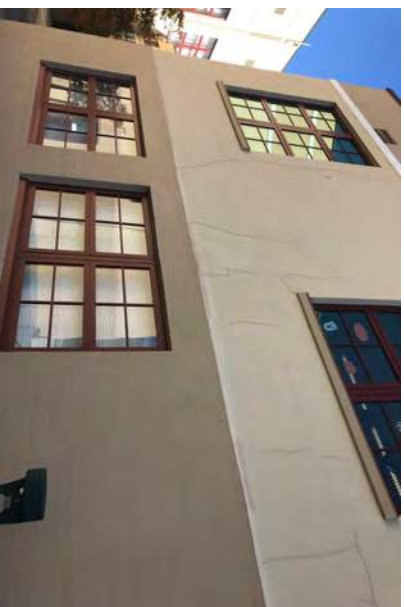
The Main Building roof was redone in 2014 and has a 15 year warranty. The lower level roofs have failed with areas of membrane separation where the downspouts drain onto the roof. There are areas of water intrusion into two classrooms which are thought to be coming from cracks in the stucco siding and where it meets the lower level foundation wall. Most of the interior maintains the 1930s architectural feel with periodical upgrades to finishes. The elevator appears too small for ADA guidelines. The Annex building has asphalt shingles missing in a few locations on the roof. Modular Building has areas of wood rot on the exterior window trim. Typical lifecycle-based interior and exterior finish replacements are budgeted and anticipated

#6 CRACKED STUCCO WALL AND AREA OF WATER INTRUSION

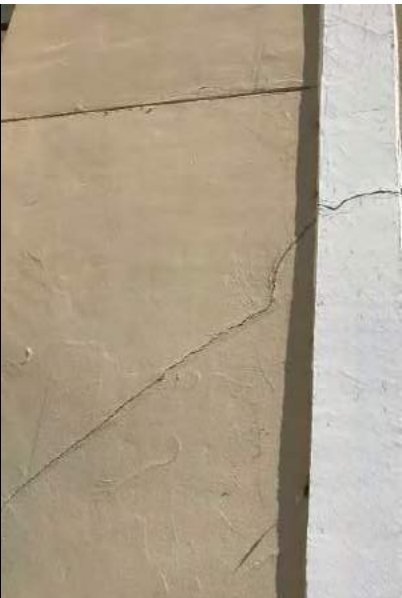
#7 STUCCO CRACKING

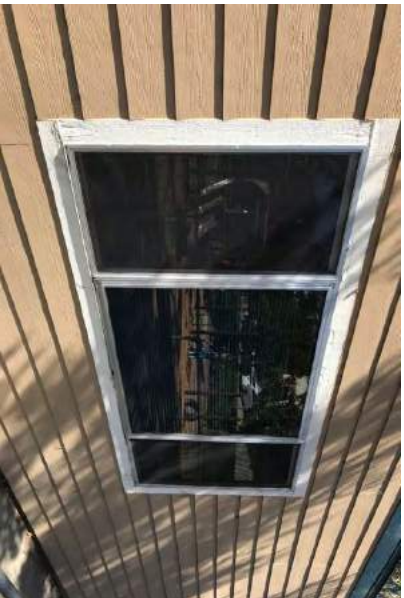
Modular Building Information		
HVAC	Heat pump	Fair
Fire Suppression	Hydrants, fire extinguishers	Fair
Electrical	Source and Distribution: Fed from Main Building with copper wiring Interior Lighting: LED Emergency: None	Fair
Fire Alarm	Smoke detectors, alarms, strobes	Fair
Equipment/Special	None	--
Key Issues and Findings	Wood rot on window trim, building lacks fire sprinklers

#11 MODULAR BUILDING DRY ROT ALONG WINDOW TRIM

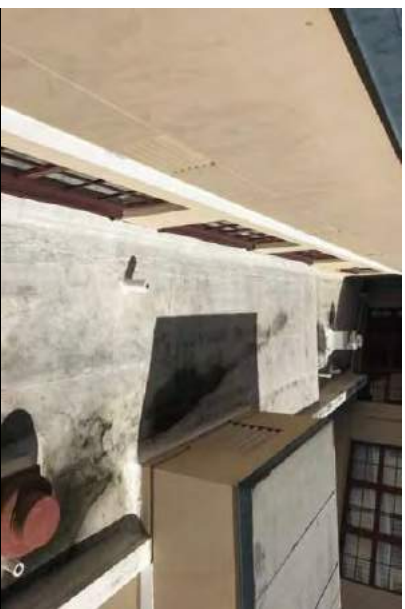
#14
ROOF SEAMS FAILING

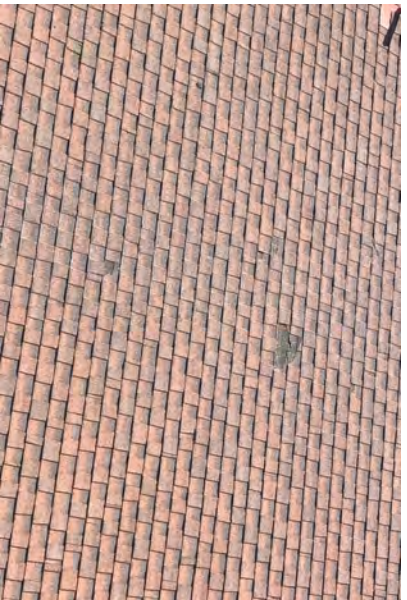
#17
ASPHALT SHINGLES MISSING

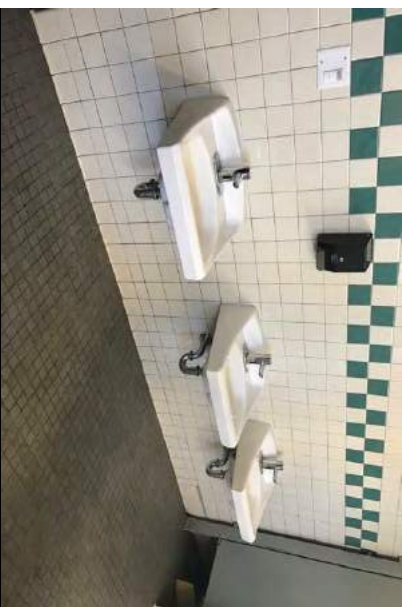
#44 SINKS WITH MISSING DRAIN WRAP

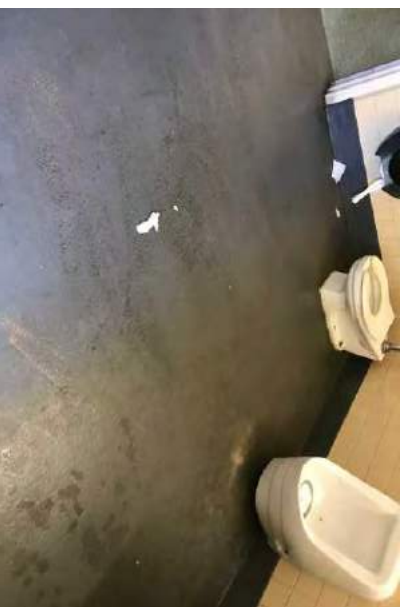
#46 WORN INTERIOR EPOXY FLOOR COATING

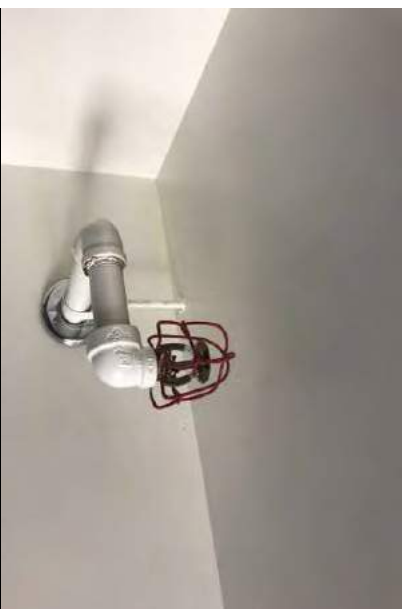
The Main Building and Annex Building share the central boiler system. The boiler appears to have been replaced in 2009 and feeds radiator heaters that received new heating controls in 2012. The boiler system reportedly has plumbing leaks that are affecting its performance, work has been scheduled to make necessary repairs. Most of the electrical distribution system components were upgraded in 1995 and 2012. Most, if not all the plumbing system components and fixtures were replaced in 2012. The fire system does not appear to have an associated backflow preventer, only PIV and riser. It is recommended to add in a fire system backflow for modernization. The fire sprinkler heads appear to be aged and will require replacement within the next few years.

#56 SPRINKLER HEADS

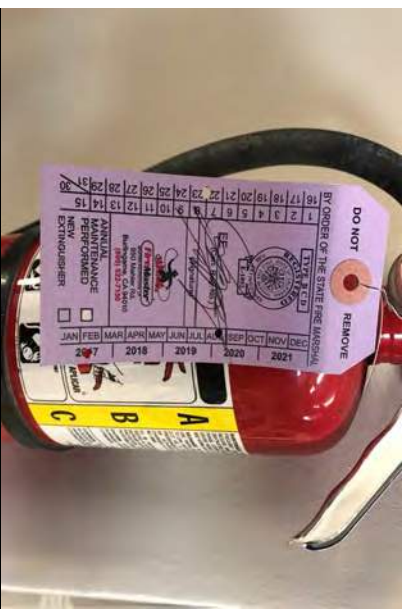
#58 FIRE EXTINGUISHER EXPIRED TAG

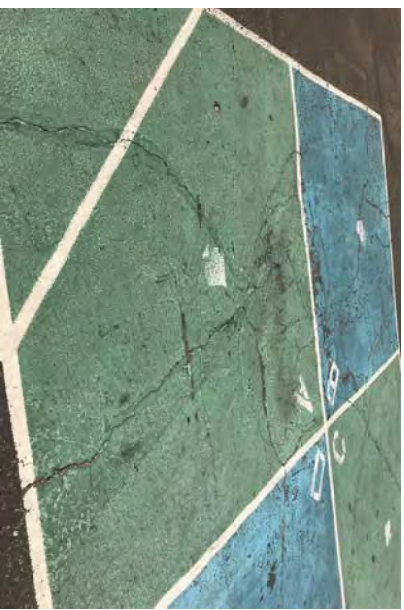
#66

Parking is provided on an adjacent lot to the east and has been well maintained with clear ADA paths of travel. Work was reportedly scheduled for next year on the asphalt playground which is cracking throughout and uneven. Concrete steps and sidewalks were reconstructed to meet ADA standards in 2012.

ASPHALT PLAY SURFACE
CRACKING
