# MILL VALLEY SCHOOL DISTRICT FACILITIES ASSESSMENT 2018

# PARK ELEMENTARY SCHOOL

# FACILITY CONDITION ASSESSMENT

Park Elementary School  
360 East Blithedale Avenue  
Mill Valley, California 94941

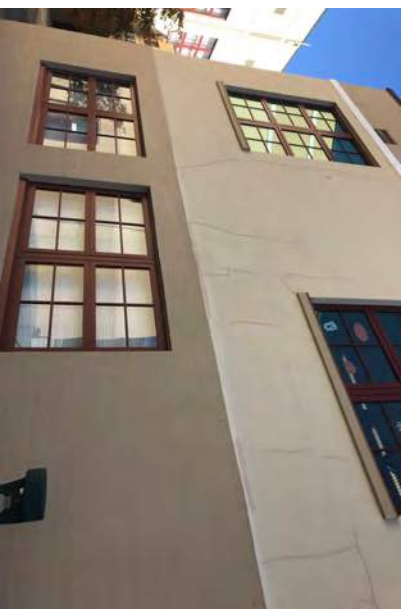
The Main Building roof was redone in 2014 and has a 15 year warranty. The lower level roofs have failed with areas of membrane separation where the downspouts drain onto the roof. There are areas of water intrusion into two classrooms which are thought to be coming from cracks in the stucco siding and where it meets the lower level foundation wall. Most of the interior maintains the 1930s architectural feel with periodical upgrades to finishes. The elevator appears too small for ADA guidelines. The Annex building has asphalt shingles missing in a few locations on the roof. Modular Building has areas of wood rot on the exterior window trim. Typical lifecycle-based interior and exterior finish replacements are budgeted and anticipated

#6 CRACKED STUCCO WALL AND AREA OF WATER INTRUSION

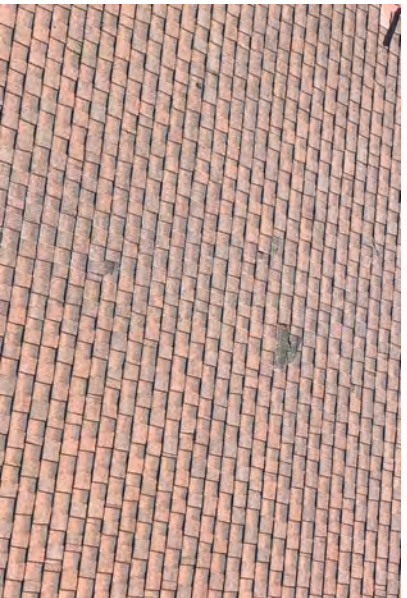
#17  
ASPHALT SHINGLES MISSING

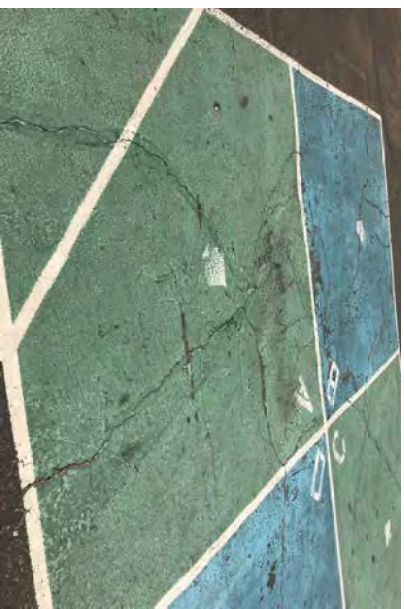
Parking is provided on an adjacent lot to the east and has been well maintained with clear ADA paths of travel. Work was reportedly scheduled for next year on the asphalt playground which is cracking throughout and uneven. Concrete steps and sidewalks were reconstructed to meet ADA standards in 2012.

#66  
ASPHALT PLAY SURFACE  
CRACKING
