MILL VALLEY SCHOOL DISTRICT FACILITIES ASSESSMENT 2018

TAM VALLEY ELEMENTARY

TAM VALLEY ELEMENTARY : PRE-PLANNING SURVEY

FACILITY CONDITION ASSESSMENT

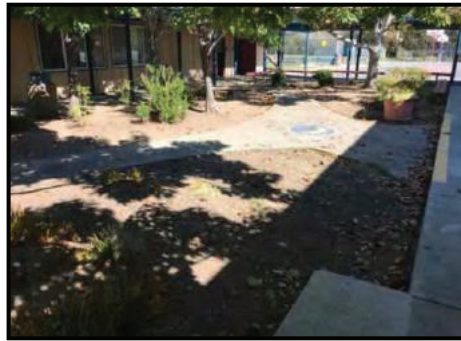
- 2 In an effort to ensure accessibility and safety throughout campus, consideration should be given to addressing the potential trip hazards caused by multiple underground utility plates throughout the campus and at the stepping stone courtyard between Buildings A and D.

**PHOTO - 2
COURTYARD**
Potential trip hazard at the stepping stone courtyard between Buildings A and D

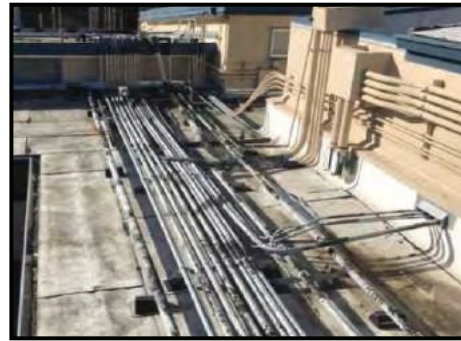
**PHOTO - 3
ELECTRICAL DISTRIBUTION SYSTEM**
Roof-mounted system is outdated and is damaged from years of water intrusion and weathering.

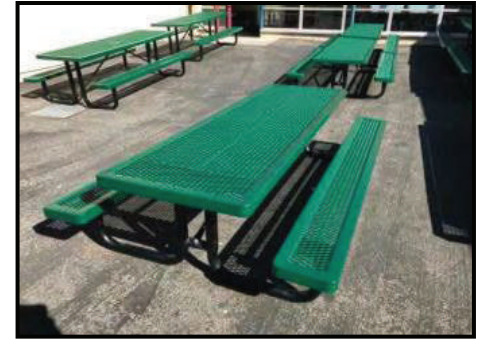
**PHOTO - 4
OUTDOOR AREA**
The outdoor area has few permanent shade structures

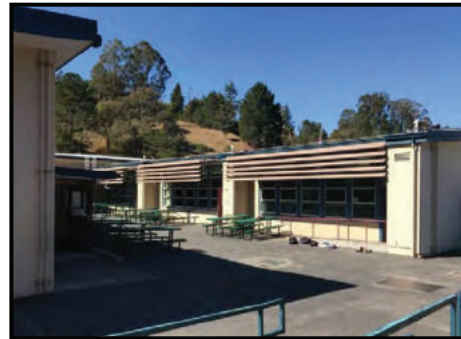
**PHOTO - 7
SHADING DEVICES**
Shading device upgrades would help provide cooling for classrooms without air conditioning

- A designated space should be allocated for the PTA, which currently has no permanent location.
- Given the lack of air conditioning in Buildings A-D, consideration should be given to installing shading/ cooling devices that prevent classroom overheating and increase circulation. Shading device upgrades would be particularly effective on Building C& D's eastern facade and Building B's southern facade.

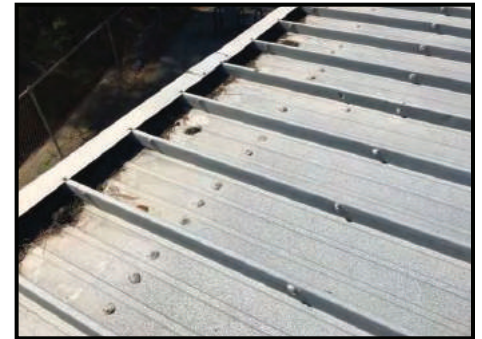
**PHOTO - 8
ROOF GUTTERS**
regular maintenance of Building C-K roof gutters to prevent flooding on roof

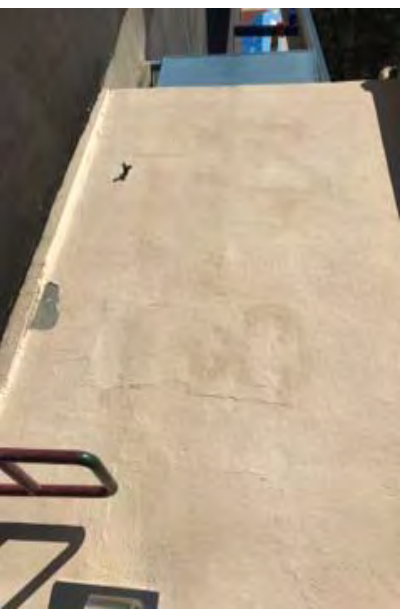
#4

A-B STUCCO DAMAGE AND
PATCHWORK

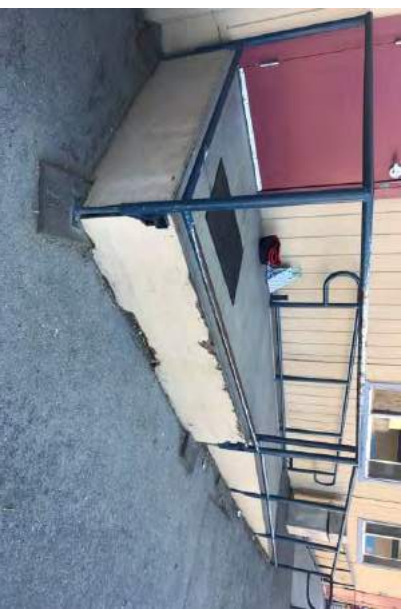
#6

EXTERIOR RAMPS
DETERIORATING

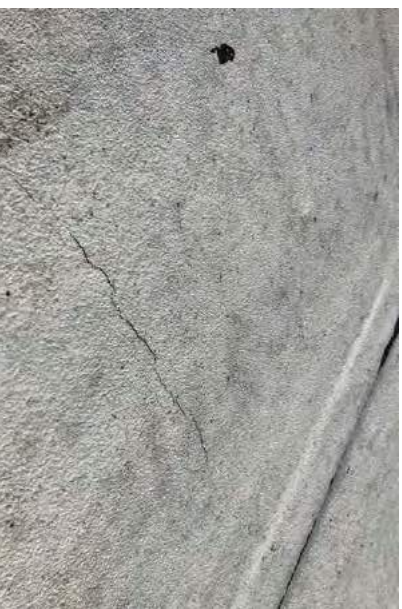
#18	ROOF CRACKS THROUGHOUT
-----	------------------------

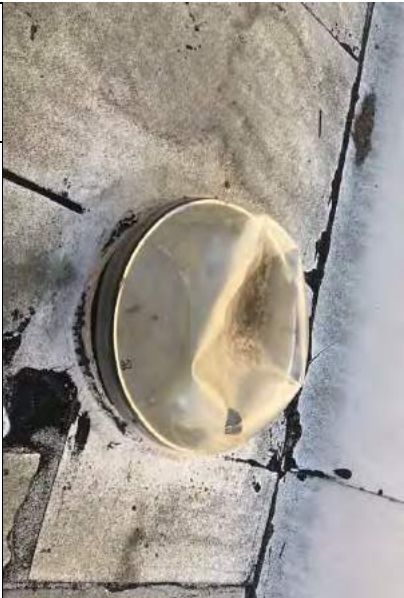
#19

FAILED SOLAR TUBE SKYLIGHT

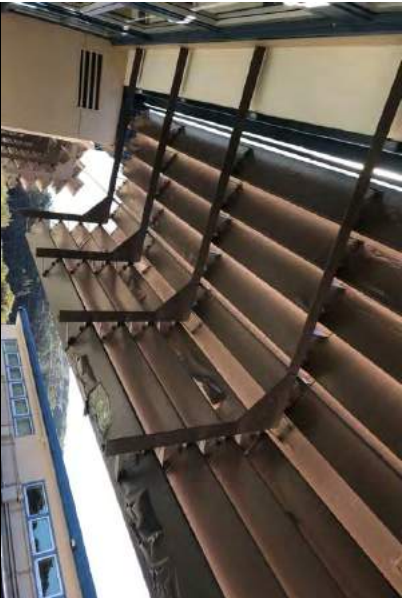
#21

SUN SHADES PAINT FAILURE

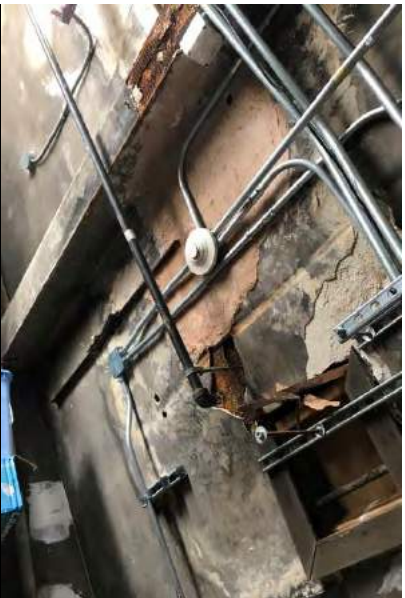
In 2012, when the main building with combined sections A1, A2, B1 and B2 was renovated most but not all the windows were replaced, most of the doors were replaced or repaired, and the roof was redone. In 2012, buildings C and D also received new doors and roofing. Current issues have been reported that the buildings still have roof leaks, door alignment, and door hardware issues. The roofing material appears to be failing with the appearance of cracking and bubbling throughout. It may be possible to extend the useful life by replacing failed sections and using an elastomeric coating over the entire surface. When the windows were replaced, the stucco was also repaired, some of the patchwork is noticeable and a few other walls are recommended to be redone. It is also recommended to investigate further the fire damage to the electric room, and to replace the gypsum board.

#31 ELECTRIC ROOM FIRE DAMAGE

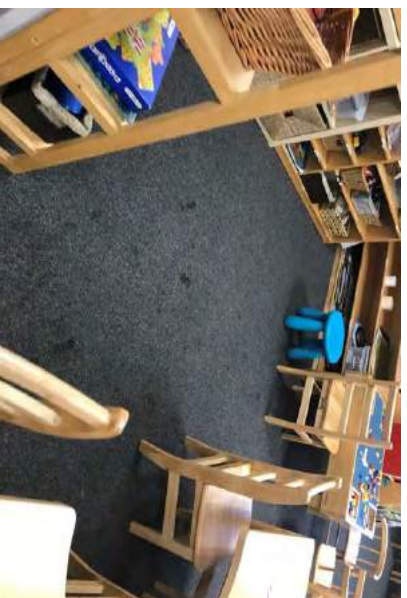
#36 E-K STAINED CARPET

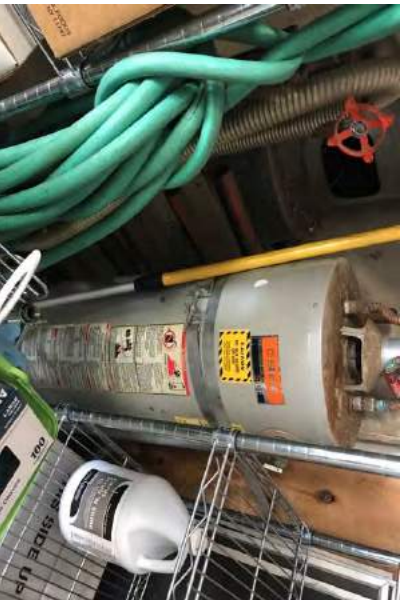
#39
FAILED GAS WATER HEATER

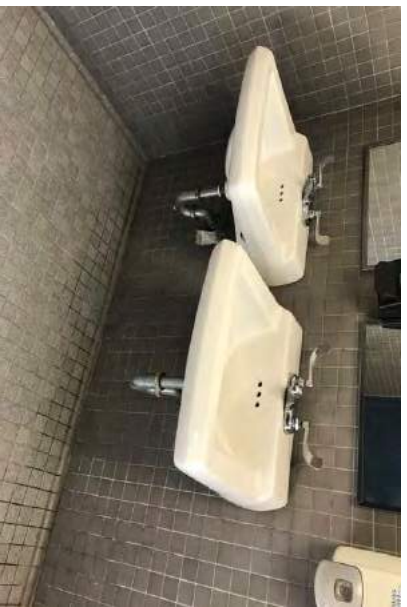
#42
PORCELAIN SINKS MISSING ADA INSULATION

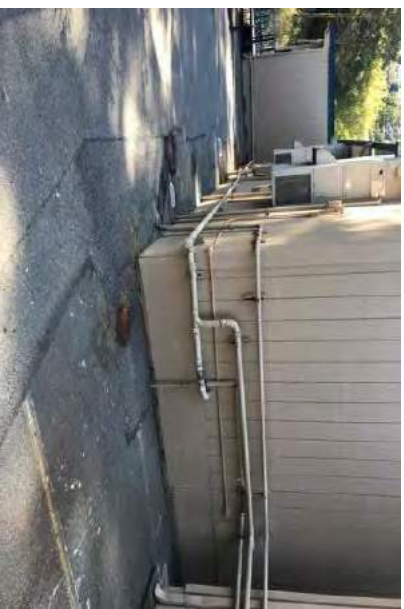
#48
E-K SANITARY PLUMBING WITH
INADEQUATE DRAINAGE SLOPE

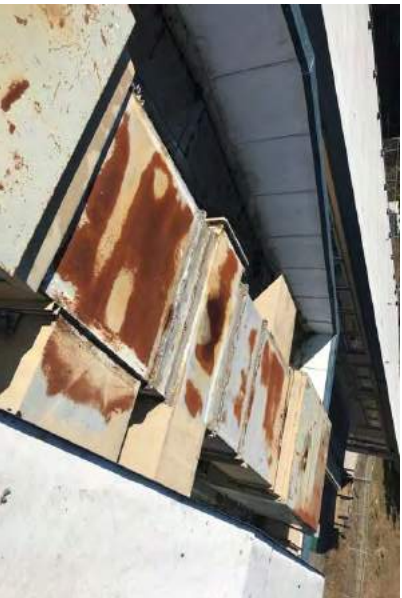
#51
RUSTED HVAC SYSTEM
DUCTWORK

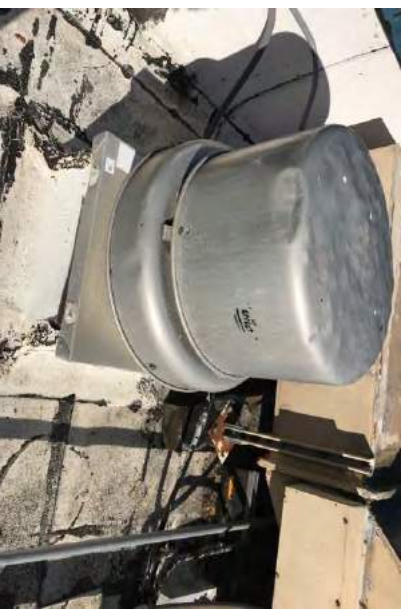
#54
DAMAGED CENTRIFUGAL
EXHAUST FAN

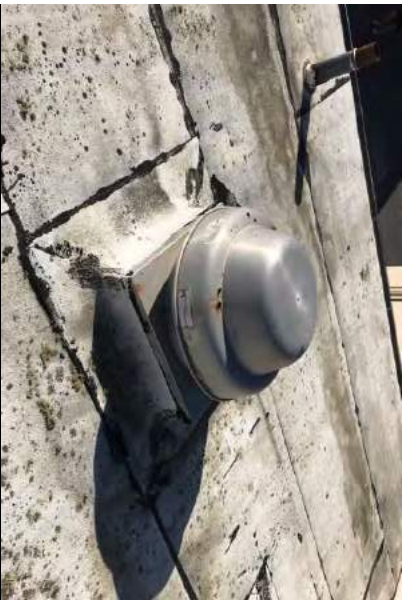
#55	BROKEN CENTRIFUGAL EXHAUST FAN
-----	--------------------------------

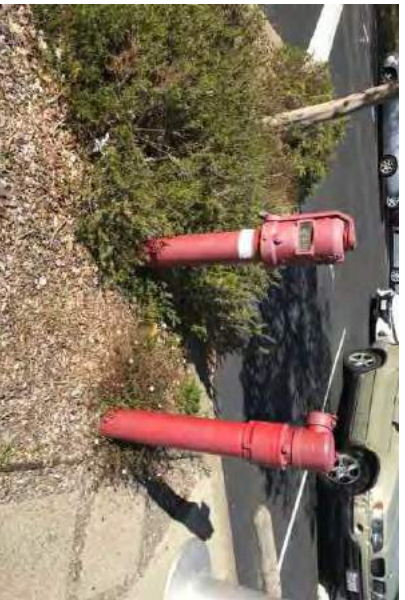
#59	FIRE PIV, MISSING FIRE BACKFLOW
-----	---------------------------------

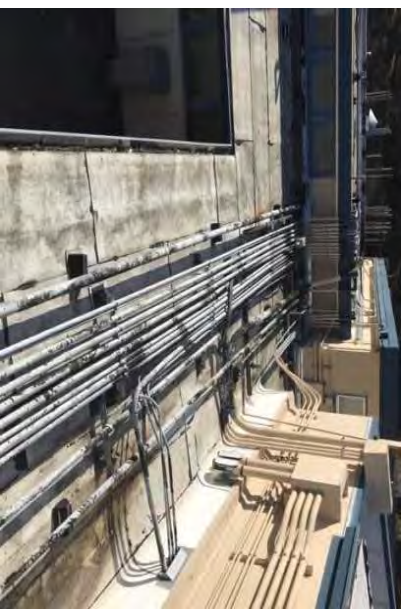
#66	A-B ROOFTOP ELECTRICAL DISTRIBUTION
-----	-------------------------------------

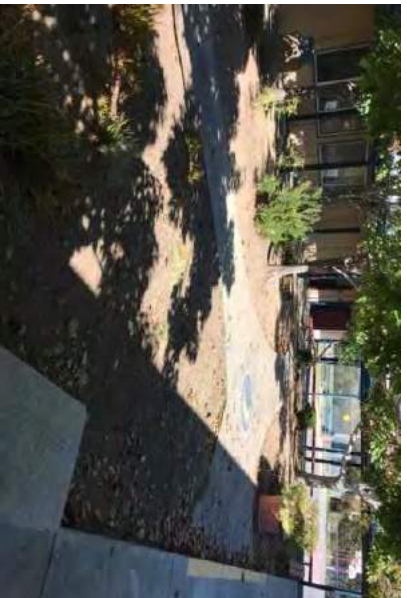
The asphalt playground and original parking area have cracking and patchwork throughout, milling and overlay is recommended for the near future. There are possible trip hazards with underground utility plates and in the courtyard between buildings A-B and C-D. The site asphalt and concrete surfaces were reconstructed to meet ADA standards in 2012.

#77 COURTYARD WITH TRIP HAZARDS

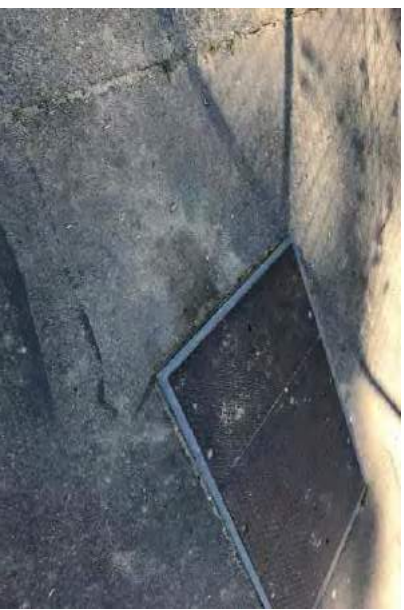
#90

TRENCH PLATE TRIP HAZARD
