ORCUTT UNION SCHOOL DISTRICT SITE ASSESSMENT & MASTER PLAN

SVA ARCHITECTS, INC.

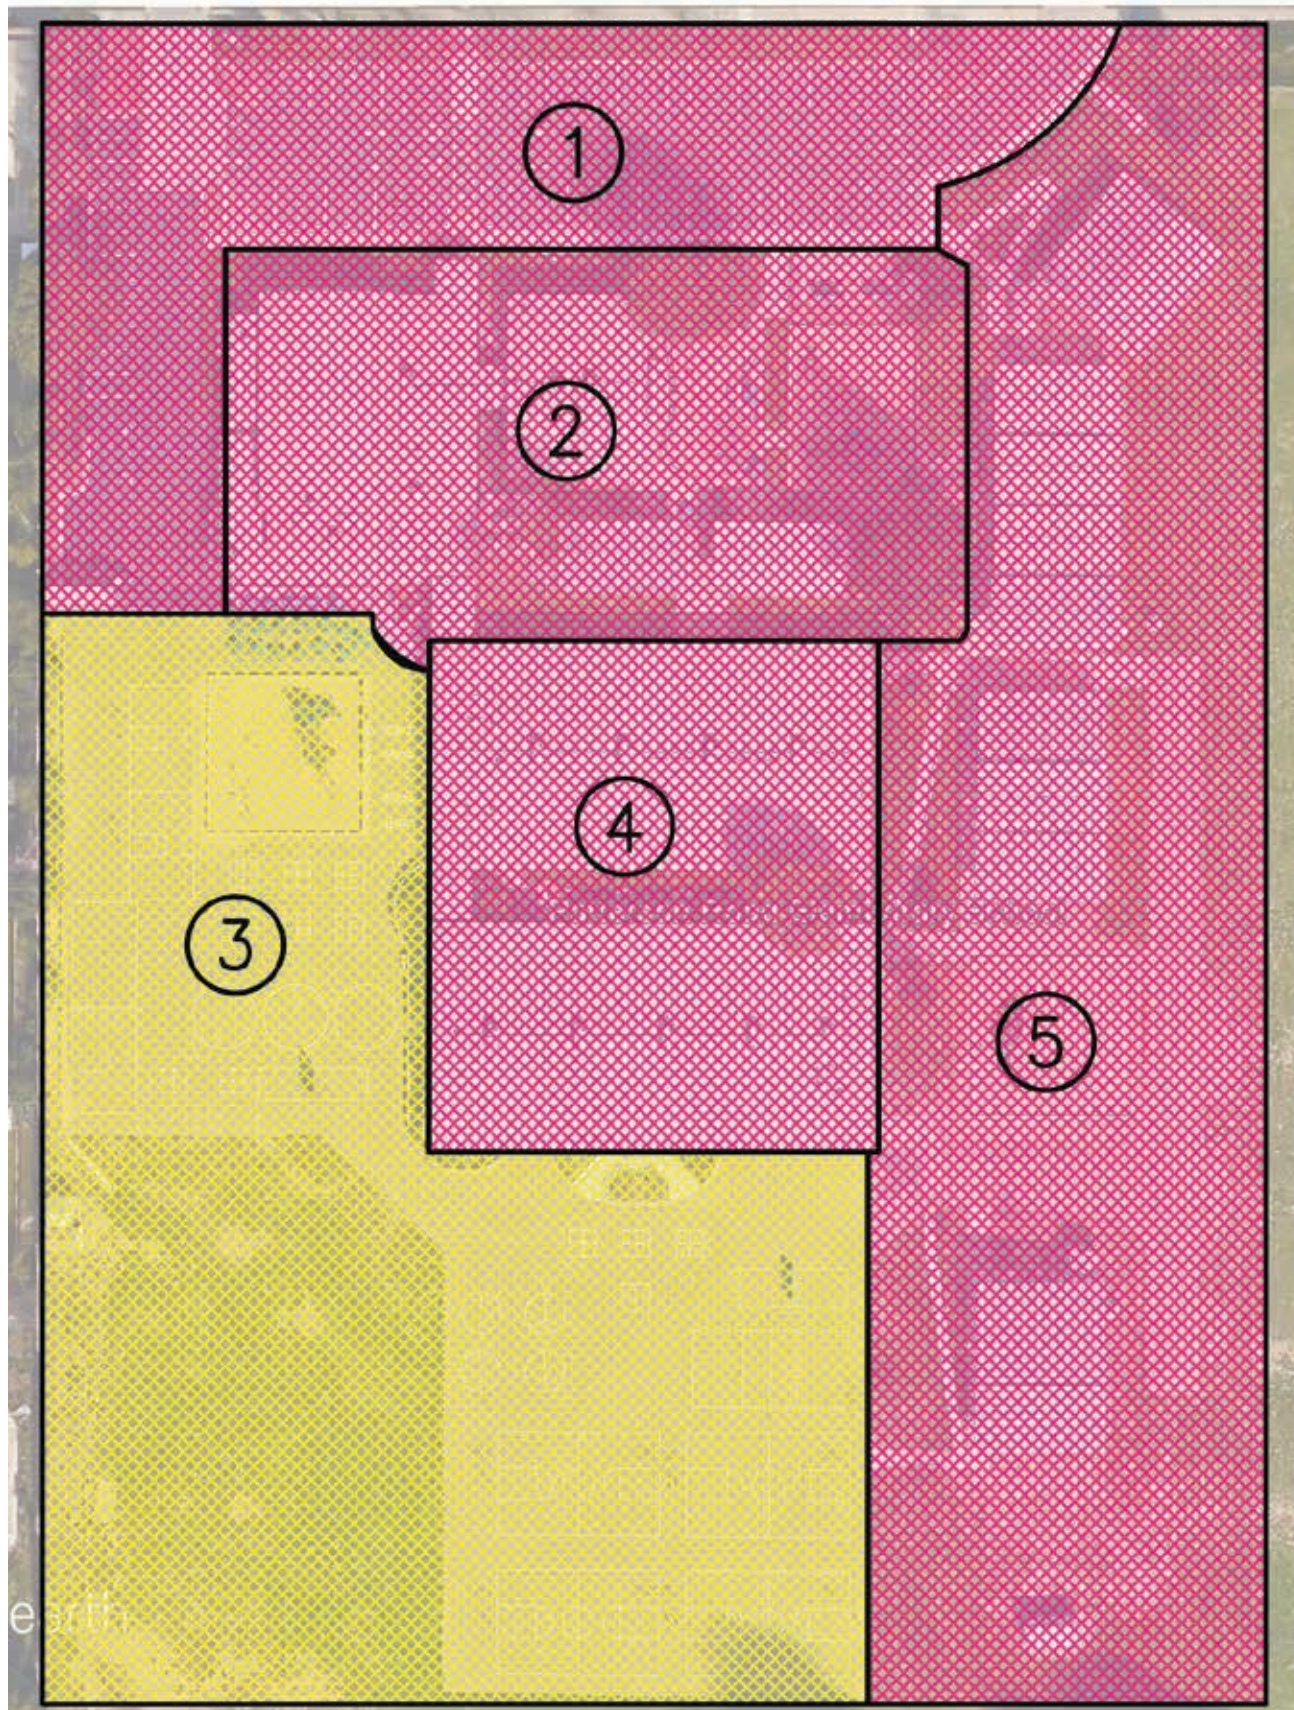
SUB-AREA	GENERAL DESCRIPTION	SUGGESTED REPAIR / MAINTENANCE
1	Asphalt concrete in parking lot is in good condition. Pedestrian ramp in center of parking lot and ADA parking stalls in west parking lot are not ADA compliant. Concrete sidewalk along east side of parking lot and along north side of gym (in parking	Remove and Replace PCC Sidewalk Ramp Remove and Replace Remove and Replace ADA parking stall and crosswalk
2	Pedestrian walkway to office entrance is not ADA compliant. Drainage issues reported between office and Kindergarden classrooms. Landing on north side of Kindergarden classrooms not ADA compliant. Evidence of ponding/erosion along south side of	Remove and Replace Ramp Remove and Replace PCC Sidewalk Regrading
3	Asphalt concrete is in good condition. Ramps to the portables are not ADA compliant.	
4	Drainage issues reported between new PCC sidewalk ramps and old PCC sidewalk ramps. Sidewalks along buildings are not ADA compliant.	Remove and Replace PCC Sidewalk Regrade around ramps

5	Ramped access to classrooms are not ADA compliant. Slopes on landings with domes are not ADA compliant. Asphalt concrete needs to be replaced near fire hydrant. Portable classroom drain screens need cleaning.	Remove and Replace PCC Sidewalk

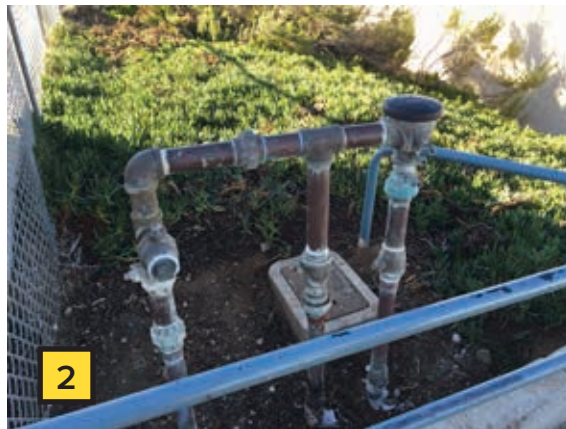
2. EXISTING BACKFLOW DEVICE ADJ. TO PLAY FIELD

Existing Condition:
 Backflow prevention device is non-compliant to current codes.

Recommendation:
 Replace device with reduced pressure backflow preventer.
 Verify water source and areas irrigated with this system.
 Determine if replacement will result in insufficient pressure to field irrigation sprinklers.

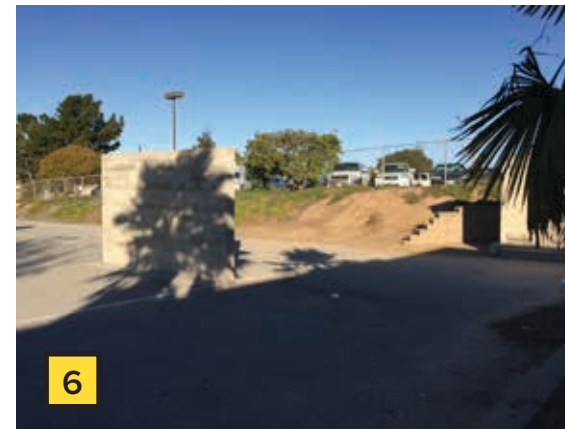
6. SLOPE PLANTER ADJACENT TO ENTRY PARKING LOT

Existing Condition:
 Run down and eroded slope planting.
