**6. OLGA REED**  
ELEMENTARY SCHOOL &  
**ORCUTT ACADEMY K-8 (OAK-8)**

## OLGA REED ELEMENTARY SCHOOL

## ARCHITECTURAL ASSESSMENT

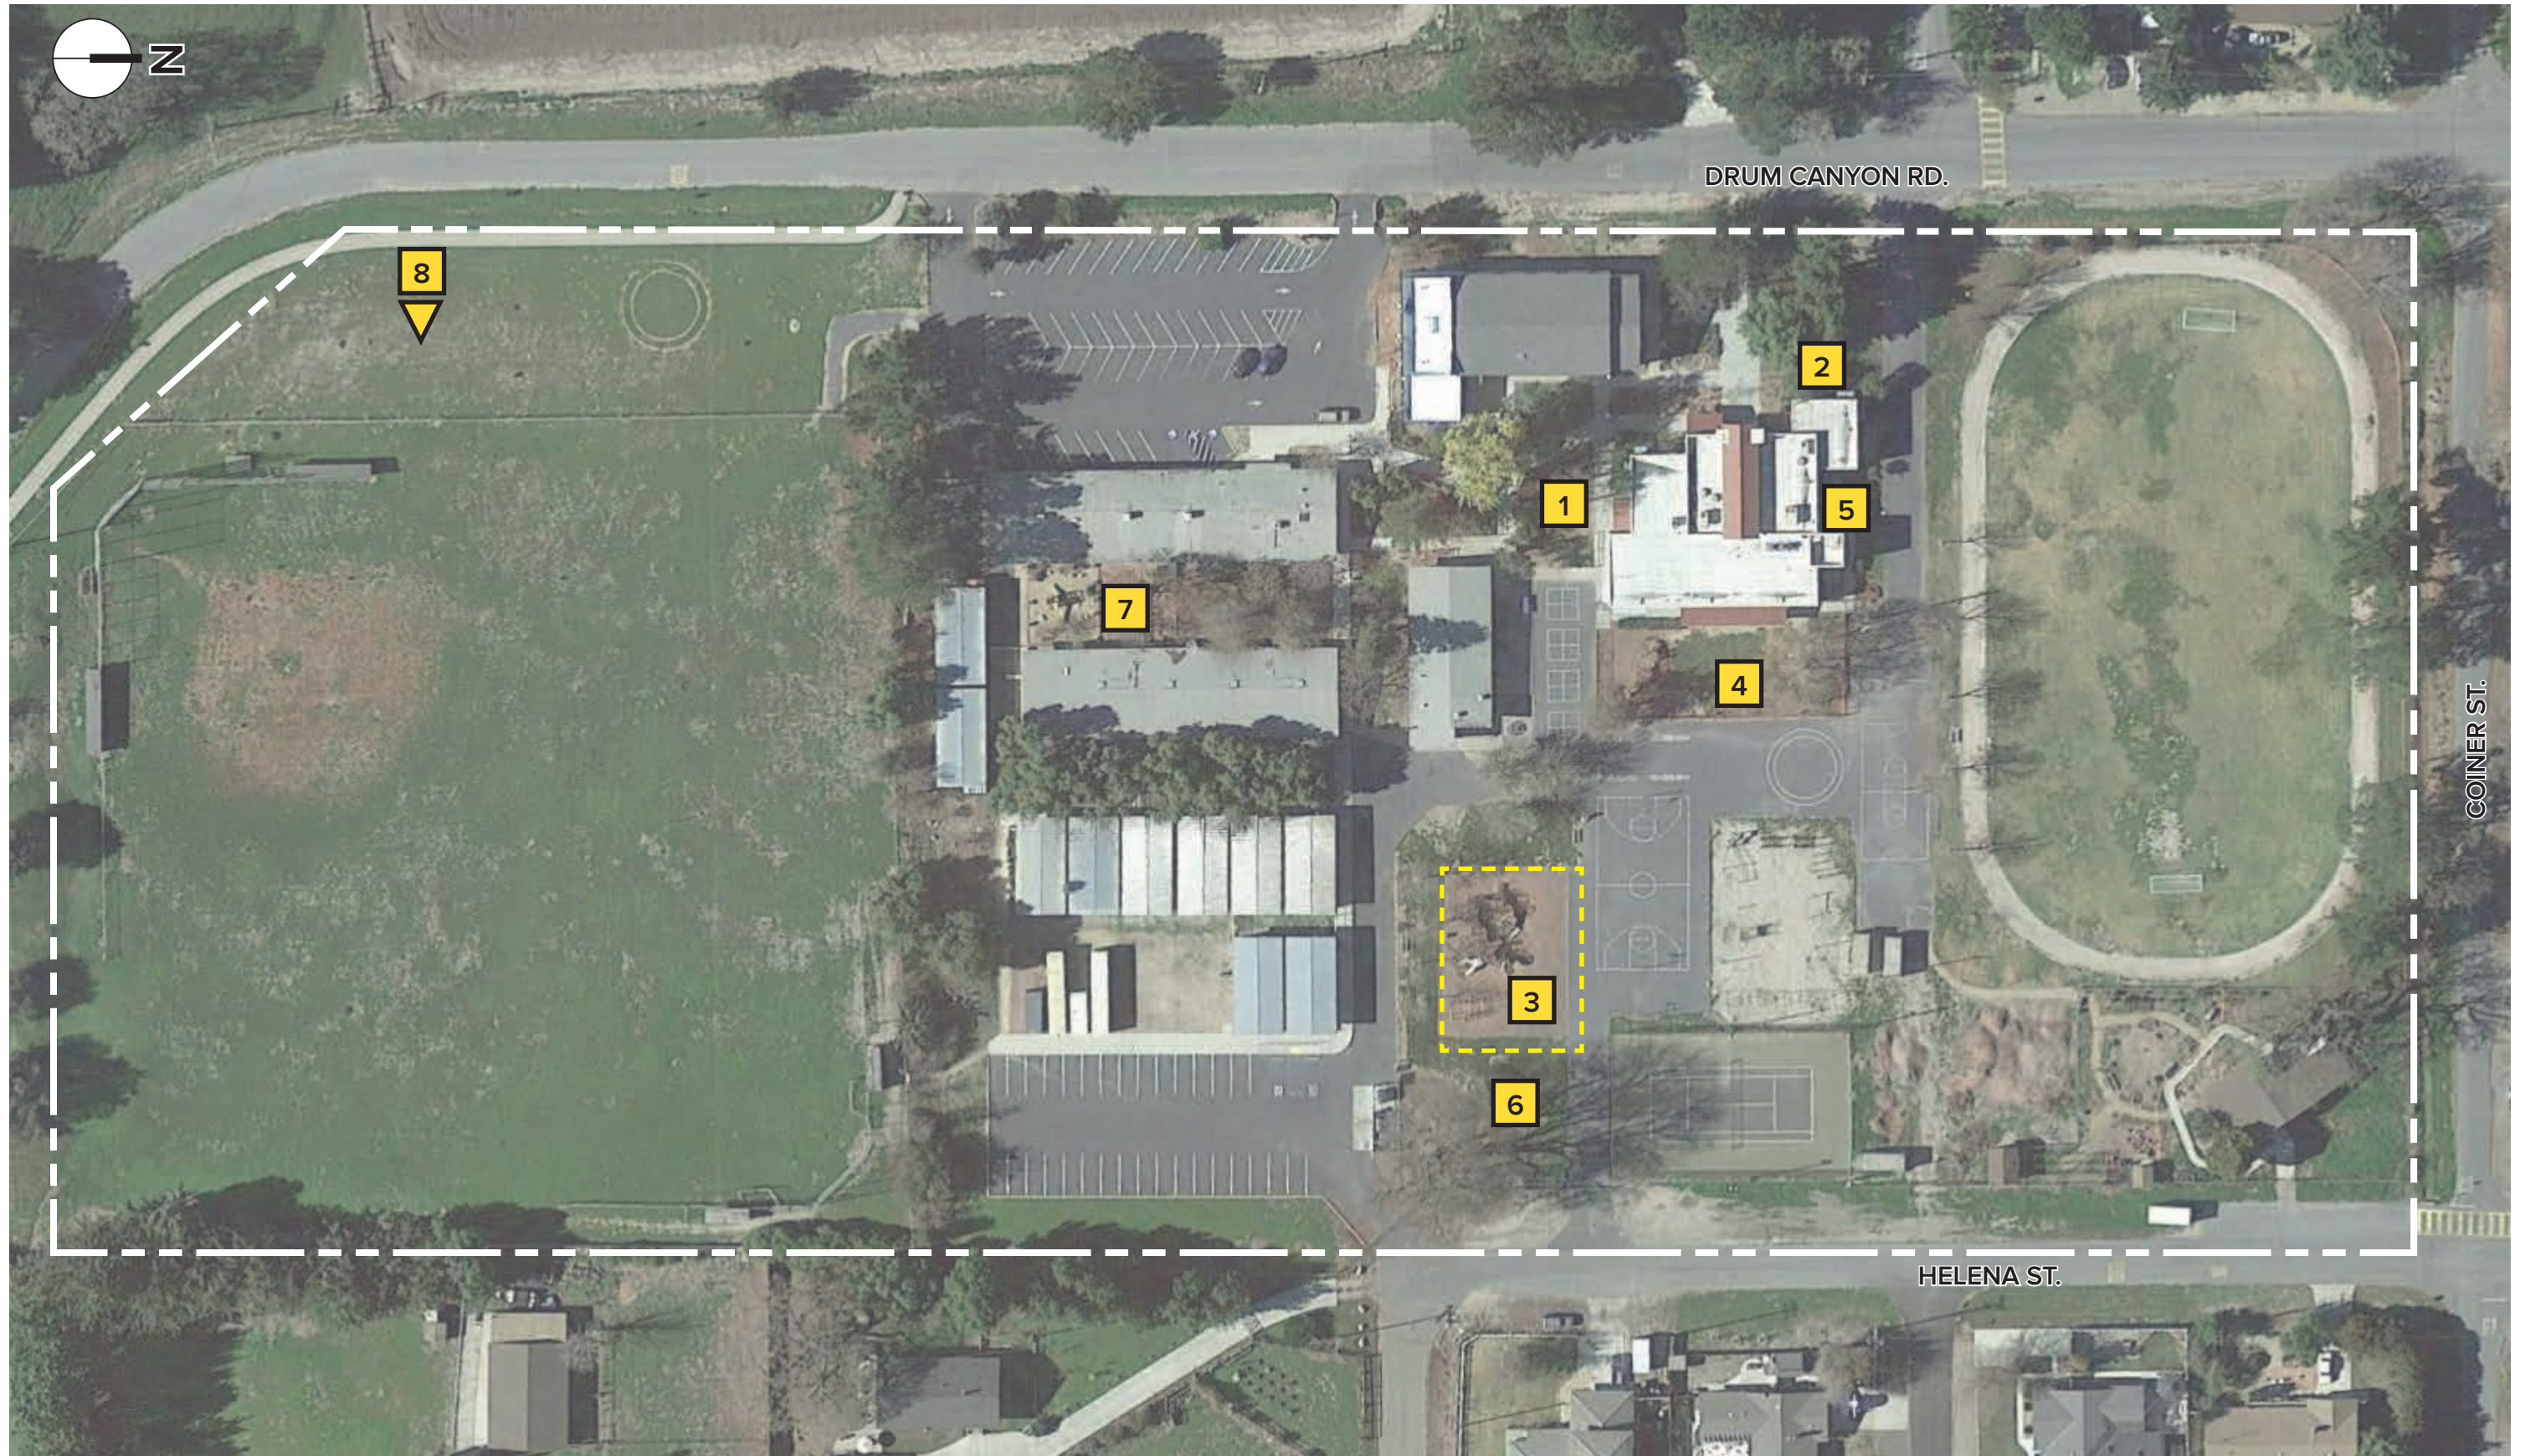
LANDSCAPE ASSESSMENT

**Existing Condition:**  
Broken valve boxes in the walking area create walking hazards.

**Existing Condition:**  
Outdated irrigation controller that's not weather or moisture sensor based.

**Existing Condition:**  
The landscape area was let die do to water restrictions and this is an access area to the lower track and field.

**Existing Condition:**  
Turf is heavily compacted and in need of repair. High volume foot traffic through the turf and seating areas.

**Existing Condition:**  
Existing primary play area has no accessible access to the equipment. Does appear to be compacted firbar and or just wood chips.

**Existing Condition:**  
The play equipment area is not accessible for special needs with only sand for the fall protection. There is no access to the transfer station on the play equipment and from the slides or other equipment back to the transfer station. The cut in the concrete goes into sand and is not accessible.

**Existing Condition:**  
No planting and or irrigation installed in planters.

**Existing Condition:**  
Existing ball field is abandoned and not in use, verify this is the adjacent park field.

**Recommendation:**  
Replace valve box lids and brand the numbers in the top associated with the correct valve numbers on the irrigation controllers.

**Recommendation:**  
Replace with compliant stand-alone or central control system.

**Recommendation:**  
Install decomposed granite pathway between the two hardscape areas for access to the lower play fields. Install low growing drought tolerant planting on drip irrigation adjacent to the pathway.

**Recommendation:**  
Need rodent eradication set up on a monthly contract with exterminator company. Till and amend the soil, repair irrigation systems and re-sod and or re-seed entire area. Determine circulation routes in and around the turf area and install pathways to benches and highly-concentrated student gathering areas.

**Recommendation:**  
Check depth of fall protection material should be a minimum of 12" deep, verify material is considered accessible. Change out material to Fibar and/or rubberized material.

**Recommendation:**  
Add rubberized fall zone material that is accessible from the entry ramp to the transfer station and to the slide areas and other equipment, or change all material to an accessible material like Fibar etc.

**Recommendation:**  
Till and amend the soil, add native and or drought tolerant plant material with drip irrigation.

**Recommendation:**  
If the District does not intend to use any part of the ball field, fence off as not in use as there are safety concerns with rodent and gopher holes etc. remove all backstops and baseball or softball standards. If the district plans to refurbish, till amend, and install new irrigation as necessary.
