Long Range Facility Audit 2009-2019

Clovis Unified School District • August 2009

Copper Hills Elementary School

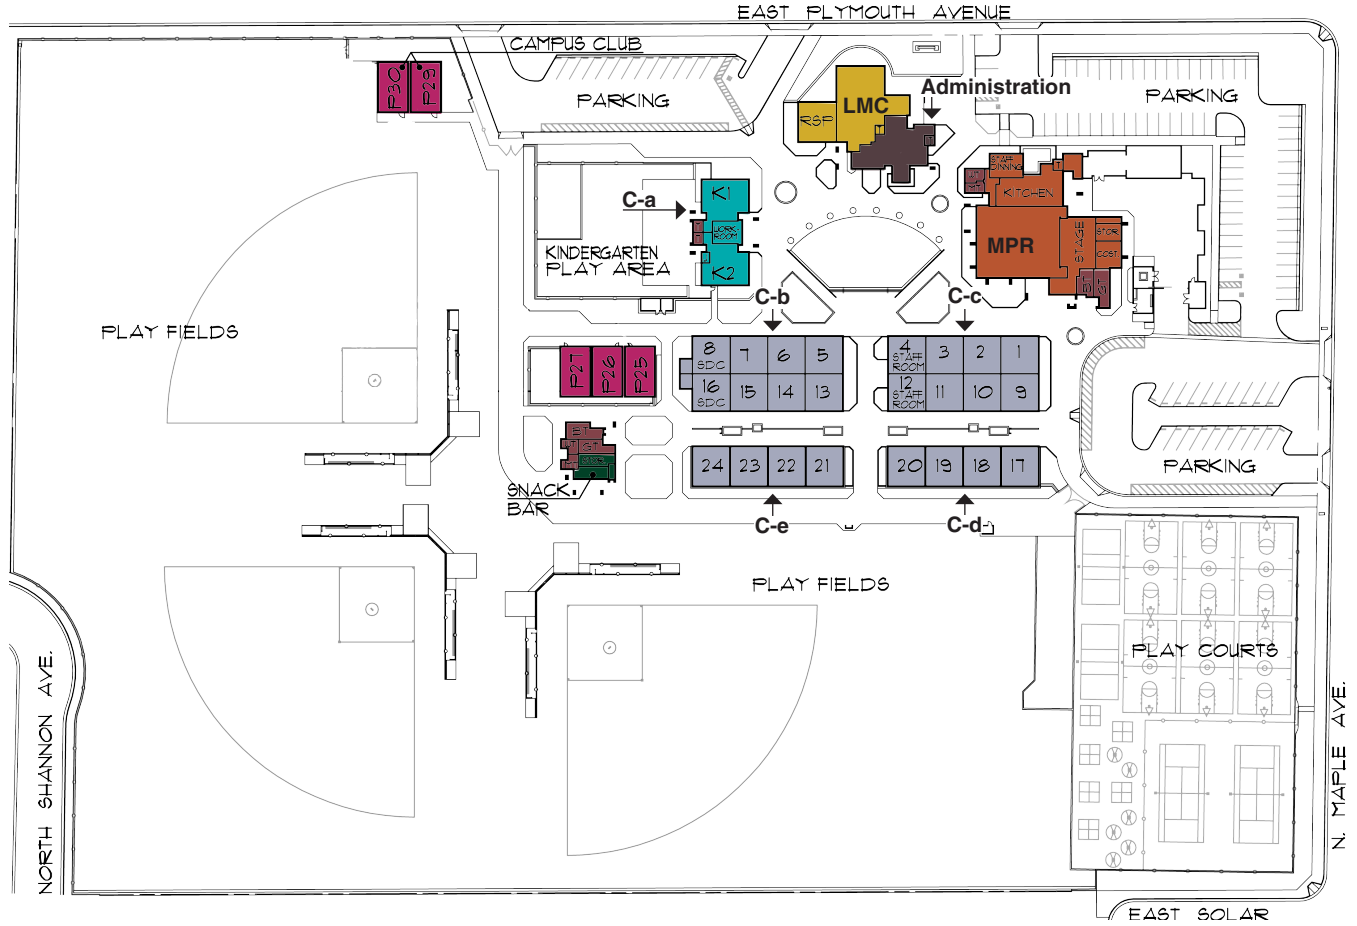
Site Plan

Observations: The concrete condition is good. There are locations of minor cracking and trip hazards. The curb ramps do not meet ADA requirements. The accessible stall signage and striping require minor changes. ADA detectable warning surface is required in various locations. Storm drain inlet grates do not meet ADA requirements for maximum grate openings. Walk gates do not meet ADA requirements.

Observations: The storm drain system is in good working condition, but there is evidence of standing water around the backstop dugouts and near the covered picnic area.

Recommendations: Reconstruct concrete improvements to eliminate trip hazards and comply with ADA curb ramp requirements. • Add accessible stall signage and striping as required. • Add ADA detectable warning surface at various locations. • Replace storm drain inlet grates in accessible paths of travel with ADA compliant grates. • Replace walk gates with ADA compliant gate hardware.

Recommendations: Add additional storm drain inlets to prevent standing water.
