Long Range Facility Audit 2009-2019

Clovis Unified School District • August 2009

Mountain View Elementary School

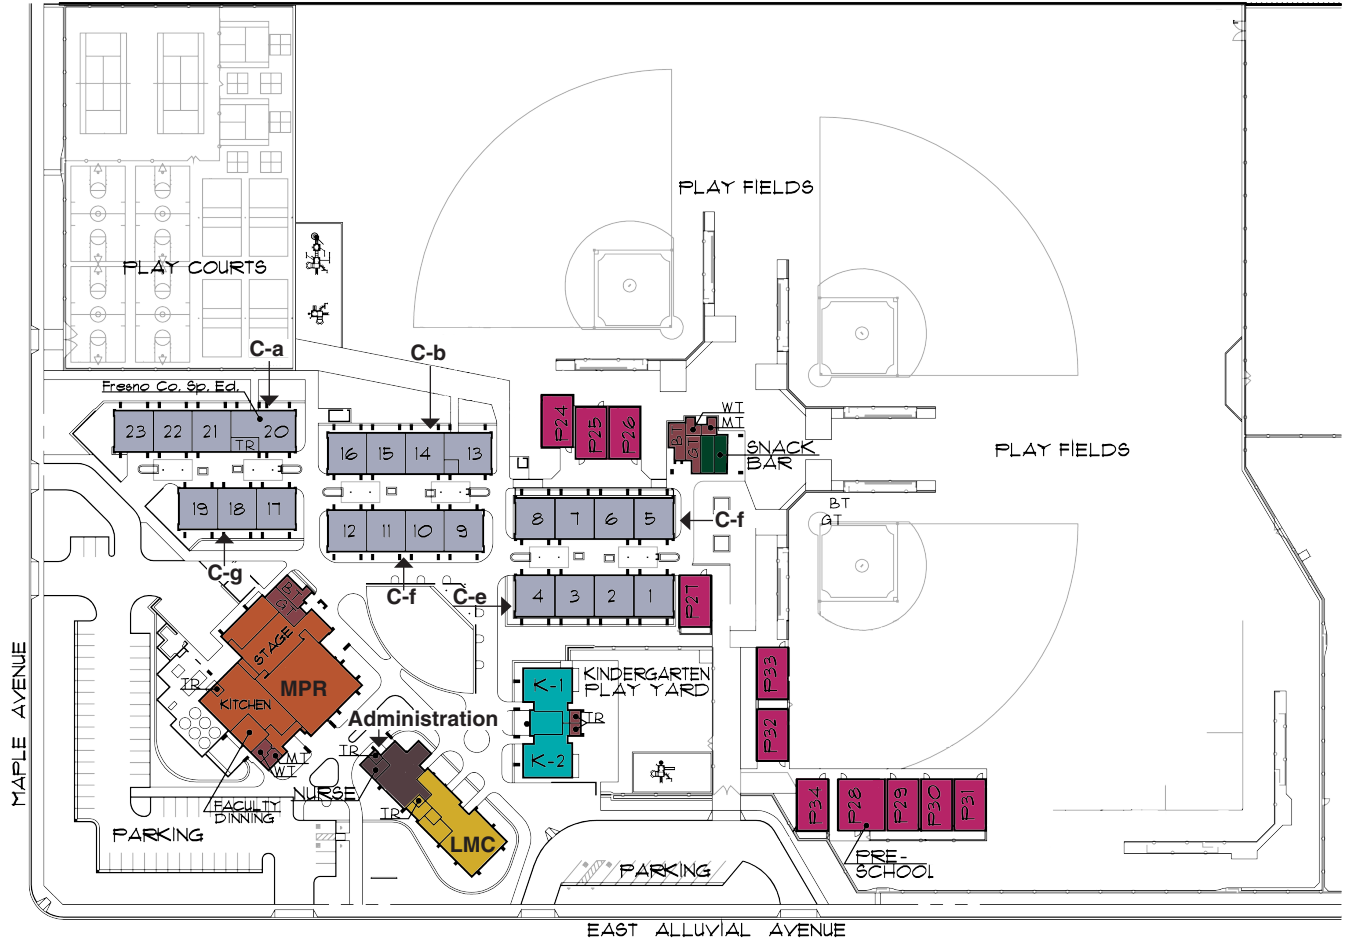
Site Plan

Observations: The concrete condition is fair. There are many locations of minor cracking and trip hazards. The curb ramps do not meet ADA requirements. The accessible stall signage and striping require minor changes. ADA detectable warning surface is required in various locations. Storm drain inlet grates do not meet ADA requirements for maximum grate openings. Walk gates do not meet ADA requirements. Some of the drinking fountains do not meet ADA requirements.

Observations: The storm drain system is in good working condition, but there is evidence of standing water around the amphitheatre and in the playfields at the backstops.

Recommendations: Reconstruct concrete improvements to eliminate trip hazards and comply with ADA curb ramp requirements. • Add accessible stall signage and striping as required. • Add ADA detectable warning surface at various locations. • Replace storm drain inlet grates in accessible paths of travel with ADA compliant grates. • Replace walk gates with ADA compliant gate hardware. • Replace drinking fountains with ADA compliant drinking fountains.

Recommendations: Add additional storm drain inlets to prevent standing water.
