Long Range Facility Audit 2009-2019

Clovis Unified School District • August 2009

Temperance-Kutner Elementary School

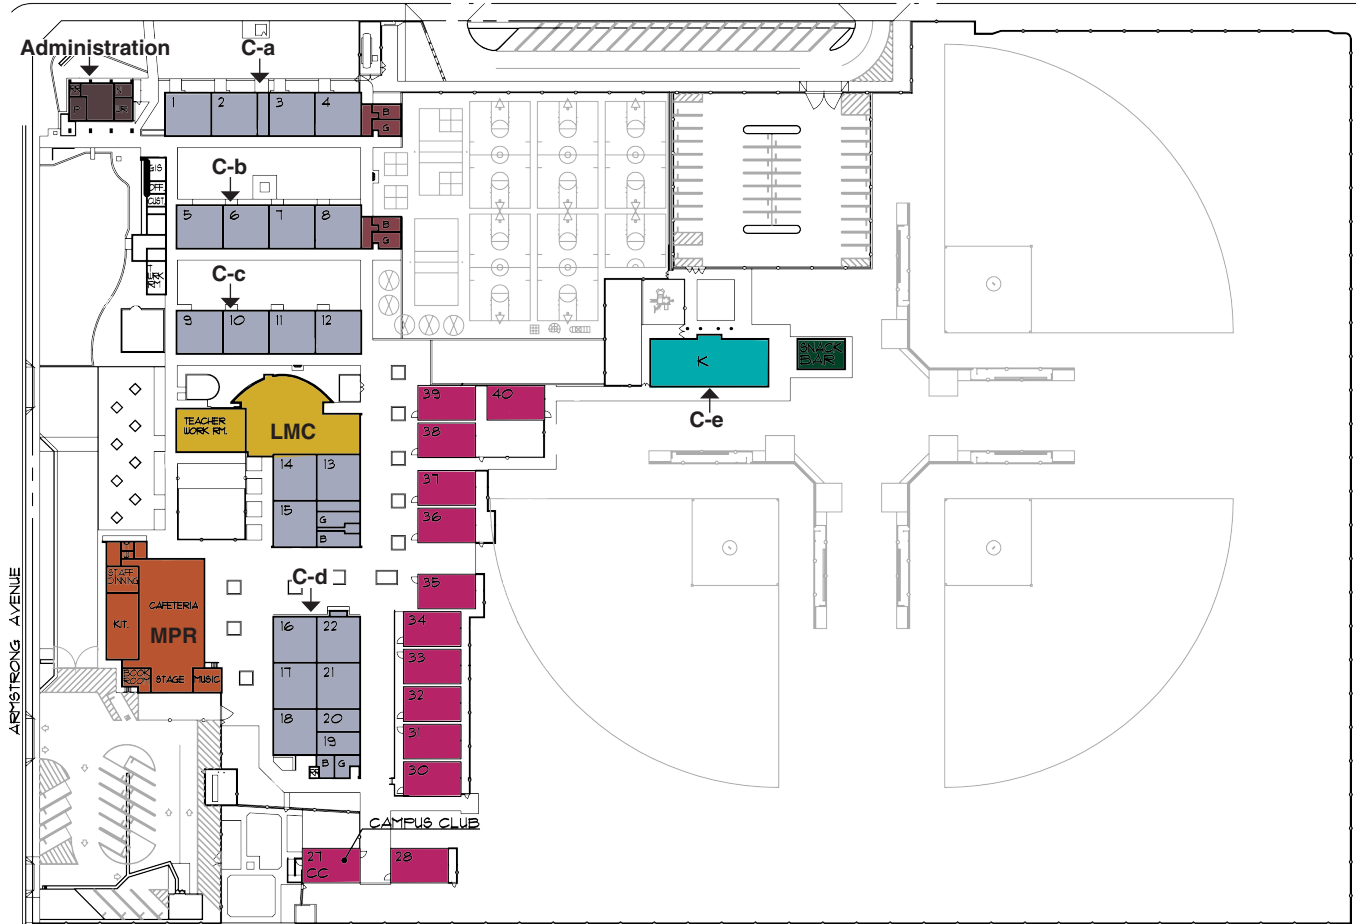
Site Plan

Observations: The concrete condition is fair. There are many locations of cracking and trip hazards. The cross-slopes and curb ramps do not meet ADA requirements. The accessible stall signage and striping require minor changes. ADA detectable warning surface is required in various locations. Storm drain inlet grates do not meet ADA requirements for maximum grate openings. Walk gates do not meet ADA requirements. Some drinking fountains do not meet ADA requirements.

Observations: The storm drain system is in good working condition, but there is evidence of standing water in the north parking lot.

Recommendations: Reconstruct concrete improvements to eliminate trip hazards, comply with ADA curb ramp requirements and meet ADA slope requirements. • Add accessible stall signage and striping as required. • Add ADA detectable warning surface at various locations. • Replace storm drain inlet grates in accessible paths of travel with ADA compliant grates. • Replace walk gates with ADA compliant gate hardware. • Replace drinking fountains with ADA compliant drinking fountains.

Recommendations: Add additional storm drain inlets to prevent standing water.
