Long Range Facility Audit 2009-2019

Clovis Unified School District • August 2009

Clovis Elementary School

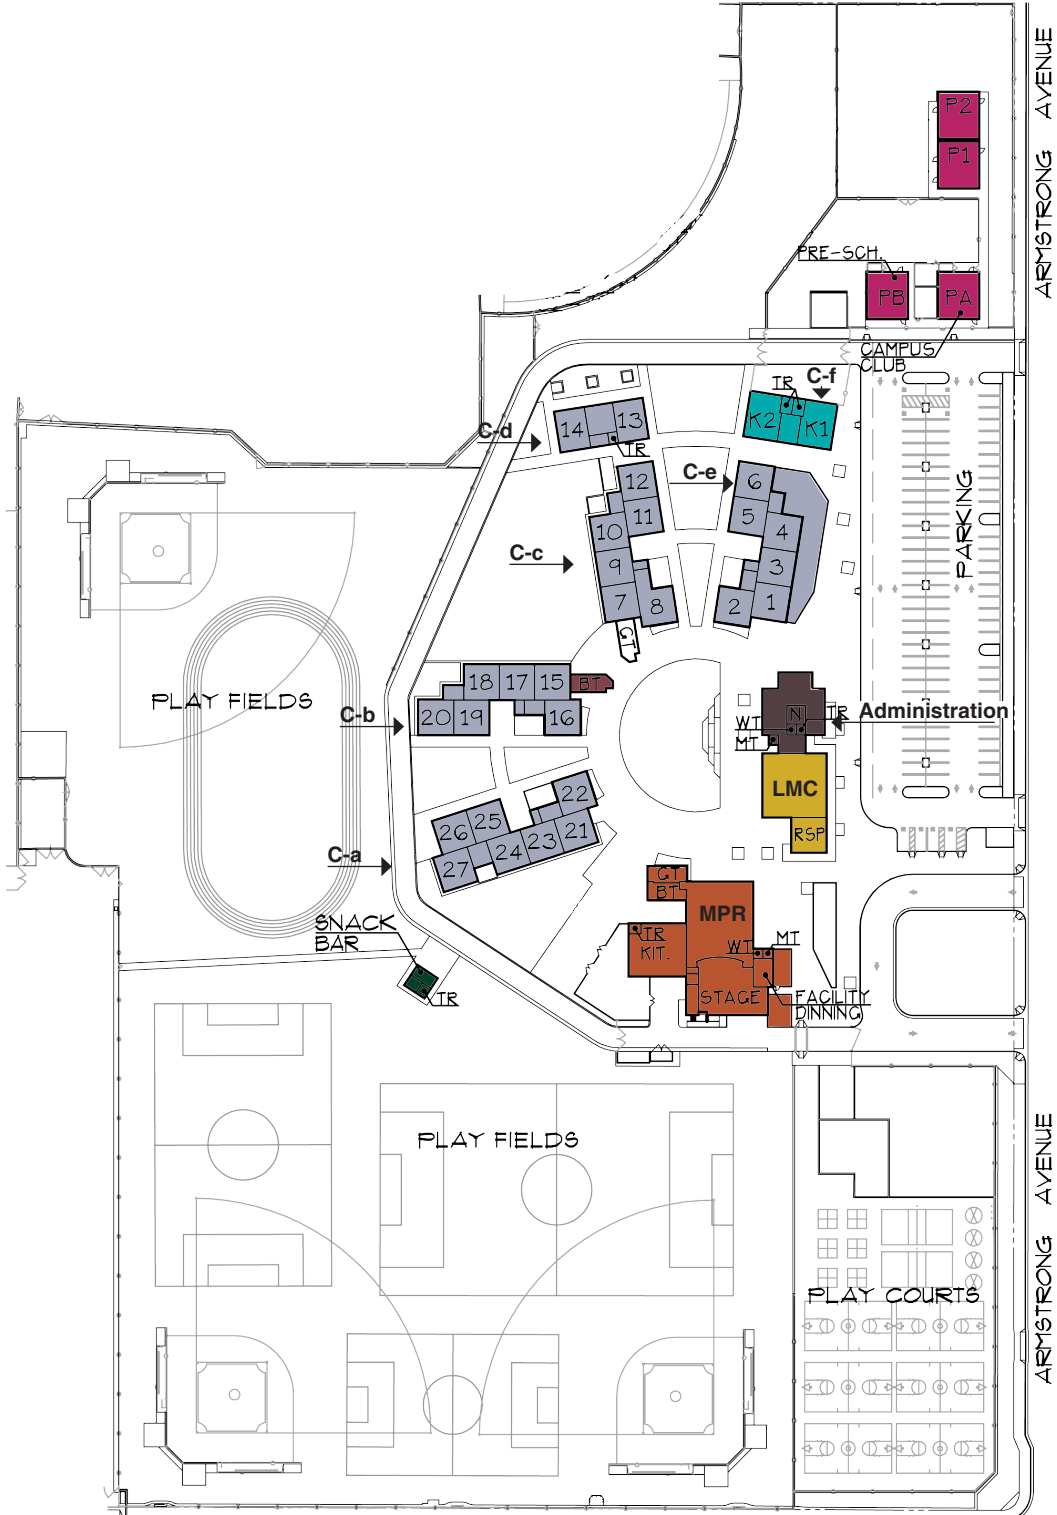
Site Plan

Observations: The concrete condition is good. There are a few locations of minor cracking. The curb ramps do not meet ADA requirements. The accessible stall signage and striping require minor changes. ADA detectable warning surface is required in many locations. Walk gates do not meet ADA requirements.

Recommendations: Reconstruct concrete improvements to eliminate trip hazards and comply with ADA curb ramp requirements. • Add accessible stall signage and striping as required. • Add ADA detectable warning surface at many locations. • Replace walk gates with ADA compliant gate hardware.
