Long Range Facility Audit 2009-2019

Clovis Unified School District • August 2009

Cole Elementary School

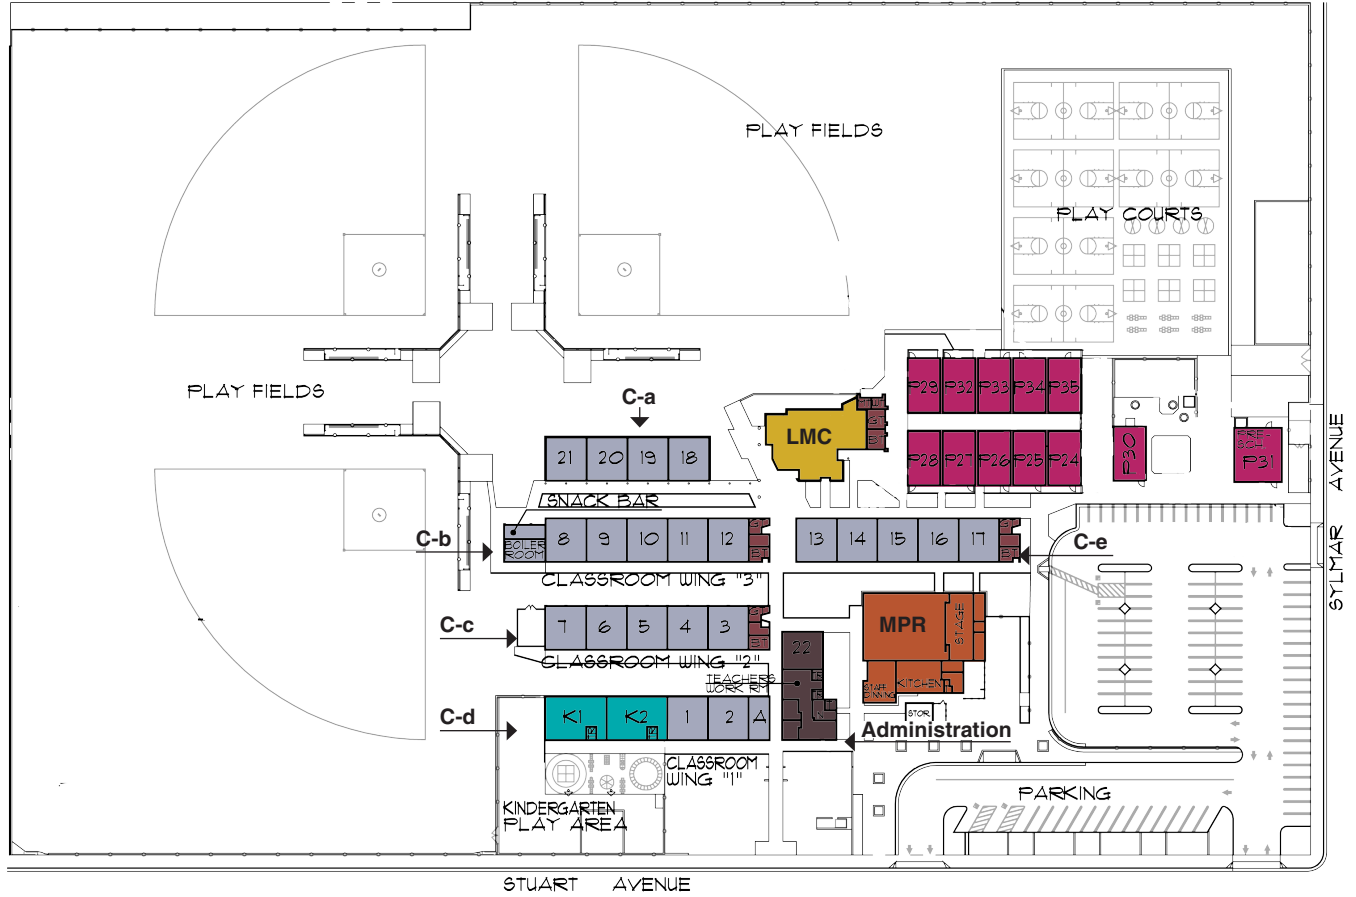
Site Plan

Observations: The concrete condition is fair. There are locations of minor cracking and trip hazards. The curb ramps do not meet ADA requirements. The accessible stall signage and striping require minor changes. ADA detectable warning surface is required in various locations. Walk gates do not meet ADA requirements. Some drinking fountains do not meet ADA requirements.

Observations: The storm drain system is in good working condition, but there is evidence of standing water in the kindergarten play area and playfields.

Recommendations: Reconstruct concrete improvements to eliminate trip hazards and comply with ADA curb ramp requirements. • Add accessible stall signage and striping as required. • Add ADA detectable warning surface at various locations. • Replace walk gates with ADA compliant gate hardware. • Replace drinking fountains with ADA compliant drinking fountains.

Recommendations: Add additional storm drain inlets to prevent standing water.
