Long Range Facility Audit 2009-2019

Clovis Unified School District • August 2009

Kastner Intermediate School

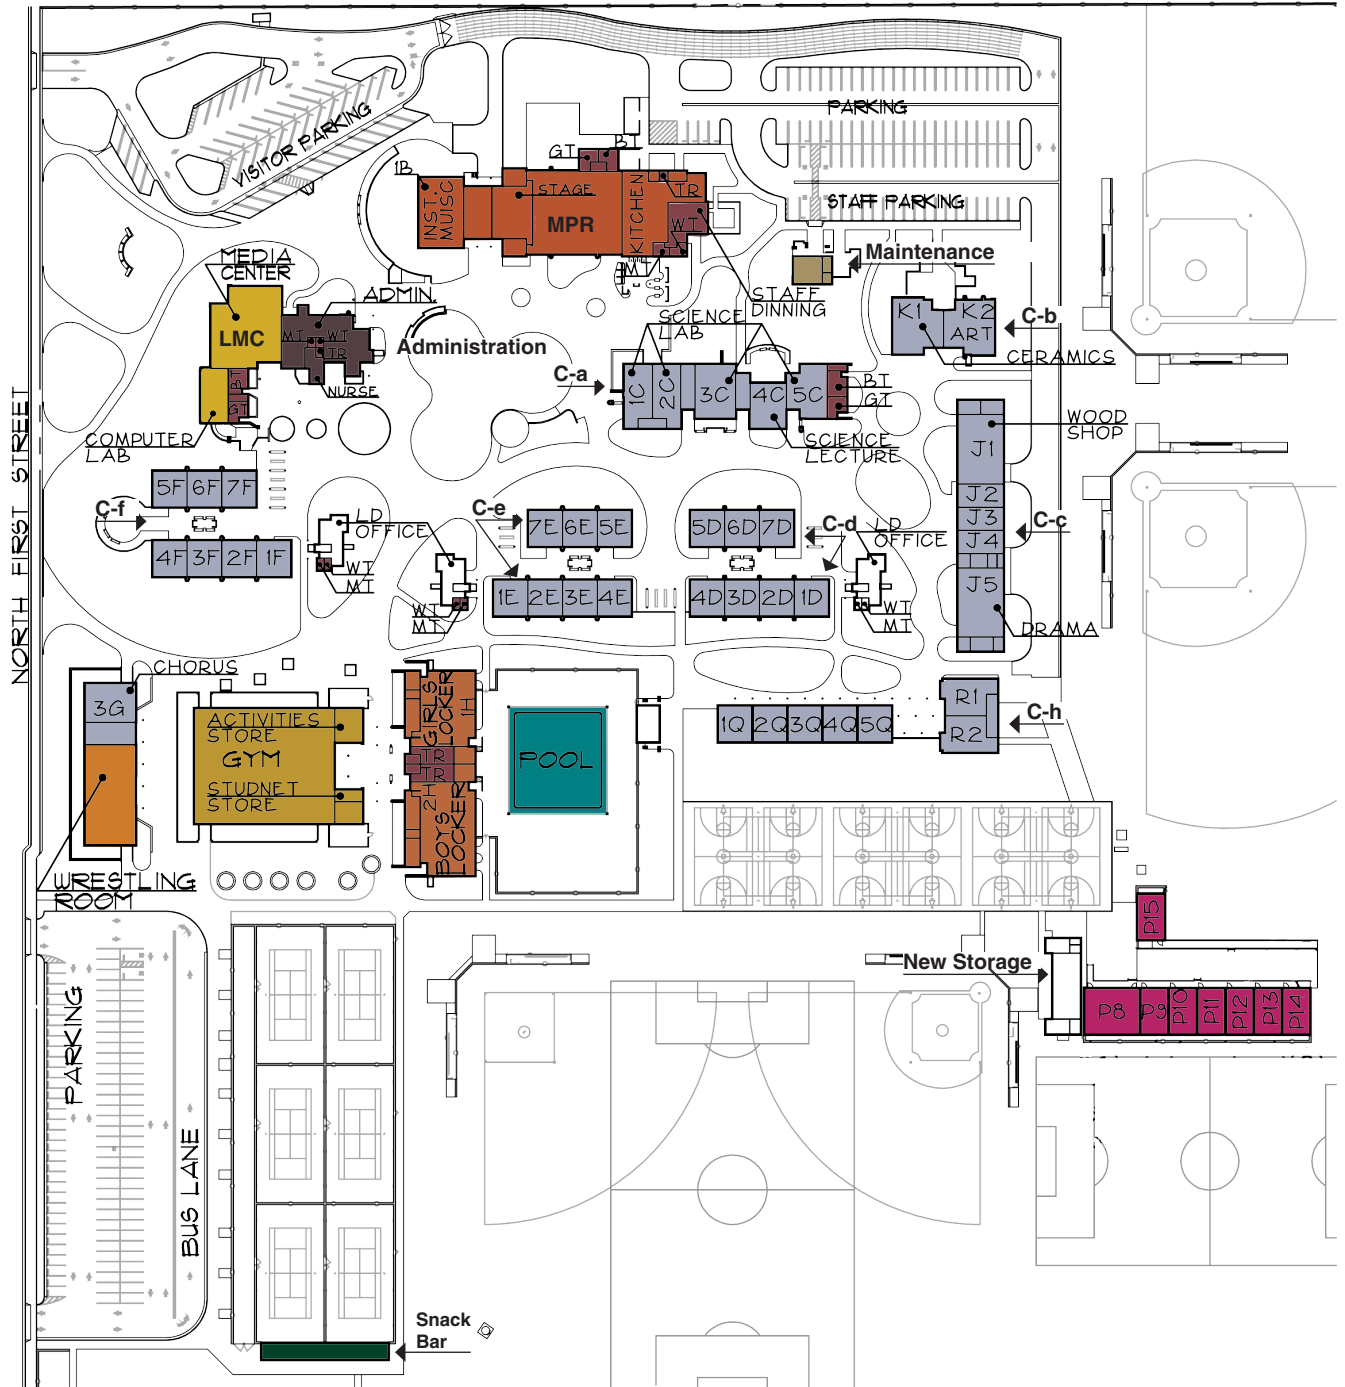
Site Plan

Observations: The concrete condition is fair, but there are some locations of cracking and trip hazards. The curb ramps do not meet ADA requirements. The concrete south of the music building does not meet ADA requirements. The accessible stall signage and striping require moderate changes. ADA detectable warning surface is required in various locations. Storm drain inlet grates do not meet ADA requirements for maximum grate openings. Some of the drinking fountains do not meet ADA requirements.

Observations: The storm drain system is in fair working condition. There is evidence of standing water in many campus areas.

Recommendations: Reconstruct concrete improvements to eliminate trip hazards and comply with ADA curb ramp requirements. • Add ADA compliant walkway near music building. • Add accessible stall signage and striping as required. • Add ADA detectable warning surface at various locations. • Replace storm drain inlet grates in accessible paths of travel with ADA compliant grates. • Replace drinking fountains with ADA compliant drinking fountains.

Recommendations: Reconstruct concrete improvements where slope can be improved. • Add additional storm drain inlets or re-grade/reconstruct improvements to eliminate standing water.
