Long Range Facility Audit 2009-2019

Clovis Unified School District • August 2009

Red Bank Elementary School

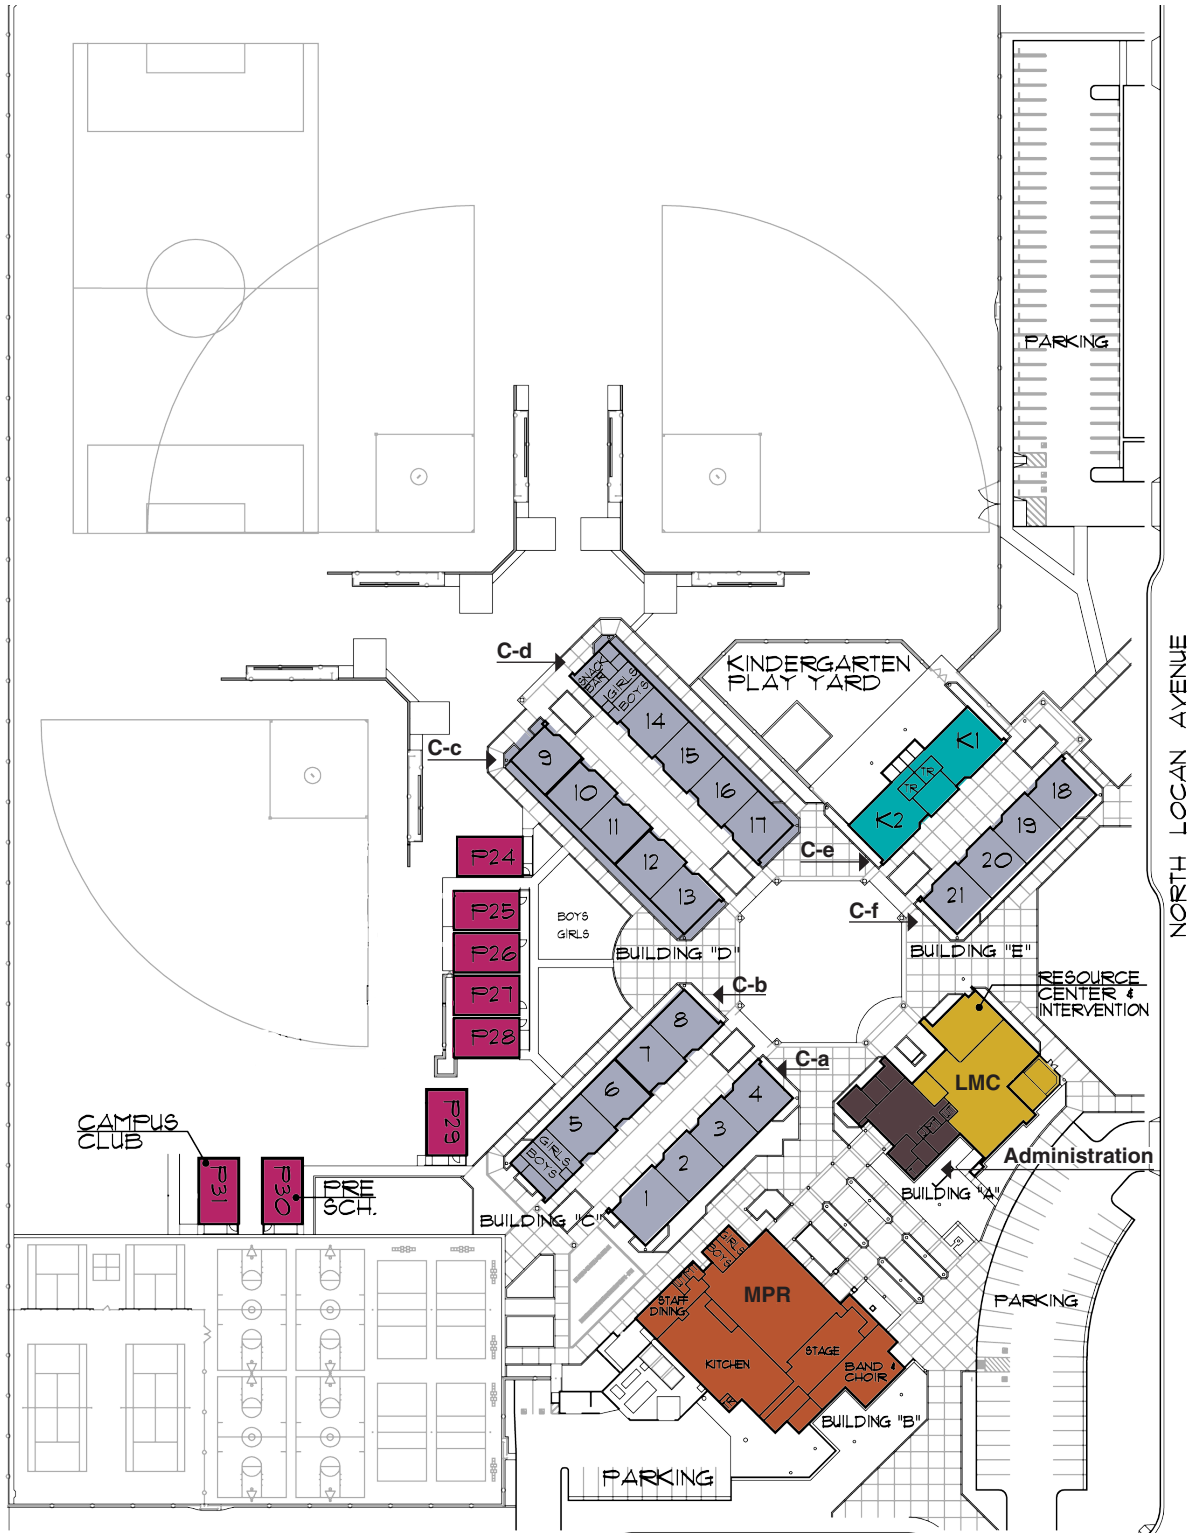
Site Plan

Observations: The concrete condition is good. There are locations of minor cracking and a few trip hazards. The side walk cross slopes and curb ramps do not meet ADA requirements. The accessible stall signage and striping require major changes. ADA detectable warning surface is required in various locations. Storm drain inlet grates do not meet ADA requirements for maximum grate openings. Walk gates do not meet ADA requirements. Some of the drinking fountains do not meet ADA requirements.

Observations: The storm drain system is in good working condition, but there is evidence of standing water in the elementary play pit area.

Recommendations: Reconstruct concrete improvements to eliminate trip hazards, comply with ADA curb ramp requirements and meet ADA slope requirements. • Add accessible stall signage and striping as required. • Add ADA detectable warning surface at various locations. • Replace storm drain inlet grates in accessible paths of travel with ADA compliant grates. • Replace walk gates with ADA compliant gate hardware. • Replace drinking fountains with ADA compliant drinking fountains.

Recommendations: Add additional storm drain inlets to prevent standing water.
