Long Range Facility Audit 2009-2019

Clovis Unified School District • August 2009

Tarpey Elementary School

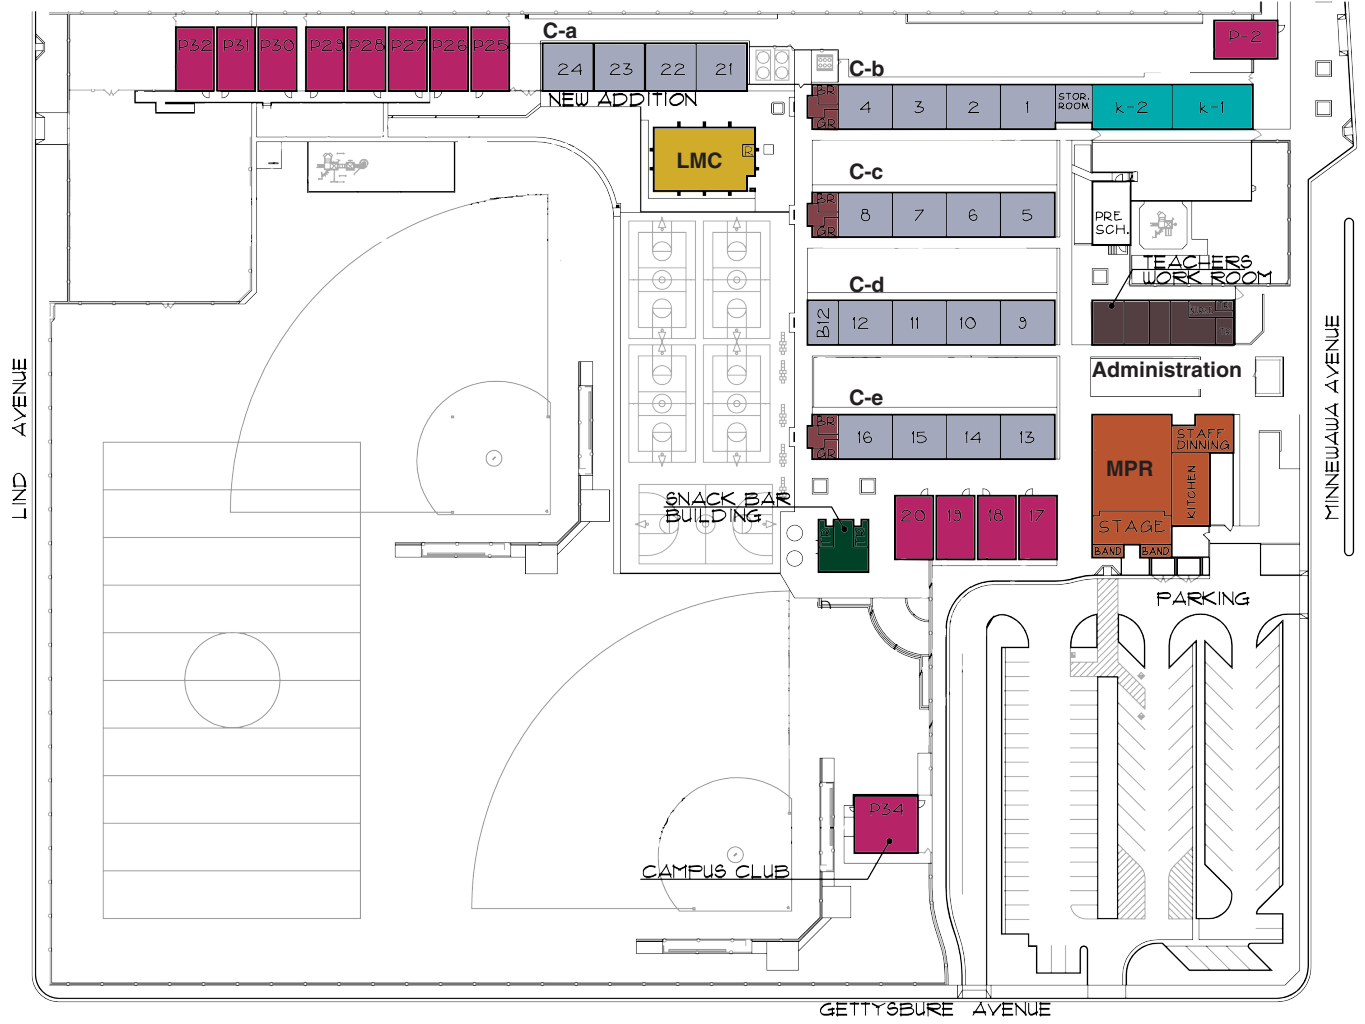
Site Plan

Observations: The concrete condition is poor. There are many locations of cracking and trip hazards. The side walk cross slopes and curb ramps do not meet ADA requirements. The accessible stall signage and striping require minor changes. ADA detectable warning surface is required in various locations. Storm drain inlet grates do not meet ADA requirements for maximum grate openings. Walk gates do not meet ADA requirements. Some drinking fountains do not meet ADA requirements.

Recommendations: Reconstruct concrete improvements to eliminate trip hazards, comply with ADA curb ramp requirements and meet ADA slope requirements. • Add accessible stall signage and striping as required. • Add ADA detectable warning surface at various locations. • Replace storm drain inlet grates in accessible paths of travel with ADA compliant grates. • Replace walk gates with ADA compliant gate hardware. • Replace drinking fountains with ADA compliant drinking fountains.
