Fuller Middle School Feasibility Study
Framingham, MA
HVAC Existing Conditions Systems Report
J#680 015 00.00
L#58621/Page 1/November 1, 2017

Heating, Ventilation, and Air Conditioning – HVAC

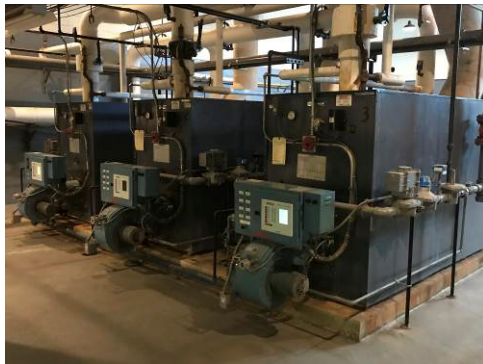
The building is primarily heated by a standard efficiency dual fuel (natural gas and No. 2 fuel oil) hot water boiler heating plant. The boiler plant consists of three (3) cast iron steel sectional Weil McLain Model 88-12 Boilers equipped with Webster dual fuel burners with Autoflame controller. The boilers each have a capacity of 3753 MBH gas input/26 GPH oil input, 3,000 MBH gross output and 2608 MBH net hot water heating output. The boilers were installed in 2003, therefore are approximately 14 years old and are past the midpoint of their expected useful service life of 20-25 years. Each boiler appears to be provided with proper operating and safety controls.

Hot Water Boilers

- Existing hot water boilers should be replaced with high efficiency gas fired condensing hot water boiler plant consisting of (3) new hot water gas-fired condensing boilers, associated breeching, accessories, pumps and controls. The new pumps should be equipped with VFD drives and provided with differential pressure controls and power wiring to replace the three (3) sets of existing hot water pumps (Quantity of 6 pumps).

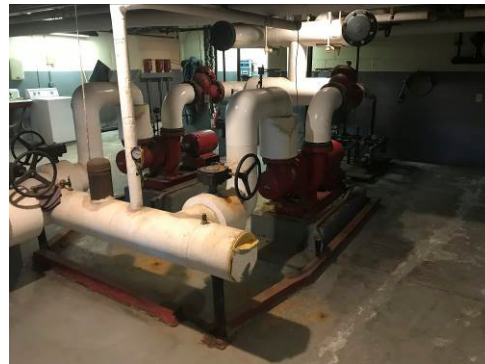
Hot Water Pumps

The overall hot water piping system is schedule 40 black steel and is insulated with fiberglass insulation. Some sections of piping are uninsulated, and some piping insulation fitting may contain asbestos. Most of the hot water piping within the boiler room was installed in 2003, whereas the remainder of the hot water piping is largely original to the building and was installed circa 1957. The boiler plant generates low-pressure low temperature heating hot water, which is distributed by a primary secondary constant flow hot water piping distribution system. The hot water loop does not have glycol solution, and according to facilities staff, hot water coils have frozen in past years but not within the past three years. The hot water circulates throughout the main building hot water loop by two (2) primary/standby end suction base mounted pumps equipped with 15 hp motors that are installed in the boiler room. These pumps appear to be in good condition and were installed circa 2003. The pumps are constant flow and are not equipped with variable speed drives.

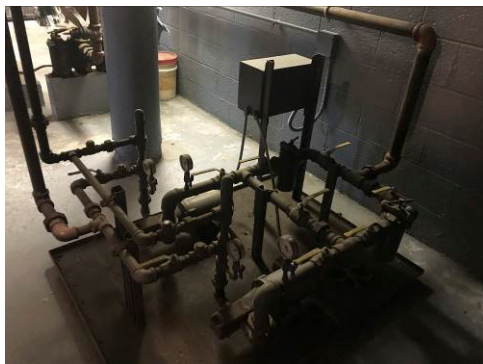
The boilers currently only use natural gas. It is our understanding that the fuel oil tank has been removed, and that the existing fuel oil pumps, monitor control panel and fuel oil piping within the boiler room have been abandoned in place.

Fuel Oil Pumps

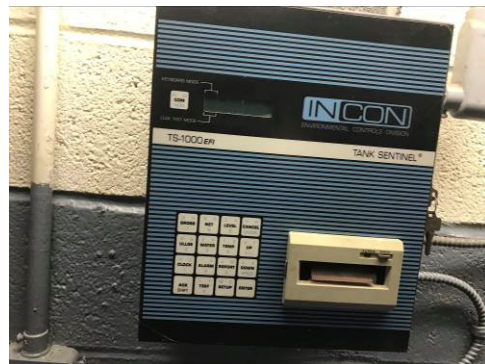
Fuel Oil Monitor Panel

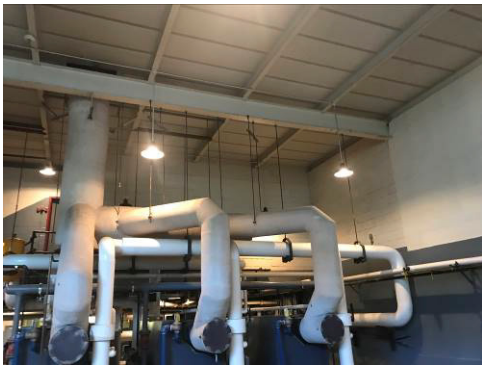
The boilers are each vented with insulated steel boiler breeching to a common breeching stack which terminates above the building roof with a single wall steel breeching equipped with a rain cap. Previously the original boilers were individually vented. Currently two of the steel breeching vents have been capped and abandoned in place.

Boiler Breeching

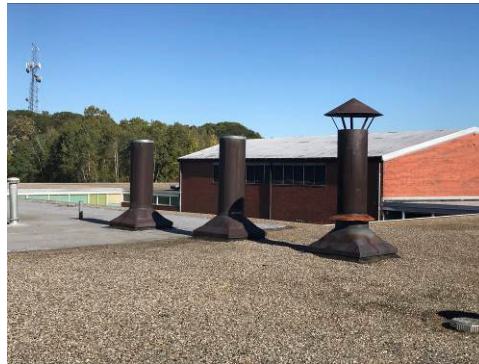
Boiler Breeching w/ Vent Cap

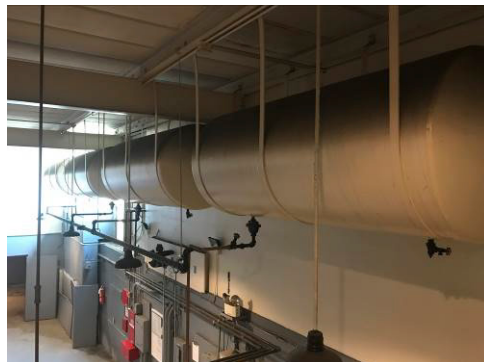
There are four ceiling suspended horizontal and one (1) vertical bladder style un-insulated expansion tanks located in the boiler room. It is our understanding that the vertical expansion tank is no longer operable and that only one (1) of the horizontal expansion tanks is connected to the system.

Expansion Tanks

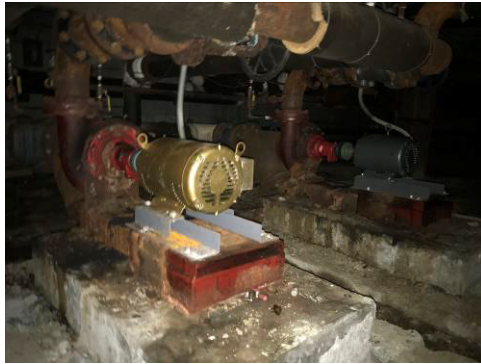
The majority of hot water piping is distributed from the Boiler room to the building heating equipment through a crawlspace. Most piping appears to be insulated and painted black, except for the pipe main fittings, which could possibly contain asbestos, and the piping adjacent to the secondary pump sets. The piping adjacent to pumps P-5&6 is missing sections of insulation, and the piping adjacent to pump set, P-7&8, appears to be newer fiberglass insulation. There are two (2) sets of primary/standby secondary hot water pumps located in the basement crawlspace area. Two of the pumps, P7&8 are equipped with 10 hp motors, appear to be in fair condition and serve the Area D (Cafeteria, Gym, Locker Room) portion of the building. Two of the other pumps, P-5&P-6 are equipped with 5 hp motors, appear to be in poor condition and serve the Area A (Classroom Wing) portion of the building. The pumps are constant flow and are not equipped with variable speed drives.

Crawlspace - Hot Water Pump P-5&P-6

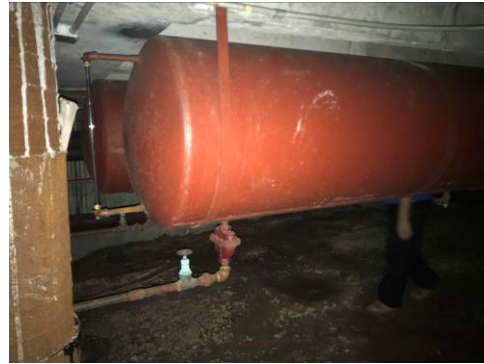
Crawlspace – Expansion Tank

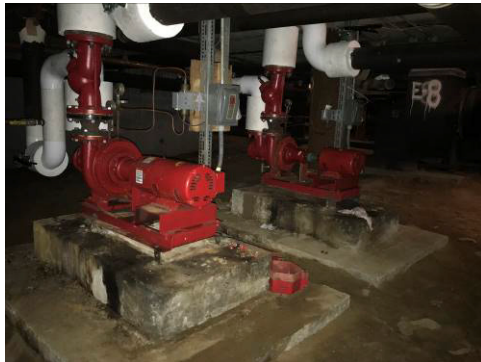
Crawlspace - Hot Water Pump P-7&P-8

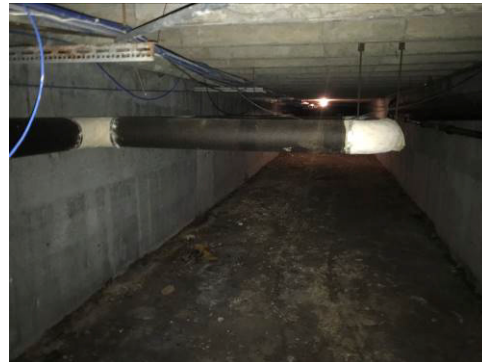
Crawlspace – Hot Water Piping

- All existing originally installed exhaust air fans should be replaced with new exhaust air fans.
- All originally installed existing HVAC system ductwork and piping should be replaced and new insulated ductwork and piping should be installed.

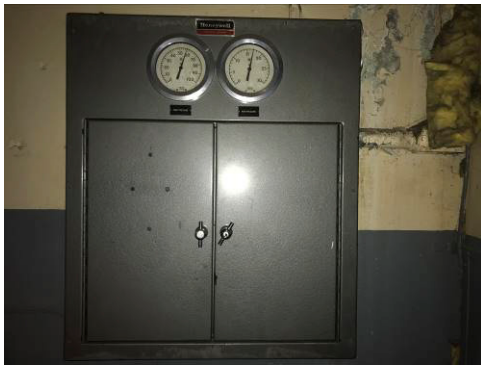
The Automatic Temperature Control (ATC) system is a combination direct digital (DDC) and pneumatic control system. The DDC components were installed by AEM (Advanced Energy Management) Inc. The DDC control system uses an Advanced Energy Management Viewport front end software with operates on Windows XP. The DDC control system was installed circa 2000, and as part of the DDC system installation the controls for the air handling units, boiler plant and unit ventilators were converted from pneumatic to DDC controls. Some heating equipment, air handling dampers and unit ventilators still operate using pneumatic controls. The pneumatic control air compressor is located in the Boiler room. Originally the building control system was largely manufactured by Johnson Controls. Overall the ATC system is antiquated in comparison to current systems, and only provides minimal monitoring, scheduling and setpoint control functionality. There is no ability for the Facility staff to make programming sequence changes for the HVAC equipment.

Pneumatic Control Panel

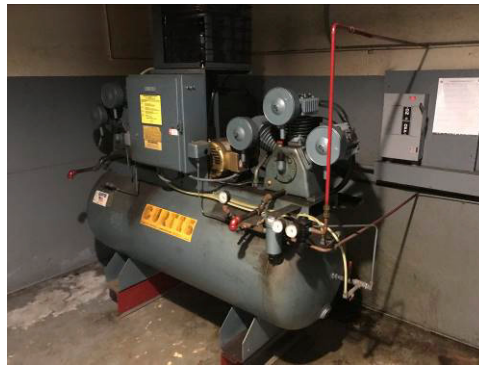
Pneumatic Control Air Compressor

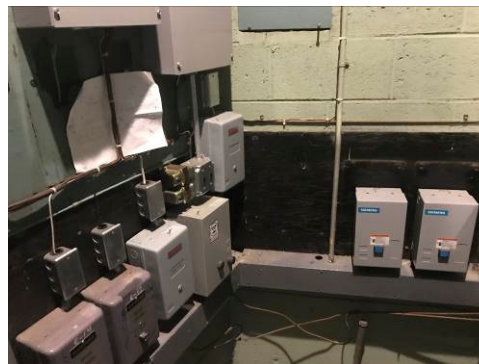
Exhaust Fan Relays and Starters

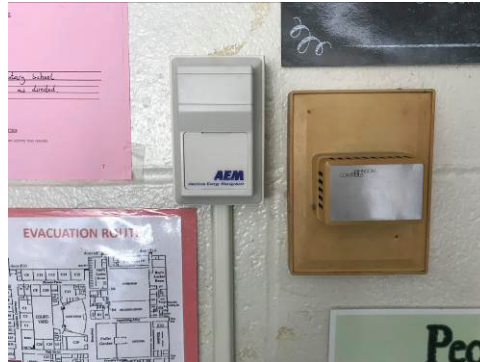
Rooms/zones with HVAC equipment that is controlled by the DDC system typically have newer AEM thermostat temperature sensors, whereas rooms/zone with HVAC equipment controlled by Pneumatic controls have older Johnson control pneumatic thermostats.

Typical DDC Tstat (left) and Pneumatic Thermostat (right)

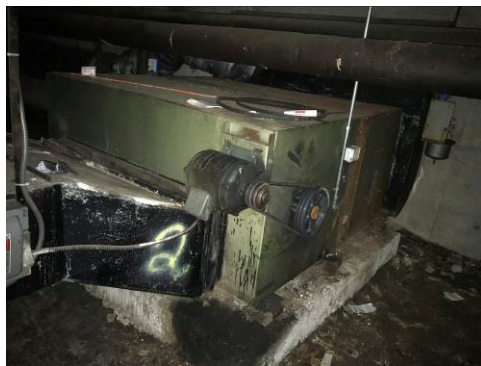
There are five (5) indoor hot water heating and ventilation (HV) air handing units located in the crawlspace of the building. These units HV-5,6,7,8,13 and 14 respectively serve the Library, Library Offices, Administration offices, Girls Locker room, Boys Locker Room and Cafeteria. Black painted uninsulated ductwork is routed up from the units to the areas they serve. All of the units were installed circa 1957, and the units and associated ductwork, piping and control components appear to be in poor conditions. Most of the HV Unit fans are not equipped with pulled guards. Due to the damp crawlspace environment, unit casing, control components and ductwork show signs of visible corrosion. In addition, duck leakage is a potential concern for reduced building indoor air quality in these areas as the crawlspace area air can potential infiltrate the HV system ductwork and spread to the areas the HV units serve.

Crawlspace – HV Unit

- All existing heating and ventilation units (Qty. of 14) should be replaced. Consideration should be given to adding energy recovery to the HV units, and possibly adding air conditioning to the new units. These units presently serve the Gym, Multi-Purpose Gym, Library and library offices, Cafeteria, Locker rooms, Music Rooms, Auditorium and Administration office. It is highly recommended that replacement units are not installed within crawlspace areas due to difficulty for service and maintenance, and the potential for reduced service life of the equipment.

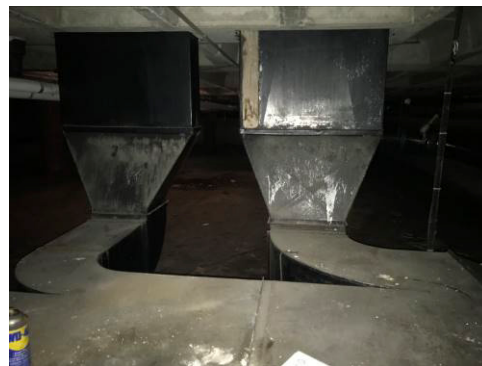
Crawlspace – HV Unit Ductwork

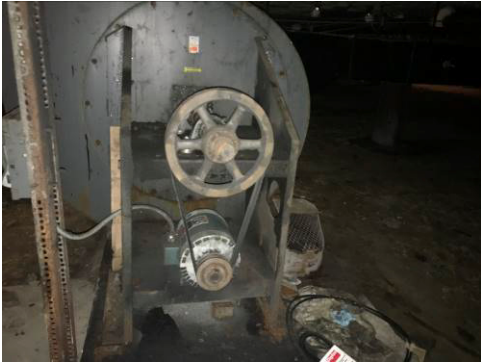
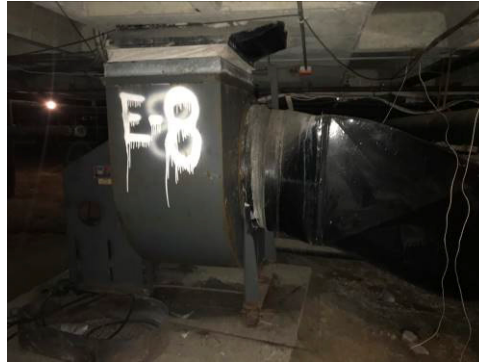
There are approximately nine (9) utility vent set style centrifugal exhaust air fans located in the crawlspace area which generally serve classroom and bathroom exhaust air systems. The exhaust fans and ductwork are generally all original equipment and systems that were installed in 1957. The fans show visible signs of corrosion, and the ductwork is generally uninsulated, painted black and some ductwork sections shows signs of corrosion and damage. Most of the exhaust fans are not equipped with pulled guards.

Crawlspace – Exhaust Fans

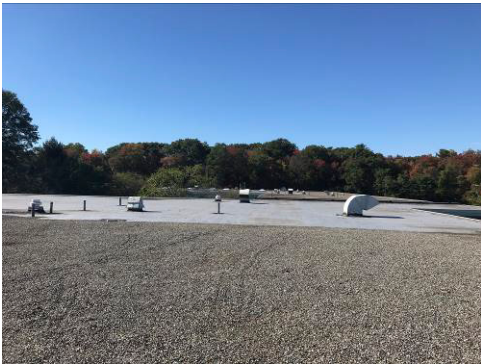
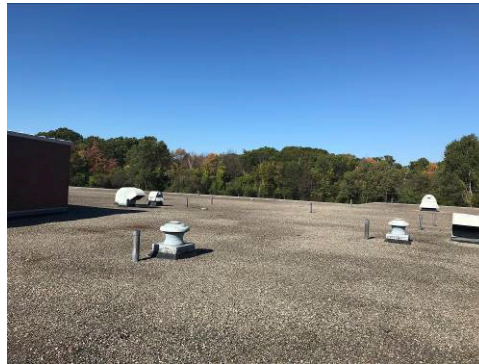
There are approximately forty-four (44) roof mounted exhaust air fans, with most fans being originally installed equipment from 1957. Some exhaust fans have been repaired and replaced since their original installation, however most of the fans are in need of replacement. There are also many intake and relief air hoods located on the roof. The intake and relief hoods serve heating and ventilation equipment and exhaust air fan systems located throughout the building.

Roof – Exhaust Fans and Intake/Relief Hoods

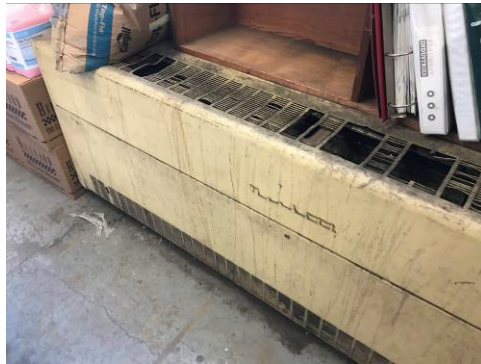
The Shop areas are typically heated and ventilated by a combination of wall mounted unit ventilators, fin tube radiation and unit heaters. The majority of equipment is originally installed equipment, circa 1957, and in need of replacement. The unit ventilators were noted to have a source of outside ventilation air, supply fans, filters, and a heating hot water coil with valve control. The general condition of the unit ventilators, unit heaters and radiation heating equipment observed were in poor condition.

Shop area Unit Ventilator

- New fume hood and exhaust air system should be provided for Science classrooms if required.
- The Shop area HVAC systems should be replaced including Unit ventilators, exhaust air systems and the dust collector unit and associated ductwork.
- Ventilation air system should be provided for the corridors and classroom/office areas that lack mechanical ventilation.
- The existing direct digital control building energy management system should be replaced and upgraded to a full DDC system. Existing pneumatic controls should be removed.
- All new HVAC systems should be tested, adjusted, balanced and commissioned.

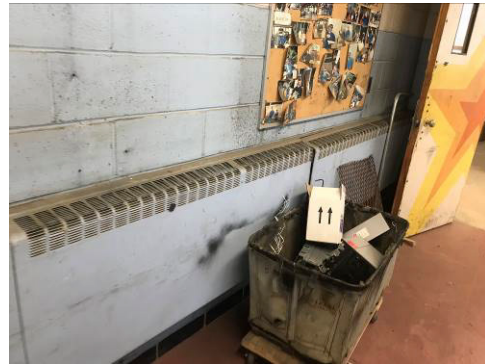
Shop Area – Fintube Radiation

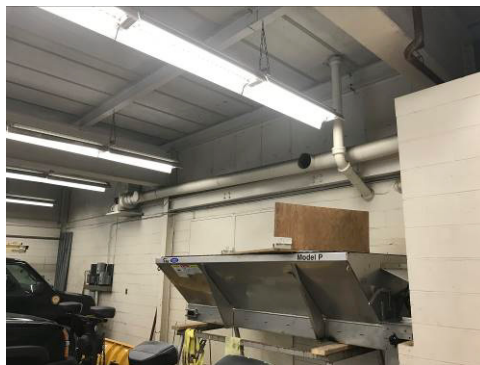
Some of the shop areas are also provided with local exhaust air fan systems, such as paint booth exhaust and capture hood exhaust fan systems which generally are in poor condition. The vehicle garage shop area has a ducted exhaust air system which appears to have been abandoned in place and a wall type propeller exhaust air fan appears to provide the majority of room exhaust.

Abandoned Exhaust Ductwork

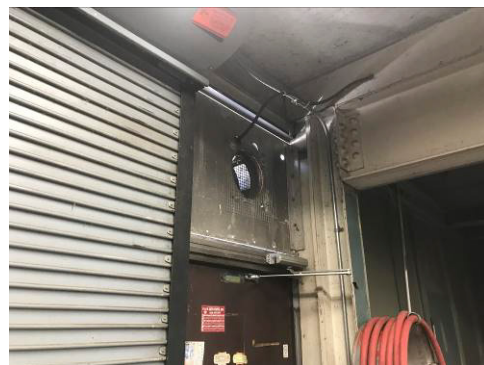
Wall Propeller Fan

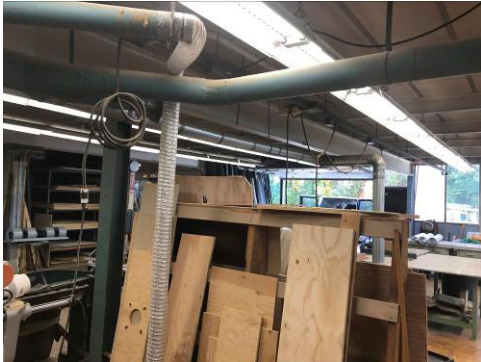
There is a dust collection system for the woodworking shop; much of the ductwork is damaged and in need of replacement. The dust collector unit, which is manufactured by AAF Co. (Model D Roto Clone, Size 8) is showing signs of corrosion.

Wood Shop Exhaust Ductwork

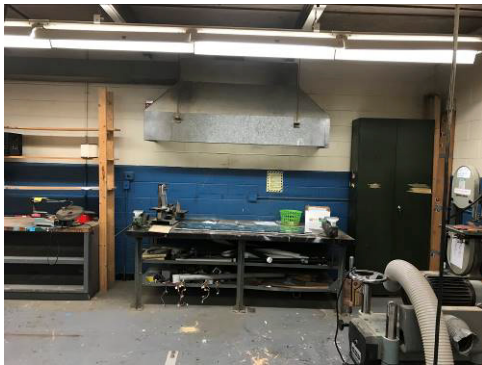
Exhaust Capture Hood

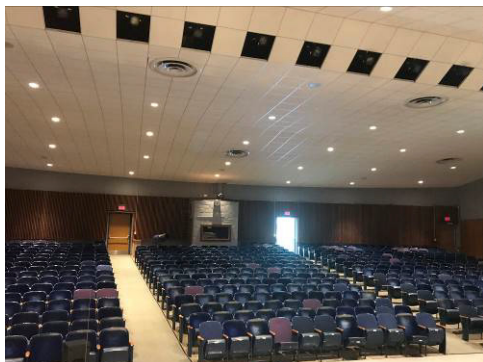
The Auditorium is served by heating and ventilation unit, HV-2, which has a capacity of 7,500 cfm and was installed in 1957. The HV unit is located in an adjacent mechanical room and the unit is ducted to overhead round supply air diffusers located in the Auditorium. The HV unit is originally installed equipment which is in need of replacement. A utility style centrifugal exhaust air fan that was installed in 1957, located in the mechanical room adjacent to the HV unit, removes exhaust air from the Auditorium.

Auditorium Supply Diffusers

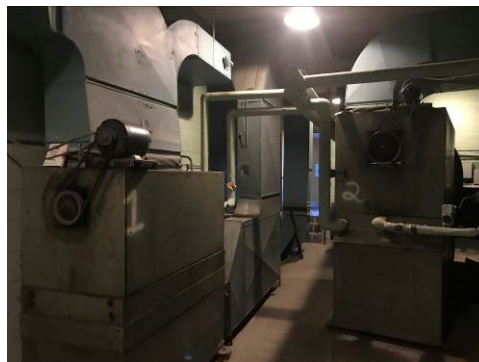
Auditorium HV Unit and Exhaust Fan

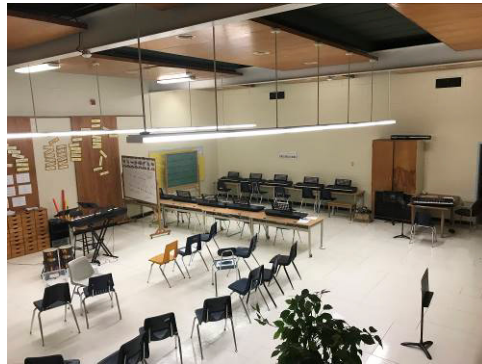
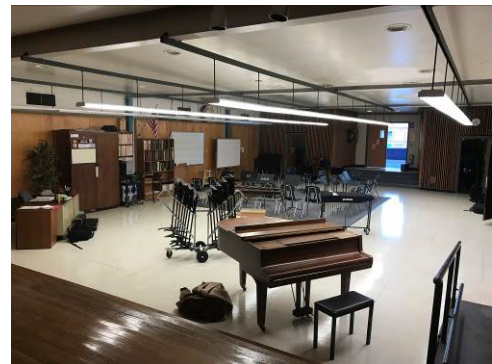
The Music Rooms are served by heating and ventilation units, HV-3 (3,400 cfm) and HV-4 (2,750 cfm), HV units are located within mechanical closets adjacent to the Music Rooms. Utility style centrifugal exhaust air fans remove exhaust air from the music rooms. The HV unit and exhaust fans are originally installed equipment that requires replacement. Sidewall supply and exhaust air diffusers and grilles are located high on the walls of the Music rooms.

Music Rooms – Supply and Exhaust Sidewall Diffusers and Registers

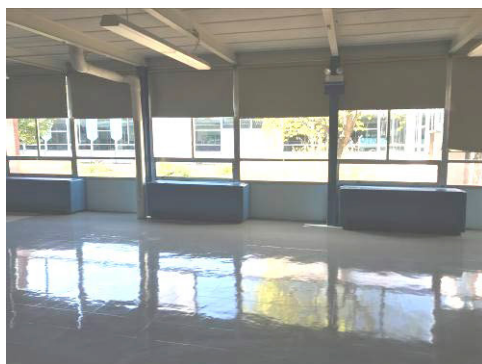
The cafeteria is served by a combination of one indoor HV unit (HV-14 – 10,200 CFM) that is located in the Crawlspace and was installed in 1957 and five (5) vertical style hot water unit ventilators. Each unit ventilator is provided with a heating hot water coil, supply fans, filters, and a source of outside ventilation air. The Cafeteria is also served by an exhaust air fan system.

Cafeteria Unit Ventilators

- All existing unit ventilators should be replaced (Qty. of 75). Adding new CO2 demand ventilation and/or energy recovery should be considered as part of a potential UV replacement project. Under a large building renovation project, potential alternative HVAC systems should be studied as part of a potential solution to replace the Unit Ventilators and Window AC unit that currently serve the Classrooms.

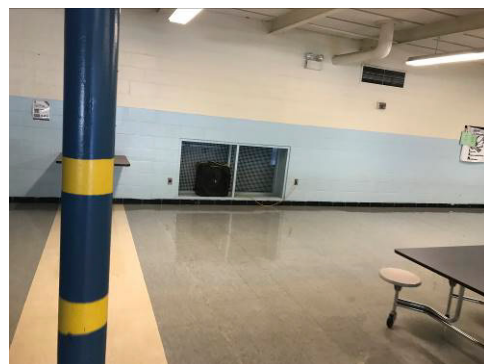
It appears that a source of the supply air from the cafeteria is transferred to the kitchen via low wall mounted transfer grilles. These registers were slightly dirty, but do appear to function.

Cafeteria Transfer Grille and Exhaust Grille

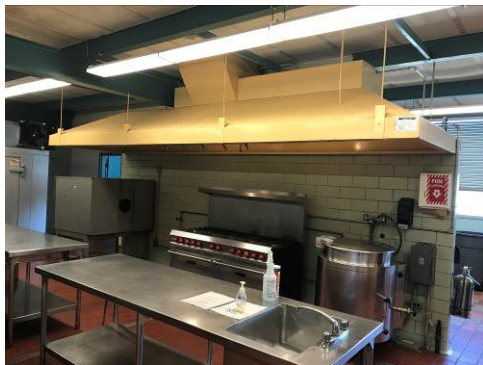
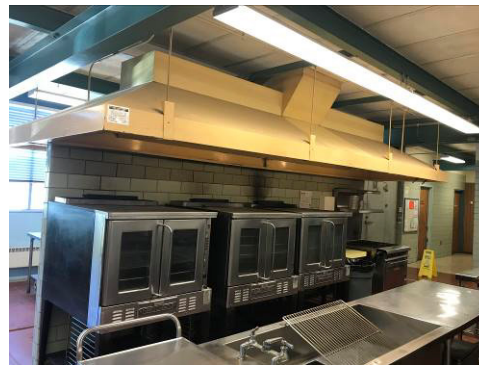
The kitchen is provided with a double-sided steel kitchen exhaust hood that is located over the cooking equipment and appears to be of adequate size and height to serve the intended purposes. The kitchen hood is provided with cleanable filters, and appear to have an Ansul type fire protection system installed. As we understand it from maintenance personnel, the exhaust hood does operate; however, we cannot be certain that it operates efficiently or per code requirements.

Kitchen Exhaust Hood

- A dedicated make-up air unit should be installed for the Kitchen, and the existing Kitchen and Dishwasher hoods and exhaust air fans system should be replaced.

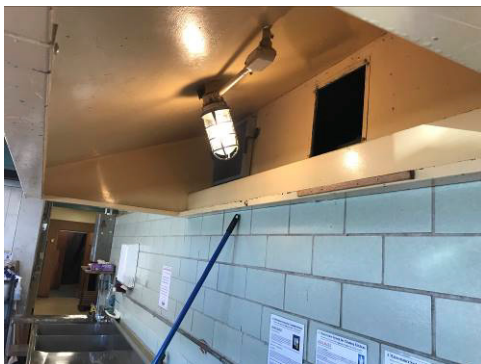
Kitchen Dishwashing Area Hood

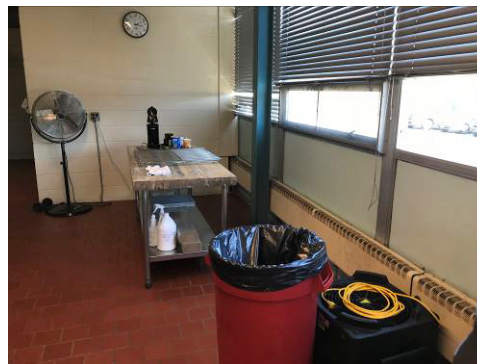
The kitchen area is heated with wall mounted fin tube radiation heating. The kitchen does not have a direct source of make-up air ventilation other than operable windows and the transfer air from the adjacent Cafeteria. The kitchen does not have any mechanical cooling systems. Instead a large propeller stand type fan is used to provide spot cooling during warmer days while cooking and dishwashing operations are taking place. There is a canopy exhaust hood located over the dishwashing sink. There is a refrigeration cooler with air cooled condensing section located within the kitchen that adds a significant heating load to the kitchen. Consideration should be given to replacing this unit with a split system type cooler unit.

Kitchen Fin Tube Radiation and Propeller Fan

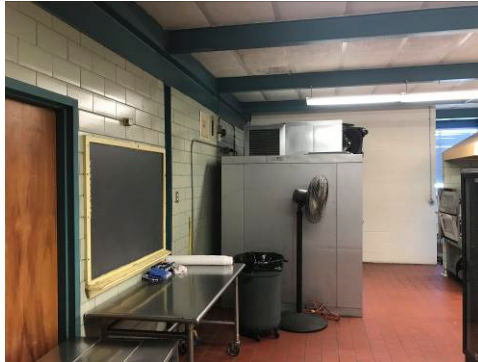
Kitchen Refrigeration Cooler

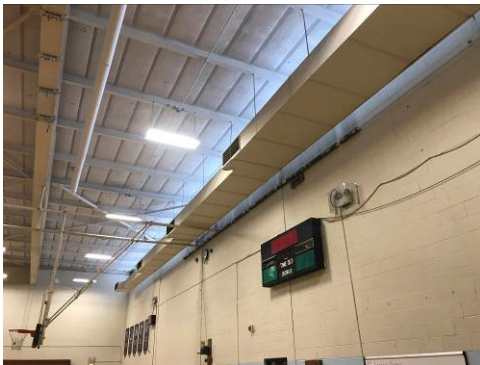
The gymnasium is provided with two individual air-handling units located in roof penthouse mechanical rooms. Heating and ventilation unit HV-9 serves the West half of the Gym and has a capacity of 7,500 cfm, and HV-10 serves the East half of the Gym and has a capacity of 7,500 cfm. Each unit is provided with a heating hot water coil, supply fans, filters, and a source of outside ventilation air. Each air-handling unit serves a supply air duct with side wall diffusers located high above the floor and provides heating and ventilation air to the entire space through these two supply ductwork and diffuser assemblies. Also, located within the gymnasium are individual low wall return air registers, which return the supply air back to each air-handling unit exhaust air fan located within the same mechanical room. These registers were noted to be slightly damaged and dirty and generally in need of replacement.

Gym Supply Duct and Diffusers

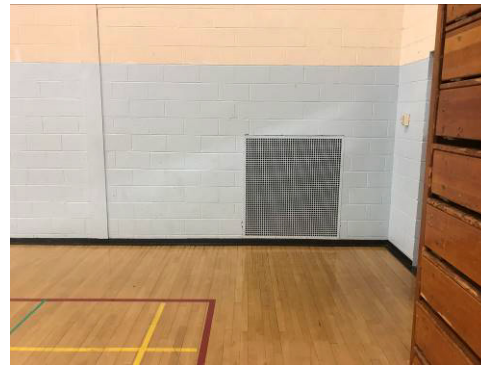
Gym Return Register

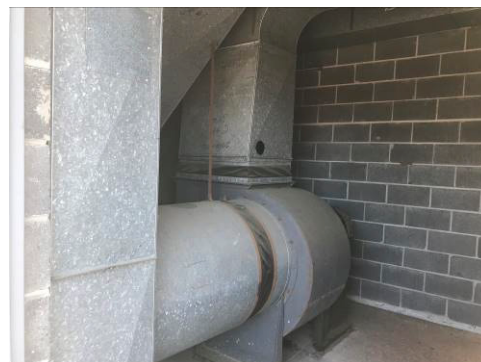
Penthouse Mech Rm – Gym Exhaust Fan

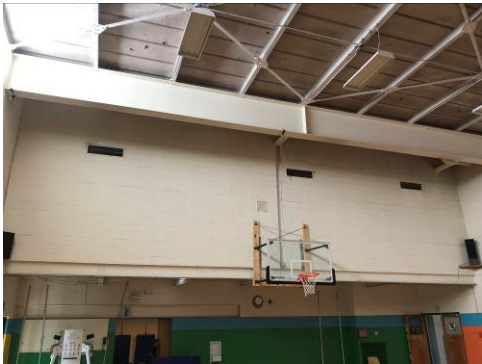
The Multi-purpose gymnasium is provided with two individual air-handling units located in roof penthouse mechanical rooms. Heating and ventilation unit HV-11 serves the West half of the gym and has a capacity of 4,000 cfm, and HV-12 serves the East half of the Gym and has a capacity of 4,000 cfm. Each unit is provided with a heating hot water coil, supply fans, filters, and a source of outside ventilation air. Each air-handling unit serves a supply air duct with side wall diffusers located high above the floor and provides heating and ventilation air to the entire space through these two supply ductwork and sidewall diffuser assemblies. Also, located within the gymnasium are individual low wall return air registers, which return the supply air back to each air-handling unit exhaust air fan located within the same mechanical room. These registers were noted to be slightly damaged and dirty and generally in need of replacement.

Multi-Purpose Gym Supply Diffusers

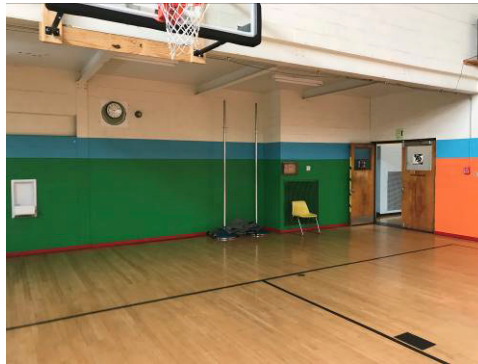
Multi-Purpose Gym – Return Register

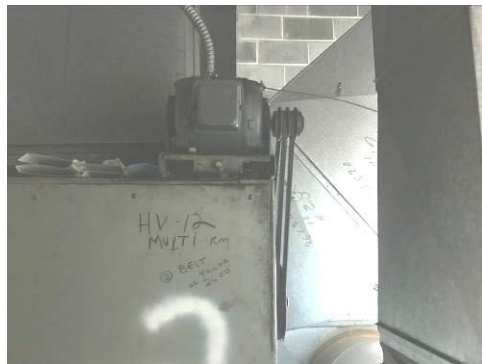
Multi-Purpose Gym HV Unit

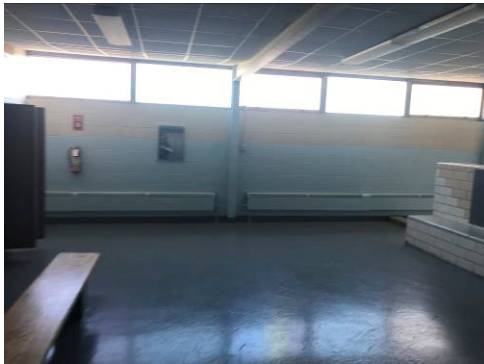
Both the girls and the boys locker rooms are each served by an indoor heating and ventilation air-handling unit, which includes a hot water heating coil, supply fan, filters, and a source of outside ventilation air. Ventilation air is provided overhead through a supply distribution system to various diffusers located throughout. The HV units are located in the crawlspace area and appear to be in poor condition. HV-8 serves the Girl's locker room and has a capacity of 5,825 cfm and HV-13 serves the Boy's locker room and has a capacity of 5,600 cfm. There are also side wall mounted and overhead exhaust air grilles that are connected to exhaust air. The system appeared to be functioning properly, however the diffusers, ductwork and fans appear to be originally installed equipment and systems that should be replaced. The locker rooms are also heated by perimeter wall mounted fin tube radiation heating.

Typical Locker Room Fintube

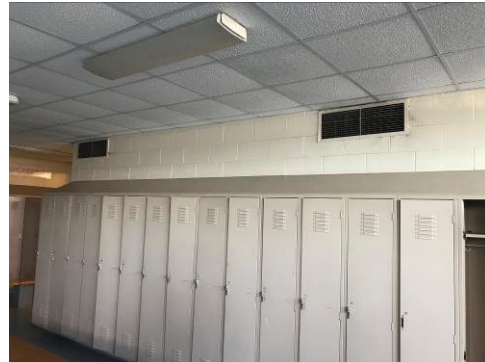
Typical Locker Room Exhaust

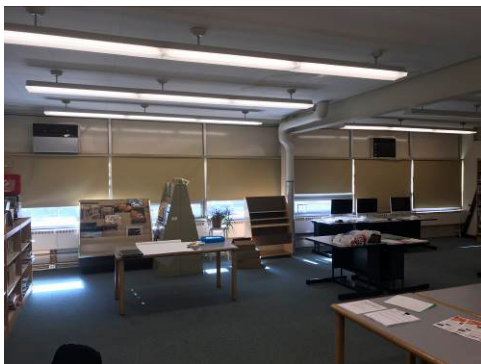
The Library and adjacent Library offices are heated and ventilated by two (2) indoor heating and ventilation units located in the crawlspace area below the Library, and are ducted to sidewall supply air diffusers. HV-5 serves the Library and has a capacity of 1,750 cfm and HV-6 serves the library offices and has a capacity of 1,880 cfm. Both units appear to be in poor condition and were installed in 1957. The Library is also heated with supplemental perimeter fin tube radiation heating, and is air conditioned by window AC units.

Library - Window AC Units and Fin Tube

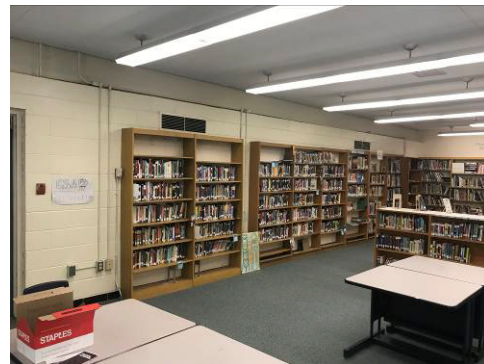
Library Supply Diffusers

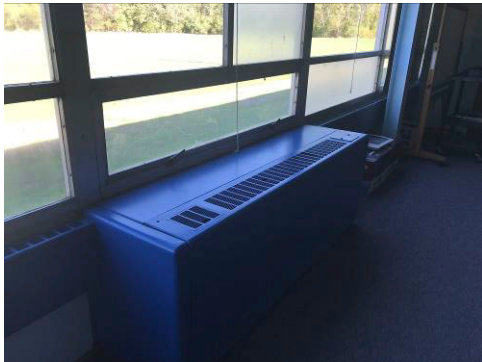
Classrooms are typically provided with wall-mounted vertical discharge unit ventilators, which include a hot water heating coil with valve control, a source of outside ventilation air, supply fans and filters. These units were installed in 1957 and are in poor condition. Overall there are approximately seventy-five unit ventilators installed throughout the building, with the majority being installed in classroom areas. Exhaust air grilles are typically located low within an architectural enclosure on the interior corridor side of the classroom. The exhaust air grilles are ducted to exhaust air ductwork and fan systems located in the crawlspace areas below the Classrooms. Many classrooms also have supplemental fin tube radiation heating along the exterior perimeter walls. Most of the unit ventilators are controlled by the DDC system and much of the hot water radiation heating is controlled by the pneumatic control system.

Classroom Unit Ventilator

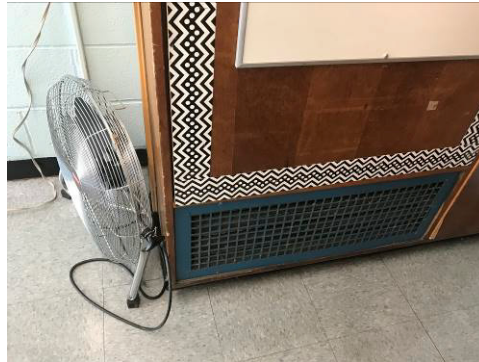
Classroom Exhaust Grille

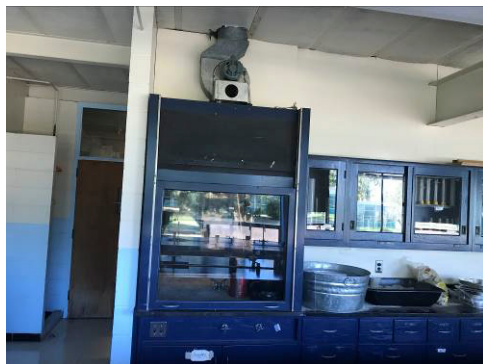
The Science Classroom has an old fume hood and exhaust air fan system which appears to have been originally installed equipment and in poor physical condition. Many of the Classrooms observed appear to have window air conditioners installed

Science Classroom Fume Hood

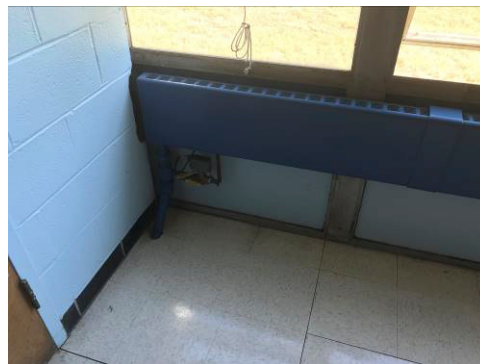
Classroom Fintube Radiation

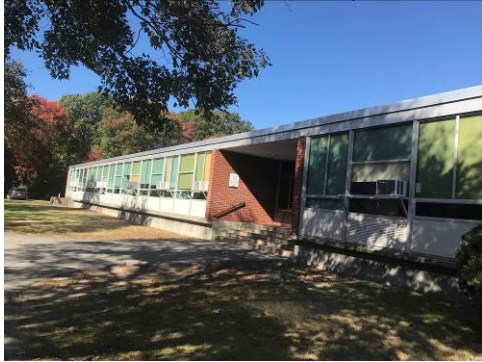
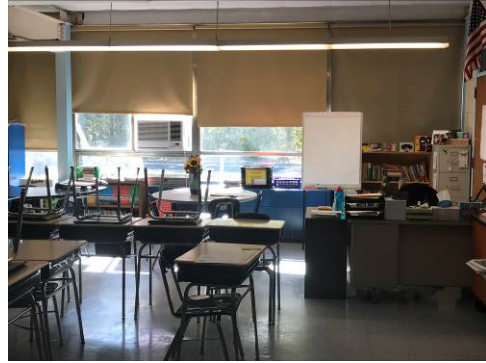
Classroom – Unit Ventilator Louvers and Window AC Units

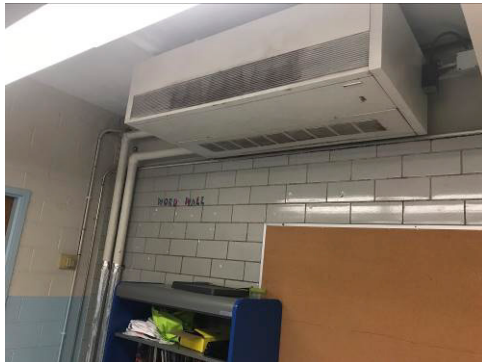
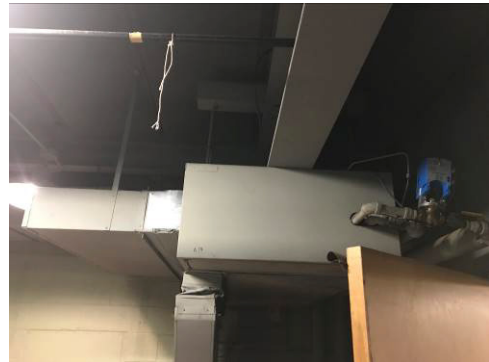
Horizontal Classroom Unit Ventilators

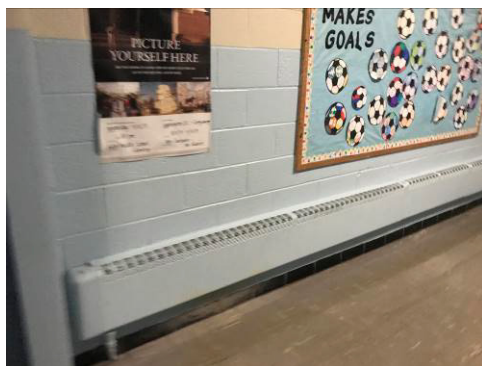
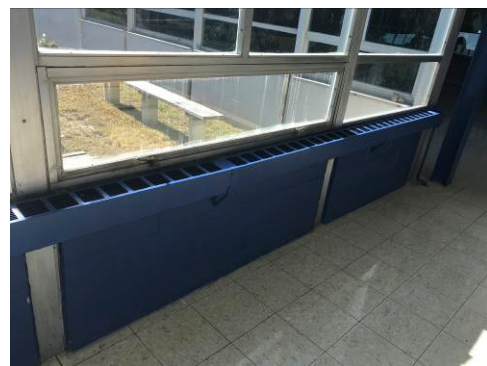
The various circulating corridors throughout the building do not appear to be provided with code required ventilation air. Ventilation air is required by code in corridors, therefore this condition should be corrected. Majority of corridors are heated by hot water fin tube radiation equipment which appears to be originally installed equipment that has exceeded its expected service life.

Corridor – Fin Tube Radiation Heating

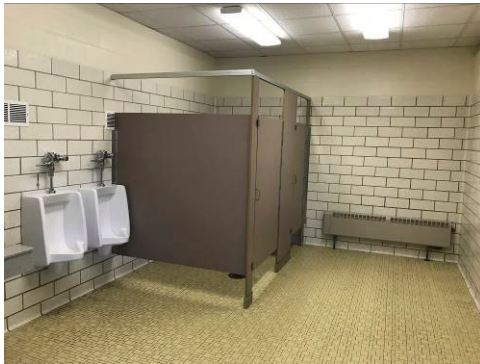
The restrooms observed during our site visit appear to be properly exhausted with exhaust air fan systems. Make up air for larger restrooms is typically provided by door grilles. Restrooms are typically heated by fin tube radiation heating. The exhaust air and heating systems appear to be original to the building, circa 1957, and therefore should be replaced.

Restroom – Exhaust Grille and Fintube Radiation Heating

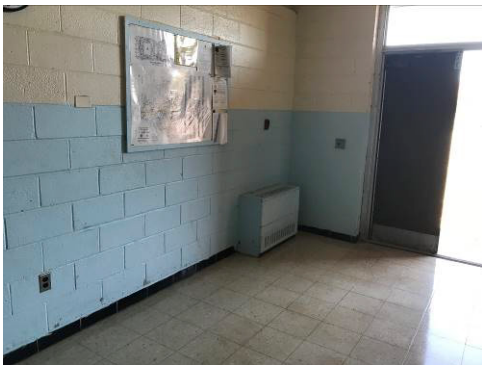
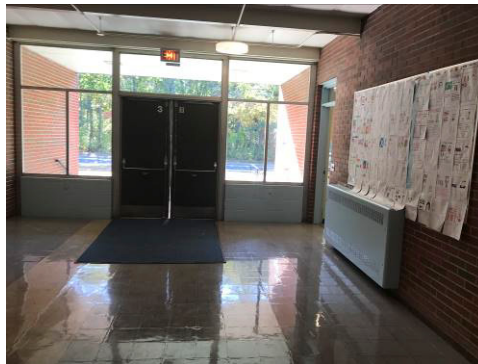
The individual entranceways throughout the building are typically heated by a combination of hot water cabinet style unit heaters, convectors, or hot water fin tube radiation heating. These cabinet heaters and fintube enclosure generally were noted to be slightly dirty and some had damaged casing; however, we understand most of the units do operate. The entranceways are not provided with any vestibule interlocks and therefore infiltration air does circulate throughout when the doors are open. It is recommended that vestibule interlocks be provided at each doorway and all cabinet heaters be replaced with a higher output unit.

Entryway – Hot Water Cabinet Unit Ventilator (left) and Convector(right)

- New cabinet unit heaters and/or convectors should be installed at Entryways.

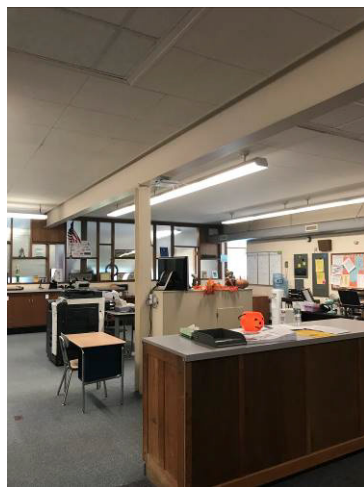
The main administration office area is heated and ventilated by an indoor heating and ventilation unit, HV-7 – 870 cfm) that is located in the crawlspace below the office area. The administration area is also heated by supplemental fin tube radiation heating and is primarily air conditioned by window AC units. The HV unit and fin tube radiation are originally installed equipment, circa 1957. One of the teacher's offices is air conditioned by a Window AC unit that is installed in an interior wall. This unit can cause condensate to drop from the unit and on to the floor during humid days. The Nurse's office is air conditioned by a ductless split system AC unit.

Administration Office

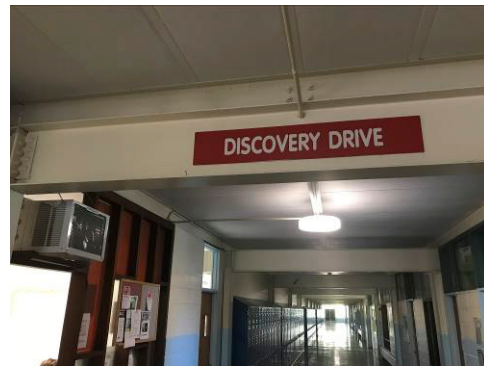
Office with Window AC installed in Interior Wall

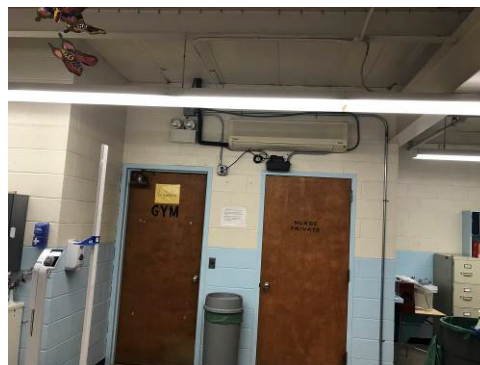
Nurse's Office Ductless AC unit

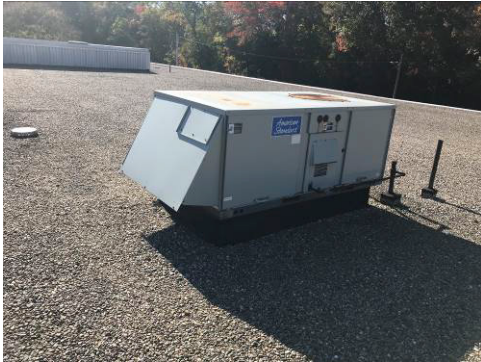
The Buildings and Grounds office area is primarily heating, ventilated and air conditioned by a packaged rooftop unit equipped with gas fired heating and direct expansion electric cooling. The unit was manufactured by Trane, has a capacity of 5 tons and was installed circa 2001. The unit appears to be in fair condition, but is nearing the end of its expected useful service life of 15-20 years. The B&G office area is also heated by supplemental hot water fintube radiation.

B&G Office - Packaged Rooftop Unit

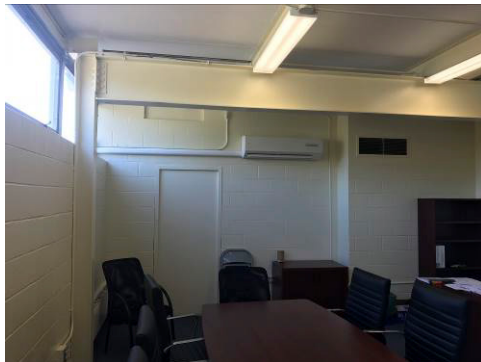
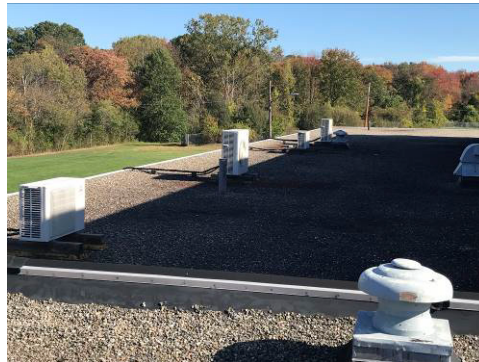
The Community Health area is primarily heated by perimeter fin tube radiation heating, and is air conditioned by a combination of Window AC and ductless split system AC units. Ventilation air is provided by a combination of operable windows and a ceiling suspended energy recovery (ERV) unit. The ductless split system unit and ERB unit appear to have been installed approximately 3-4 years ago.

Community Health – Ductless AC Unit and Associated Roof Condensing Units

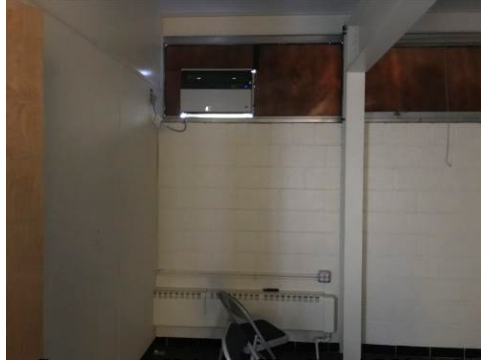
*Community Health - Window AC Unit
and Fintube Radiation*

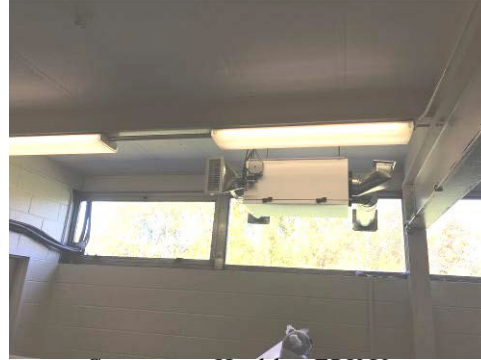
Community Health – ERV Unit
