Southampton Union Free School District

**Districtwide Lead in Drinking Water
Sampling and Remediation Plan**

Project #19878

September 2020
Updated January 18, 2021

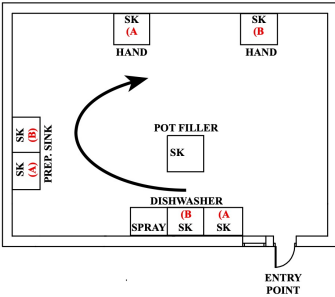
KITCHEN DIAGRAM

LOCATION	SOURCE
Kitchen Dishwash Station @ (A)	SK
Kitchen Dishwash Station @ (B)	SK
Kitchen Dishwasher	SPRAY
Prep. Sink @ (A)	SK
Prep. Sink @ (B)	SK
Kitchen Hand Wash @ (A)	SK
Kitchen Hand Wash @ (B)	SK
Kitchen Pot Filler	SK

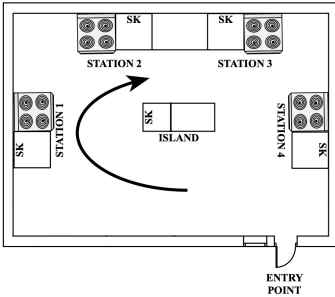
HOME ECONOMICS / CAREER DIAGRAM

LOCATION	SOURCE
Career RM - Station 1	SK
Career RM - Station 2	SK
Career RM - Station 3	SK
Career RM - Station 4	SK
Career RM - Island	SK

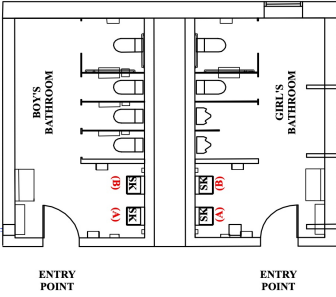
GANG BATHROOM DIAGRAM

LOCATION	SOURCE
Girl's BR @ (A)	SK
Girl's BR @ (B)	SK
Boy's BR @ (A)	SK
Boy's BR @ (B)	SK

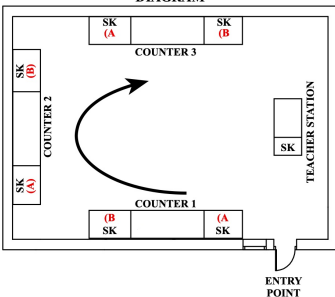
SCIENCE ROOM TYPE 1 DIAGRAM

LOCATION	SOURCE
Room 200 - Teacher Station	SK
Room 200 - Counter 1 @ (A)	SK
Room 200 - Counter 1 @ (B)	SK
Room 200 - Counter 2 @ (A)	SK
Room 200 - Counter 2 @ (B)	SK
Room 200 - Counter 3 @ (A)	SK
Room 200 - Counter 3 @ (B)	SK

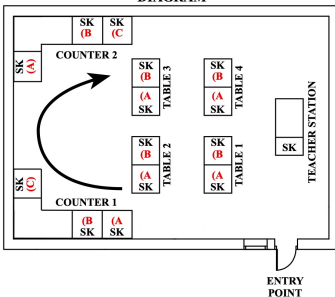
SCIENCE ROOM TYPE 2 DIAGRAM

LOCATION	SOURCE
Room 200 - Teacher Station	SK
Room 200 - Table 1 @ (A)	SK
Room 200 - Table 1 @ (B)	SK
Room 200 - Table 2 @ (A)	SK
Room 200 - Table 2 @ (B)	SK
Room 200 - Table 3 @ (A)	SK
Room 200 - Table 3 @ (B)	SK
Room 200 - Table 4 @ (A)	SK
Room 200 - Table 4 @ (B)	SK
Room 200 - Counter 1 @ (A)	SK
Room 200 - Counter 1 @ (B)	SK
Room 200 - Counter 1 @ (C)	SK
Room 200 - Counter 2 @ (A)	SK
Room 200 - Counter 2 @ (B)	SK
Room 200 - Counter 2 @ (C)	SK

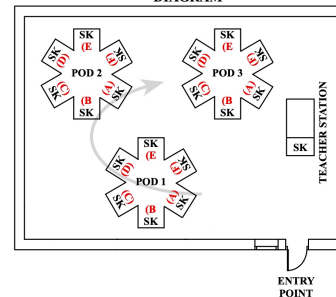
SCIENCE ROOM TYPE 3 DIAGRAM

LOCATION	SOURCE
Room 200 - Teacher Station	SK
Room 200 - POD 1 @ (A)	SK
Room 200 - POD 1 @ (B)	SK
Room 200 - POD 1 @ (C)	SK
Room 200 - POD 1 @ (D)	SK
Room 200 - POD 1 @ (E)	SK
Room 200 - POD 1 @ (F)	SK
Room 200 - POD 2 @ (A)	SK
Room 200 - POD 2 @ (B)	SK
Room 200 - POD 2 @ (C)	SK
Room 200 - POD 2 @ (D)	SK
Room 200 - POD 2 @ (E)	SK
Room 200 - POD 2 @ (F)	SK
Room 200 - POD 3 @ (A)	SK
Room 200 - POD 3 @ (B)	SK
Room 200 - POD 3 @ (C)	SK
Room 200 - POD 3 @ (D)	SK
Room 200 - POD 3 @ (E)	SK
Room 200 - POD 3 @ (F)	SK

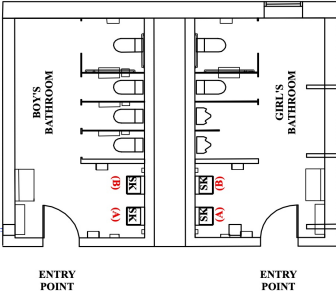
GANG BATHROOM DIAGRAM

LOCATION	SOURCE
Girl's BR @ (A)	SK
Girl's BR @ (B)	SK
Boy's BR @ (A)	SK
Boy's BR @ (B)	SK
