CHAPTER 34 NARRITIVE

FRAMINGHAM FULLER SCHOOL
FRAMINGHAM, MA

SUBMITTED: NOVEMBER 8, 2017

**FULLER MIDDLE SCHOOL
FRAMINGHAM, MASSACHUSETTS
STRUCTURAL EXISTING CONDITIONS REPORT
NOVEMBER 1, 2017**

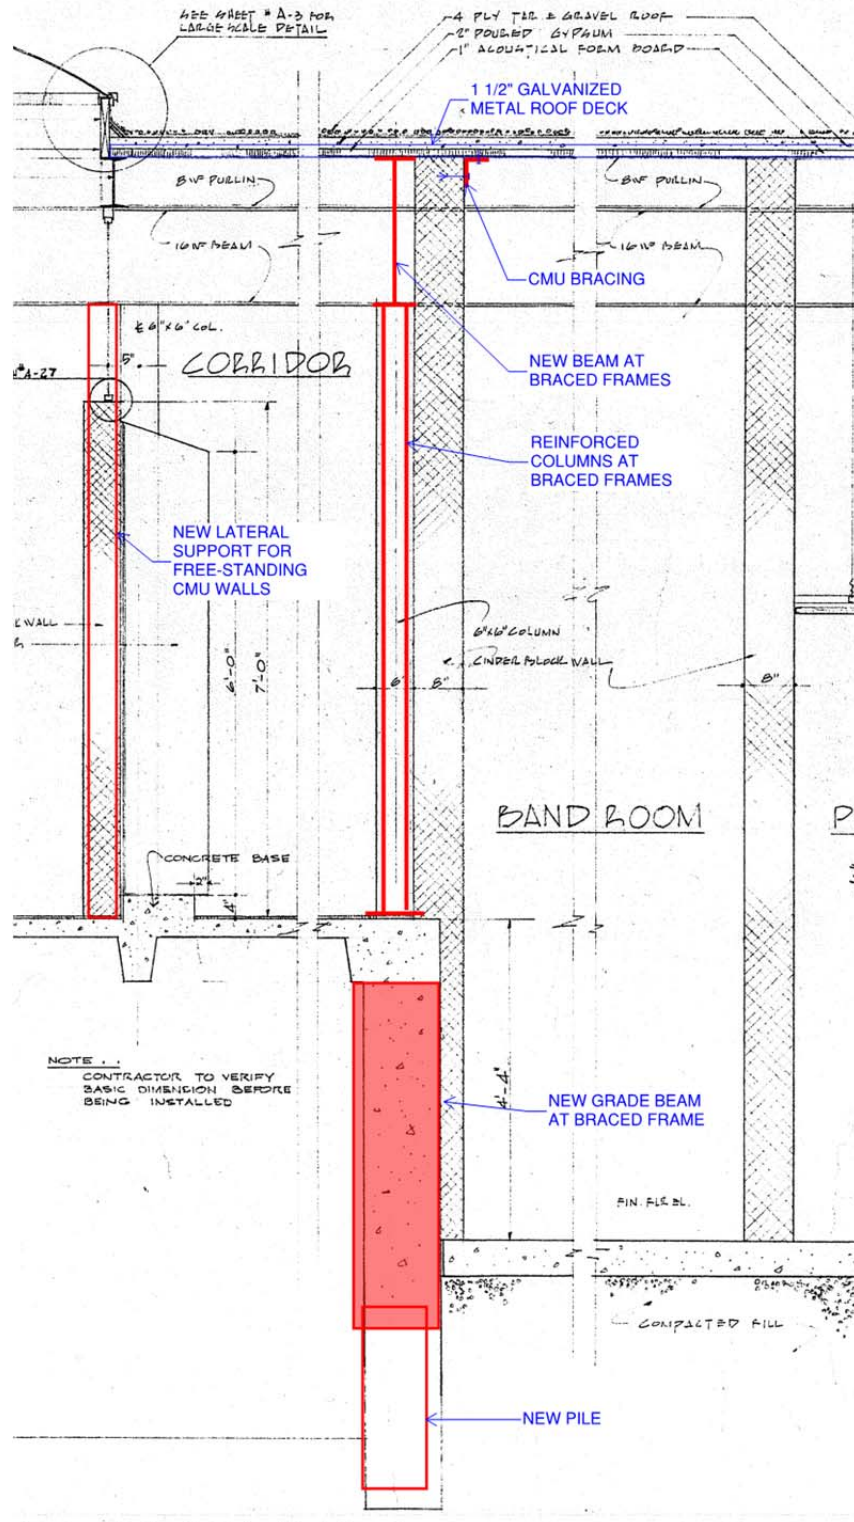
Seismic Upgrade Sketch

The original design of the building did not consider lateral loads. By default, the lateral stiffness is provided by the unreinforced CMU partitions. A renovation of the building will likely result in removed or relocated CMU partitions, and therefore a lateral design will be required based on the current code. If the CMU walls are not removed, RSE still recommends a seismic upgrade due to the significant financial investment and prolonged life expectancy of the building.

- i. Replace the entire gypsum roof deck with a metal deck that can distribute diaphragm loads. Gypsum is a brittle material that by nature does not have sufficient ductility to transfer diaphragm loads to the lateral system. Add supplemental steel framing (such as 8" steel beams) at the diaphragm edges that don't have existing steel beams. These are required because the 8" purlins sit above the girders and the load path is broken at the diaphragm edges.

- iii. Brace CMU partitions to the roof diaphragm. If the gypsum roof is not replaced, supplemental steel will be required above the CMU partitions where the gypsum has been affected by roof leaks since fastening to saturated gypsum is not reliable.

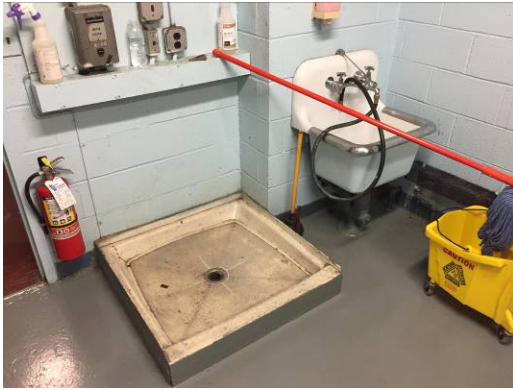
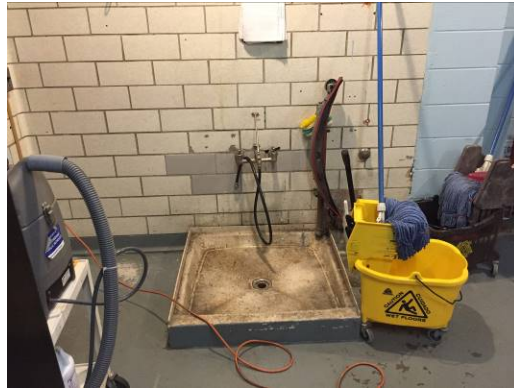
Typical Janitor's Room

Janitor's rooms are provided with floor mounted mop receptor and wall hung service sink. Floor mounted mop receptor is not provided with faucet, it is used only for waste drainage. The service sink is provided with faucet with vacuum breaker and the faucet has hose connection.

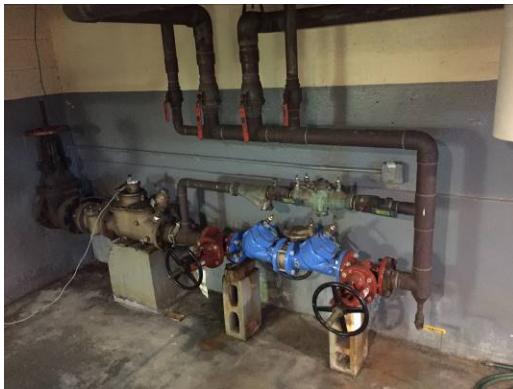
Domestic Water Service

The main domestic water service is located in the Basement Mechanical/Boiler Room. The service is 6" in size and reduces to 4" and includes a 4" meter. The water main reduces to 3" with 2" by-pass and backflow preventer. The system gauge reading was between 70-80 PSI. The main domestic cold-water distribution is 3" in size. A 3" pressure reducing backflow preventer is provided after the meter. The majority of the domestic distribution piping is located in crawl space throughout the building.

Piping, where exposed, appears to be copper with sweat joints. The majority of the piping is insulated. Due to the lack of accessibility a major renovation should include all new domestic water piping.

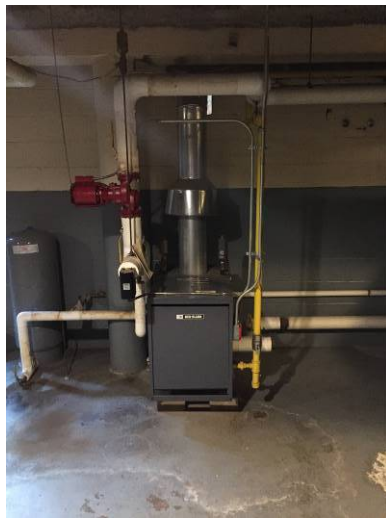
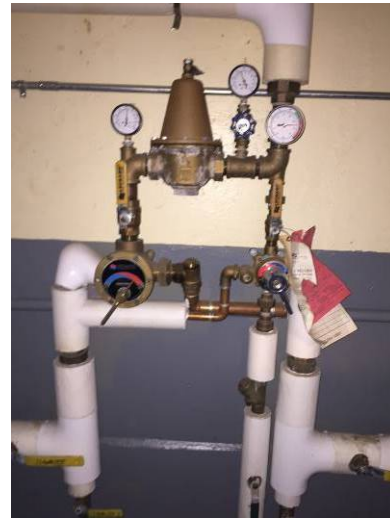
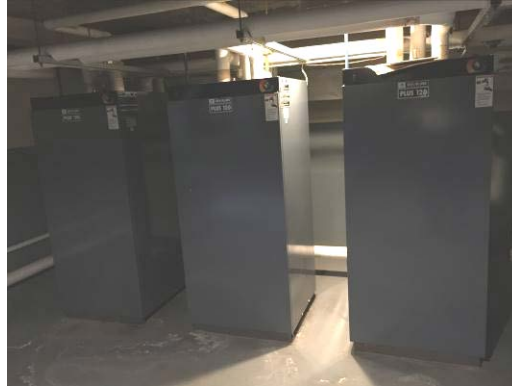
Domestic Water Heater System

Domestic hot water in Buildings and the Science Classrooms are generated through one (1) Weil-McLain boiler piped to three (3) 120 gallon storage tanks. There is a master Leonard mixing valve and one B&G hot water return pump. The system is in good condition.

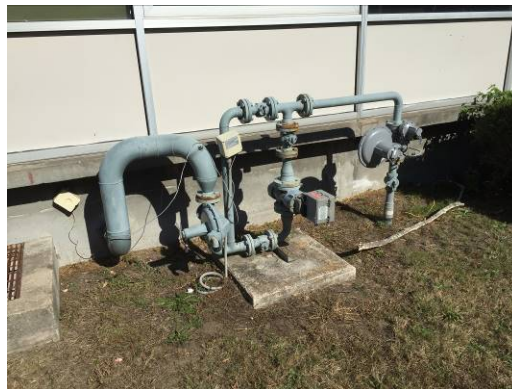
Gas Meter

Natural gas is supplied to the building. Exterior gas meter is located at front of the building. Natural gas is distributed throughout the building in the crawl space.

- Replace all domestic water piping.
- Provide all new plumbing fixtures and science room equipment.
- Replace all natural gas piping.

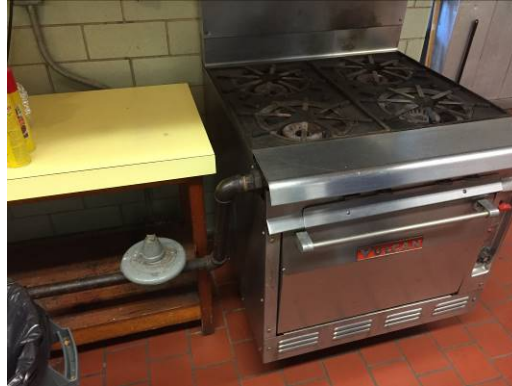
Gas Connection

Natural gas is provided for kitchen cooking equipment. Kitchen supply is not equipped with an automatic shutoff valve.

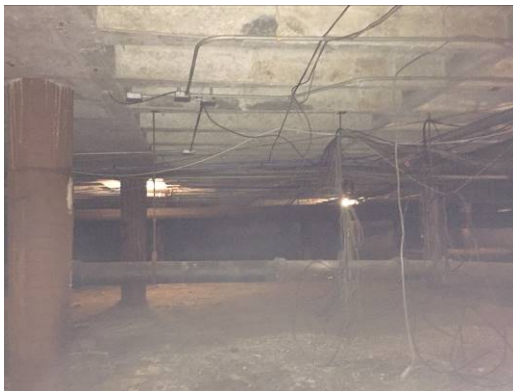
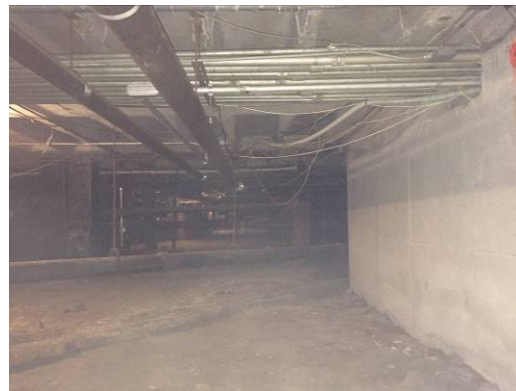
Crawl Space

Cast iron is used for sanitary and storm drainage. Where visible, the cast iron pipe appears to be in fair condition. Smaller pipe sizes appear to be copper

In general, the cast iron drainage piping can be reused even in a major renovation where adequately sized for the intended new use.

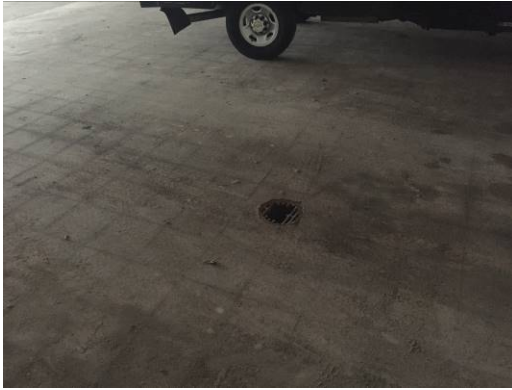
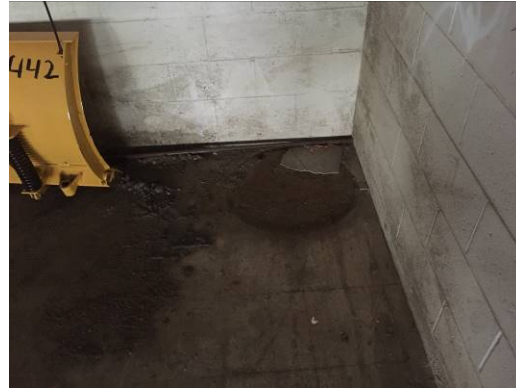
Cast iron drains with gasoline/oil separator located in crawl space.

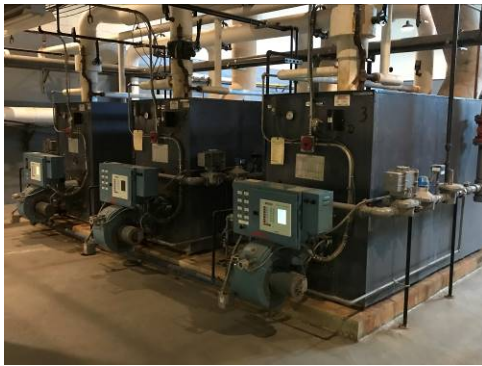
Hot Water Boilers

The building is primarily heated by a standard efficiency dual fuel (natural gas and No. 2 fuel oil) hot water boiler heating plant. The boiler plant consists of three (3) cast iron steel sectional Weil McLain Model 88-12 Boilers equipped with Webster dual fuel burners with Autoflame controller. The boilers each have a capacity of 3753 MBH gas input/26 GPH oil input, 3,000 MBH gross output and 2608 MBH net hot water heating output. The boilers were installed in 2003, therefore are approximately 14 years old and are past the midpoint of their expected useful service life of 20-25 years. Each boiler appears to be provided with proper operating and safety controls.

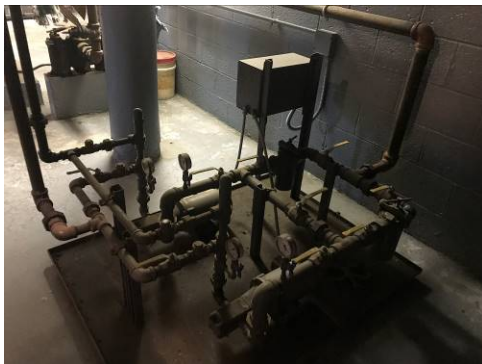
Fuel Oil Pumps

The boilers currently only use natural gas. It is our understanding that the fuel oil tank has been removed, and that the existing fuel oil pumps, monitor control panel and fuel oil piping within the boiler room have been abandoned in place.

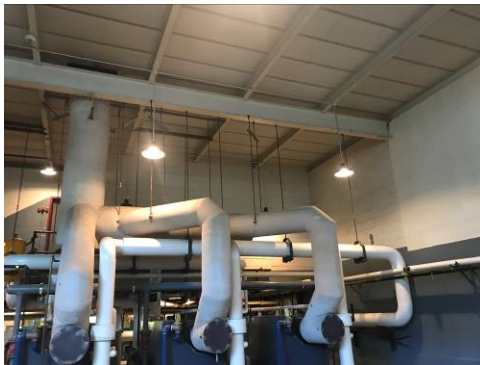
Boiler Breeching

The boilers are each vented with insulated steel boiler breeching to a common breeching stack which terminates above the building roof with a single wall steel breeching equipped with a rain cap. Previously the original boilers were individually vented. Currently two of the steel breeching vents have been capped and abandoned in place.

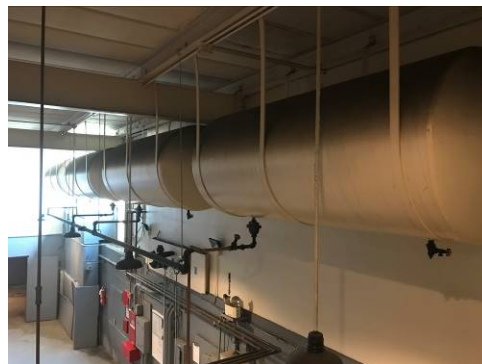
Expansion Tanks

There are four ceiling suspended horizontal and one (1) vertical bladder style un-insulated expansion tanks located in the boiler room. It is our understanding that the vertical expansion tank is no longer operable and that only one (1) of the horizontal expansion tanks is connected to the system.

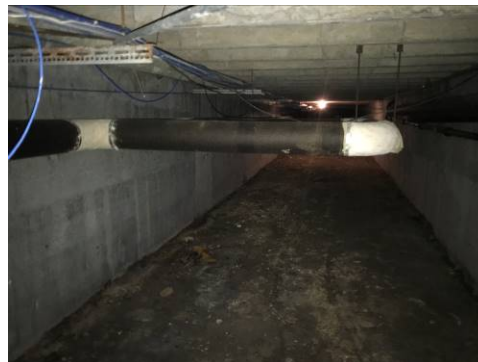
Crawlspace – Hot Water Piping

The majority of hot water piping is distributed from the Boiler room to the building heating equipment through a crawlspace. Most piping appears to be insulated and painted black, except for the pipe main fittings, which could possibly contain asbestos, and the piping adjacent to the secondary pump sets. The piping adjacent to pumps P-5&6 is missing sections of insulation, and the piping adjacent to pump set, P-7&8, appears to be newer fiberglass insulation. There are two (2) sets of primary/standby secondary hot water pumps located in the basement crawlspace area. Two of the pumps, P7&8 are equipped with 10 hp motors, appear to be in fair condition and serve the Area D (Cafeteria, Gym, Locker Room) portion of the building. Two of the other pumps, P-5&P-6 are equipped with 5 hp motors, appear to be in poor condition and serve the Area A (Classroom Wing) portion of the building. The pumps are constant flow and are not equipped with variable speed drives.

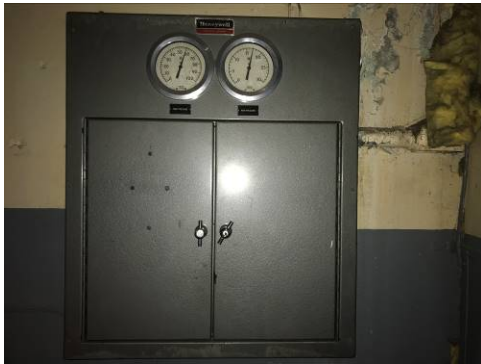
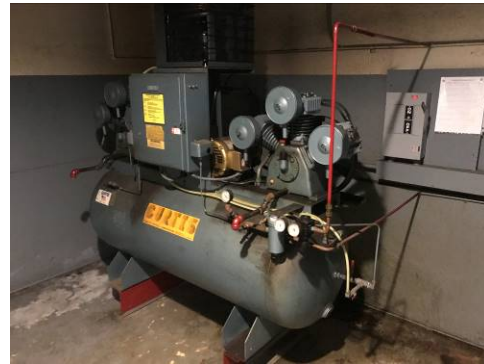
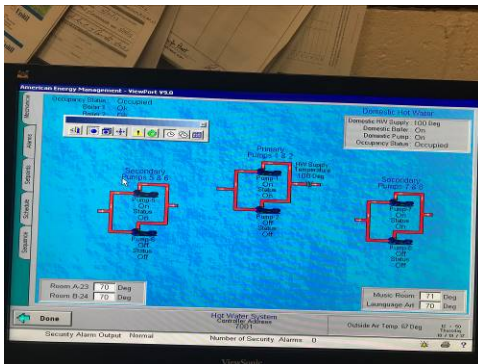
The Automatic Temperature Control (ATC) system is a combination direct digital (DDC) and pneumatic control system. The DDC components were installed by AEM (Advanced Energy Management) Inc. The DDC control system uses an Advanced Energy Management Viewport front end software with operates on Windows XP. The DDC control system was installed circa 2000, and as part of the DDC system installation the controls for the air handling units, boiler plant and unit ventilators were converted from pneumatic to DDC controls. Some heating equipment, air handling dampers and unit ventilators still operate using pneumatic controls. The pneumatic control air compressor is located in the Boiler room. Originally the building control system was largely manufactured by Johnson Controls. Overall the ATC system is antiquated in comparison to current systems, and only provides minimal monitoring, scheduling and setpoint control functionality. There is no ability for the Facility staff to make programming sequence changes for the HVAC equipment.

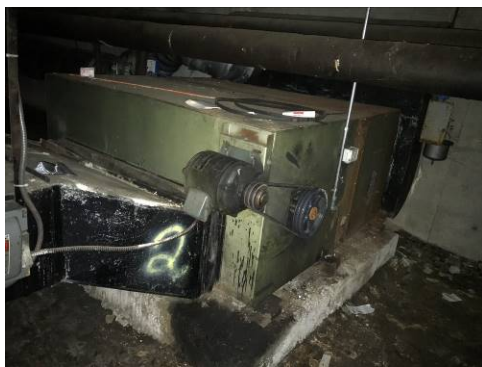
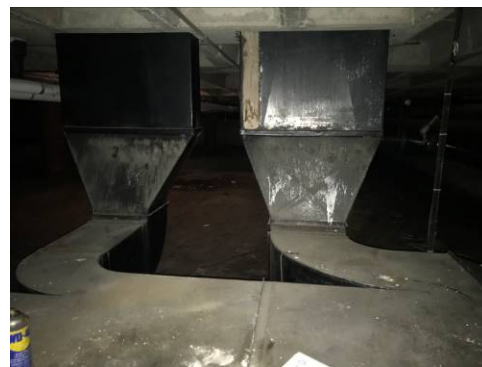
There are five (5) indoor hot water heating and ventilation (HV) air handing units located in the crawlspace of the building. These units HV-5,6,7,8,13 and 14 respectively serve the Library, Library Offices, Administration offices, Girls Locker room, Boys Locker Room and Cafeteria. Black painted uninsulated ductwork is routed up from the units to the areas they serve. All of the units were installed circa 1957, and the units and associated ductwork, piping and control components appear to be in poor conditions. Most of the HV Unit fans are not equipped with pulled guards. Due to the damp crawlspace environment, unit casing, control components and ductwork show signs of visible corrosion. In addition, duck leakage is a potential concern for reduced building indoor air quality in these areas as the crawlspace area air can potential infiltrate the HV system ductwork and spread to the areas the HV units serve.

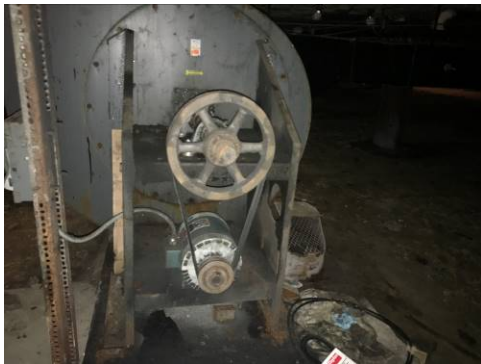
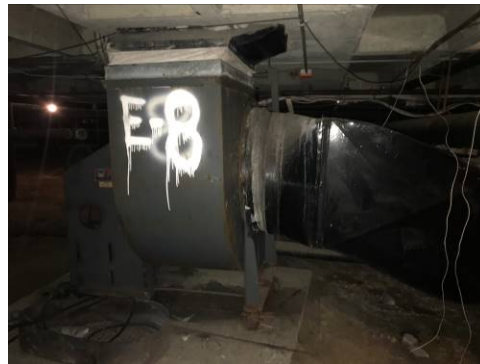
Crawlspace – Exhaust Fans

There are approximately nine (9) utility vent set style centrifugal exhaust air fans located in the crawlspace area which generally serve classroom and bathroom exhaust air systems. The exhaust fans and ductwork are generally all original equipment and systems that were installed in 1957. The fans show visible signs of corrosion, and the ductwork is generally uninsulated, painted black and some ductwork sections shows signs of corrosion and damage. Most of the exhaust fans are not equipped with pulled guards.

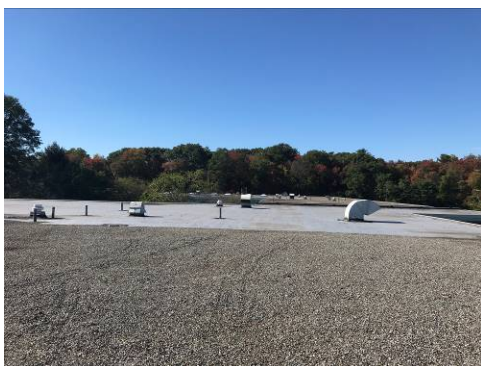
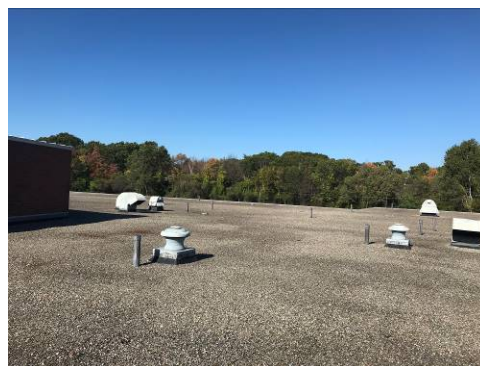
Roof – Exhaust Fans and Intake/Relief Hoods

There are approximately forty-four (44) roof mounted exhaust air fans, with most fans being originally installed equipment from 1957. Some exhaust fans have been repaired and replaced since their original installation, however most of the fans are in need of replacement. There are also many intake and relief air hoods located on the roof. The intake and relief hoods serve heating and ventilation equipment and exhaust air fan systems located throughout the building.

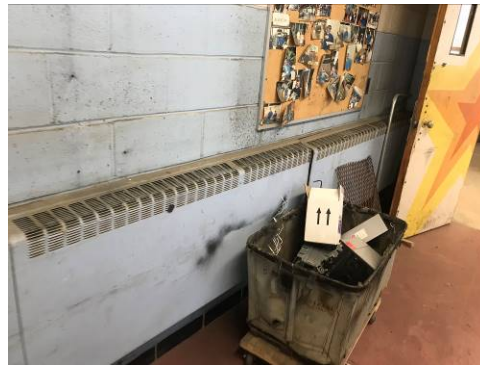
Shop Area – Fintube Radiation

The Shop areas are typically heated and ventilated by a combination of wall mounted unit ventilators, fin tube radiation and unit heaters. The majority of equipment is originally installed equipment, circa 1957, and in need of replacement. The unit ventilators were noted to have a source of outside ventilation air, supply fans, filters, and a heating hot water coil with valve control. The general condition of the unit ventilators, unit heaters and radiation heating equipment observed were in poor condition.

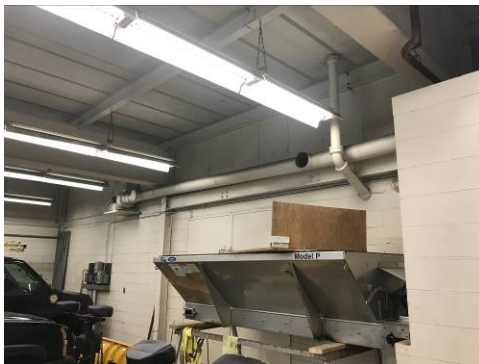
Abandoned Exhaust Ductwork

Some of the shop areas are also provided with local exhaust air fan systems, such as paint booth exhaust and capture hood exhaust fan systems which generally are in poor condition. The vehicle garage shop area has a ducted exhaust air system which appears to have been abandoned in place and a wall type propeller exhaust air fan appears to provide the majority of room exhaust.

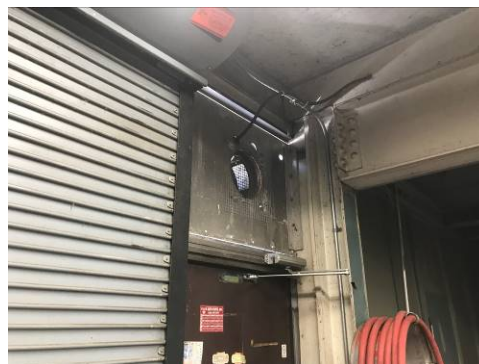
Wall Propeller Fan

- New fume hood and exhaust air system should be provided for Science classrooms if required.
- The Shop area HVAC systems should be replaced including Unit ventilators, exhaust air systems and the dust collector unit and associated ductwork.
- Ventilation air system should be provided for the corridors and classroom/office areas that lack mechanical ventilation.
- The existing direct digital control building energy management system should be replaced and upgraded to a full DDC system. Existing pneumatic controls should be removed.
- All new HVAC systems should be tested, adjusted, balanced and commissioned.

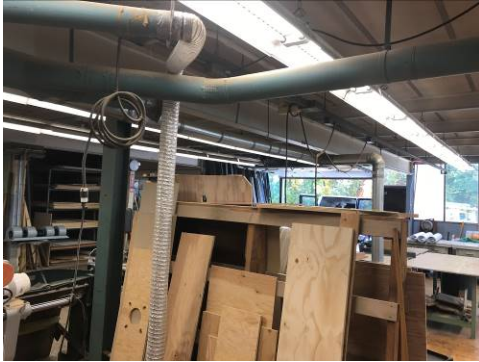
There is a dust collection system for the woodworking shop; much of the ductwork is damaged and in need of replacement. The dust collector unit, which is manufactured by AAF Co. (Model D Roto Clone, Size 8) is showing signs of corrosion.

Wood Shop Exhaust Ductwork

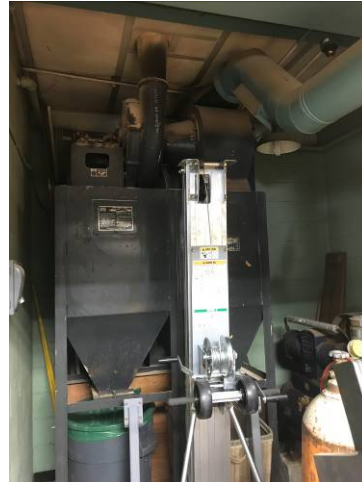
Dust Collector

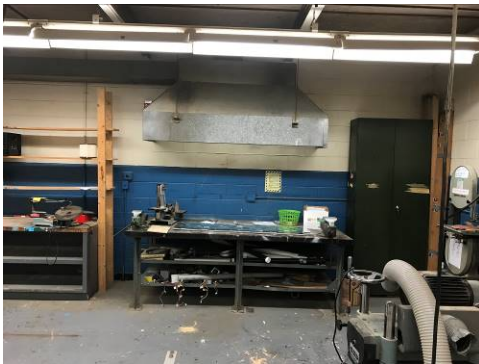
Exhaust Capture Hood

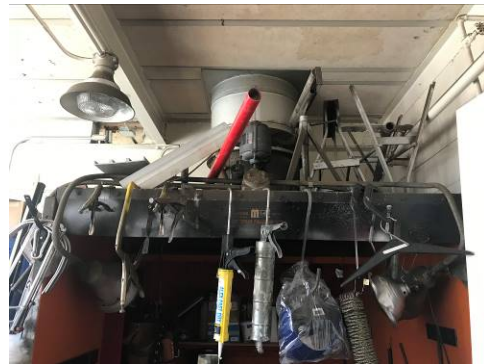
Paint Booth

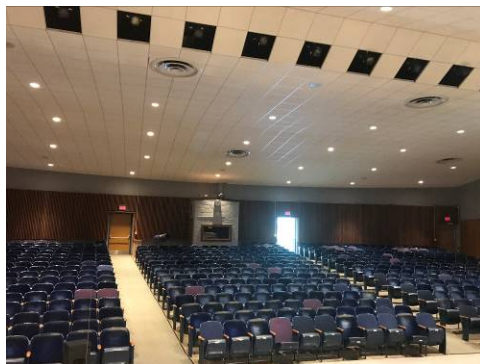
The Auditorium is served by heating and ventilation unit, HV-2, which has a capacity of 7,500 cfm and was installed in 1957. The HV unit is located in an adjacent mechanical room and the unit is ducted to overhead round supply air diffusers located in the Auditorium. The HV unit is originally installed equipment which is in need of replacement. A utility style centrifugal exhaust air fan that was installed in 1957, located in the mechanical room adjacent to the HV unit, removes exhaust air from the Auditorium.

Auditorium Supply Diffusers

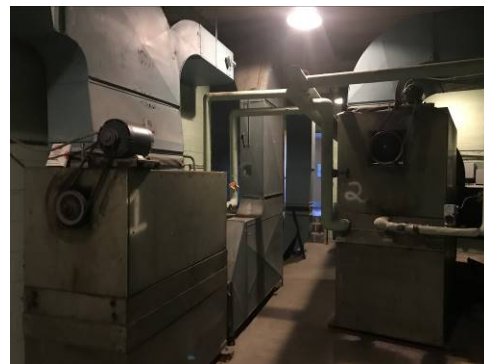
Auditorium HV Unit and Exhaust Fan

- All existing heating and ventilation units (Qty. of 14) should be replaced. Consideration should be given to adding energy recovery to the HV units, and possibly adding air conditioning to the new units. These units presently serve the Gym, Multi-Purpose Gym, Library and library offices, Cafeteria, Locker rooms, Music Rooms, Auditorium and Administration office. It is highly recommended that replacement units are not installed within crawlspace areas due to difficulty for service and maintenance, and the potential for reduced service life of the equipment.

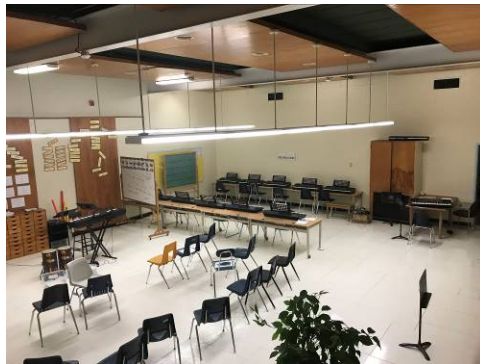
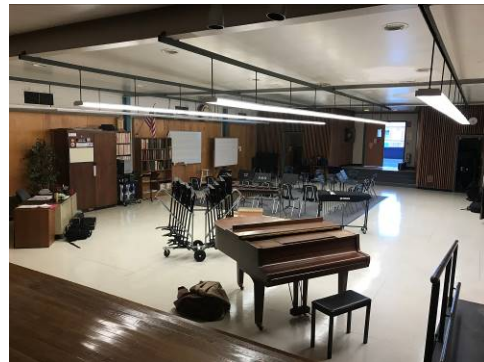
The Music Rooms are served by heating and ventilation units, HV-3 (3,400 cfm) and HV-4 (2,750 cfm), HV units are located within mechanical closets adjacent to the Music Rooms. Utility style centrifugal exhaust air fans remove exhaust air from the music rooms. The HV unit and exhaust fans are originally installed equipment that requires replacement. Sidewall supply and exhaust air diffusers and grilles are located high on the walls of the Music rooms.

Music Rooms – Supply and Exhaust Sidewall Diffusers and Registers

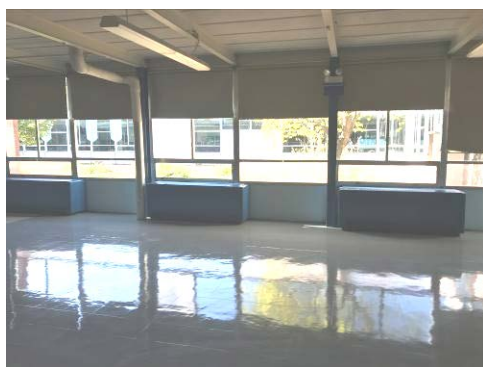
The cafeteria is served by a combination of one indoor HV unit (HV-14 – 10,200 CFM) that is located in the Crawlspace and was installed in 1957 and five (5) vertical style hot water unit ventilators. Each unit ventilator is provided with a heating hot water coil, supply fans, filters, and a source of outside ventilation air. The Cafeteria is also served by an exhaust air fan system.

Cafeteria Unit Ventilators

- All existing unit ventilators should be replaced (Qty. of 75). Adding new CO2 demand ventilation and/or energy recovery should be considered as part of a potential UV replacement project. Under a large building renovation project, potential alternative HVAC systems should be studied as part of a potential solution to replace the Unit Ventilators and Window AC unit that currently serve the Classrooms.

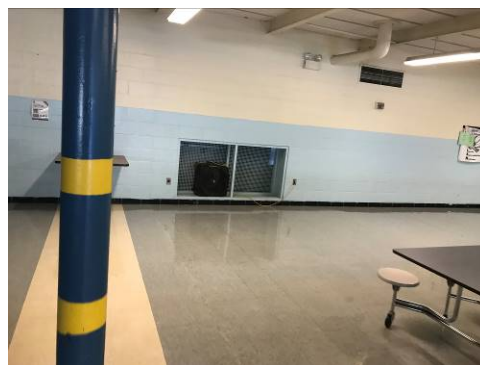
It appears that a source of the supply air from the cafeteria is transferred to the kitchen via low wall mounted transfer grilles. These registers were slightly dirty, but do appear to function.

Cafeteria Transfer Grille and Exhaust Grille

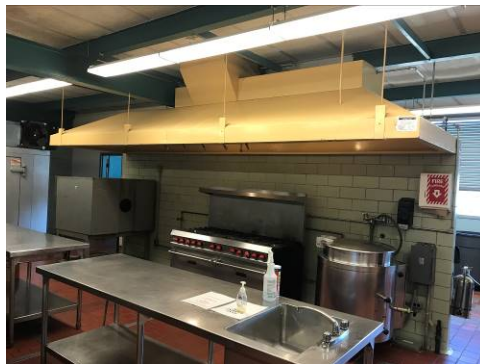
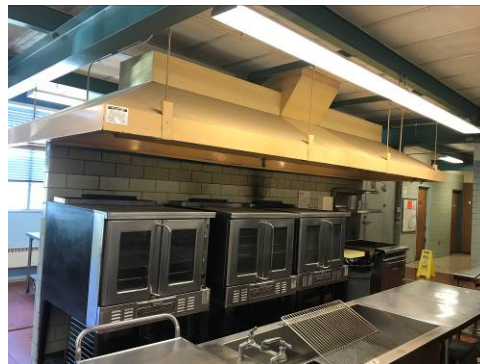
The kitchen is provided with a double-sided steel kitchen exhaust hood that is located over the cooking equipment and appears to be of adequate size and height to serve the intended purposes. The kitchen hood is provided with cleanable filters, and appear to have an Ansul type fire protection system installed. As we understand it from maintenance personnel, the exhaust hood does operate; however, we cannot be certain that it operates efficiently or per code requirements.

Kitchen Exhaust Hood

- A dedicated make-up air unit should be installed for the Kitchen, and the existing Kitchen and Dishwasher hoods and exhaust air fans system should be replaced.

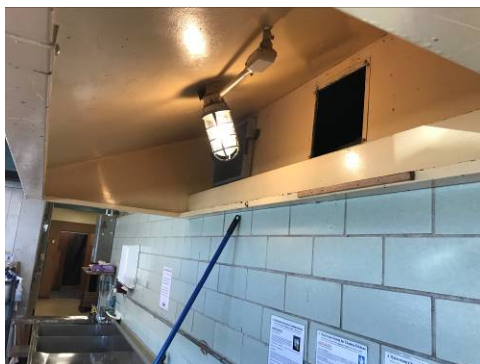
Kitchen Dishwashing Area Hood

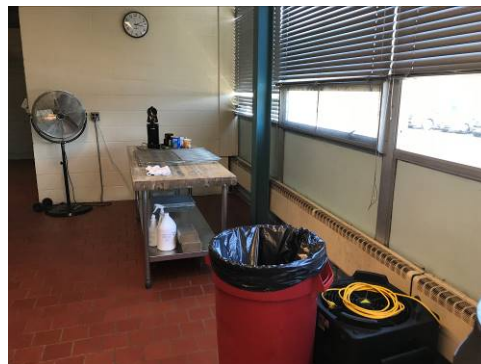
The kitchen area is heated with wall mounted fin tube radiation heating. The kitchen does not have a direct source of make-up air ventilation other than operable windows and the transfer air from the adjacent Cafeteria. The kitchen does not have any mechanical cooling systems. Instead a large propeller stand type fan is used to provide spot cooling during warmer days while cooking and dishwashing operations are taking place. There is a canopy exhaust hood located over the dishwashing sink. There is a refrigeration cooler with air cooled condensing section located within the kitchen that adds a significant heating load to the kitchen. Consideration should be given to replacing this unit with a split system type cooler unit.

Kitchen Fin Tube Radiation and Propeller Fan

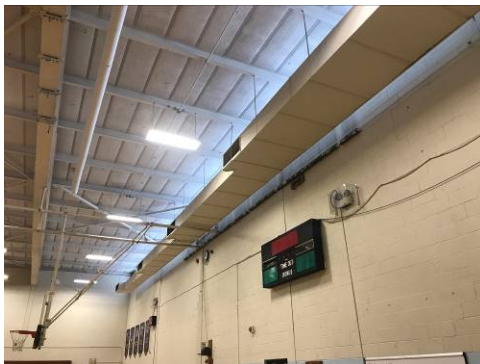
The gymnasium is provided with two individual air-handling units located in roof penthouse mechanical rooms. Heating and ventilation unit HV-9 serves the West half of the Gym and has a capacity of 7,500 cfm, and HV-10 serves the East half of the Gym and has a capacity of 7,500 cfm. Each unit is provided with a heating hot water coil, supply fans, filters, and a source of outside ventilation air. Each air-handling unit serves a supply air duct with side wall diffusers located high above the floor and provides heating and ventilation air to the entire space through these two supply ductwork and diffuser assemblies. Also, located within the gymnasium are individual low wall return air registers, which return the supply air back to each air-handling unit exhaust air fan located within the same mechanical room. These registers were noted to be slightly damaged and dirty and generally in need of replacement.

Gym Supply Duct and Diffusers

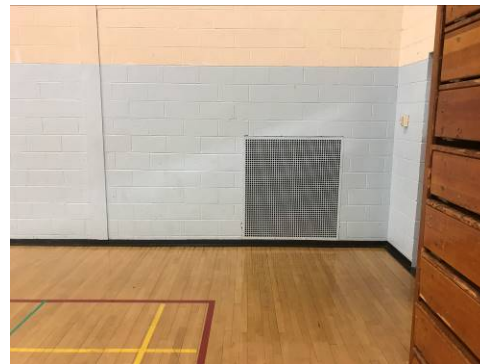
Gym Return Register

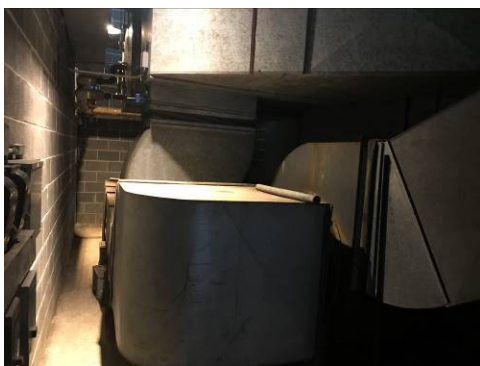
Penthouse Mech Rm - Gym HV Unit

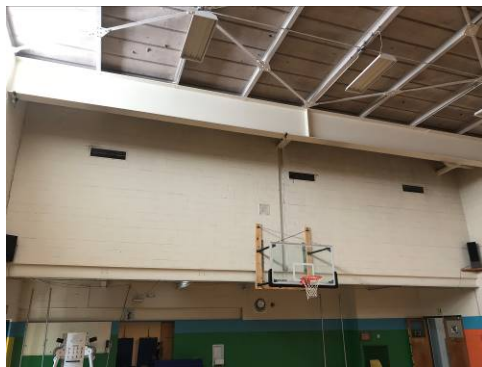
The Multi-purpose gymnasium is provided with two individual air-handling units located in roof penthouse mechanical rooms. Heating and ventilation unit HV-11 serves the West half of the gym and has a capacity of 4,000 cfm, and HV-12 serves the East half of the Gym and has a capacity of 4,000 cfm. Each unit is provided with a heating hot water coil, supply fans, filters, and a source of outside ventilation air. Each air-handling unit serves a supply air duct with side wall diffusers located high above the floor and provides heating and ventilation air to the entire space through these two supply ductwork and sidewall diffuser assemblies. Also, located within the gymnasium are individual low wall return air registers, which return the supply air back to each air-handling unit exhaust air fan located within the same mechanical room. These registers were noted to be slightly damaged and dirty and generally in need of replacement.

Multi-Purpose Gym Supply Diffusers

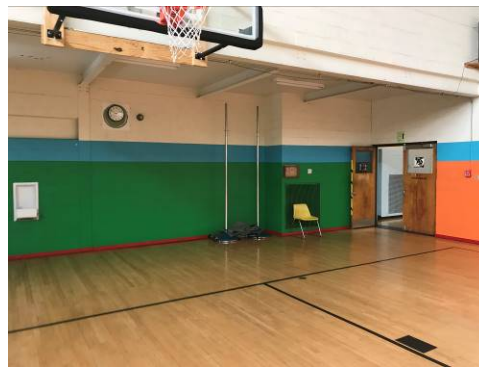
Multi-Purpose Gym – Return Register

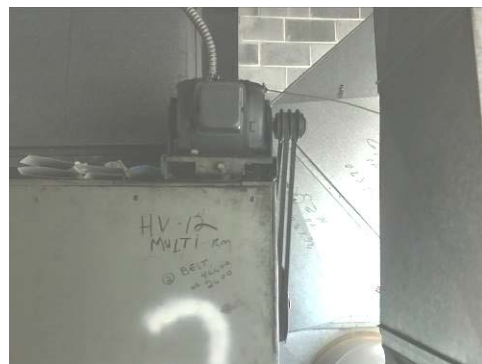
Multi-Purpose Gym HV Unit

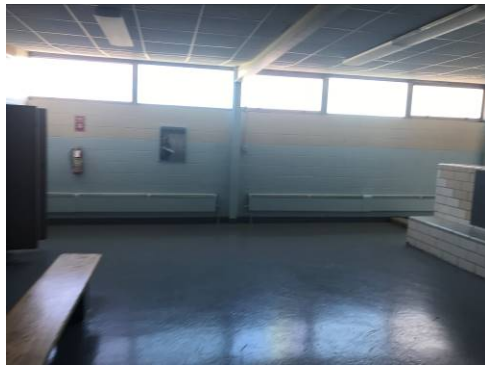
Both the girls and the boys locker rooms are each served by an indoor heating and ventilation air-handling unit, which includes a hot water heating coil, supply fan, filters, and a source of outside ventilation air. Ventilation air is provided overhead through a supply distribution system to various diffusers located throughout. The HV units are located in the crawlspace area and appear to be in poor condition. HV-8 serves the Girl's locker room and has a capacity of 5,825 cfm and HV-13 serves the Boy's locker room and has a capacity of 5,600 cfm. There are also side wall mounted and overhead exhaust air grilles that are connected to exhaust air. The system appeared to be functioning properly, however the diffusers, ductwork and fans appear to be originally installed equipment and systems that should be replaced. The locker rooms are also heated by perimeter wall mounted fin tube radiation heating.

Typical Locker Room Fintube

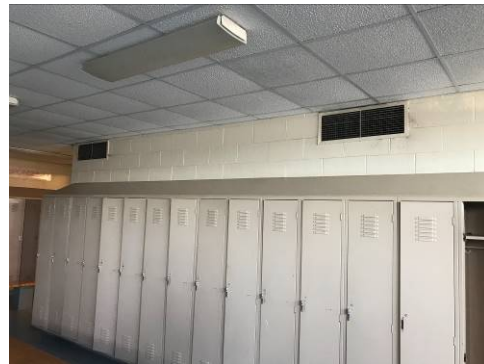
Typical Locker Room Exhaust

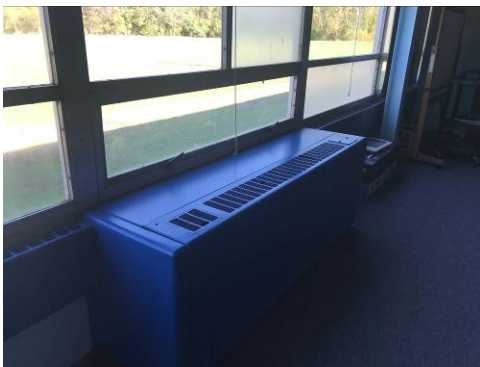
Classrooms are typically provided with wall-mounted vertical discharge unit ventilators, which include a hot water heating coil with valve control, a source of outside ventilation air, supply fans and filters. These units were installed in 1957 and are in poor condition. Overall there are approximately seventy-five unit ventilators installed throughout the building, with the majority being installed in classroom areas. Exhaust air grilles are typically located low within an architectural enclosure on the interior corridor side of the classroom. The exhaust air grilles are ducted to exhaust air ductwork and fan systems located in the crawlspace areas below the Classrooms. Many classrooms also have supplemental fin tube radiation heating along the exterior perimeter walls. Most of the unit ventilators are controlled by the DDC system and much of the hot water radiation heating is controlled by the pneumatic control system.

Classroom Unit Ventilator

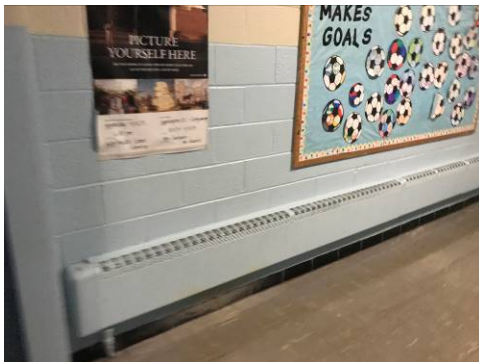
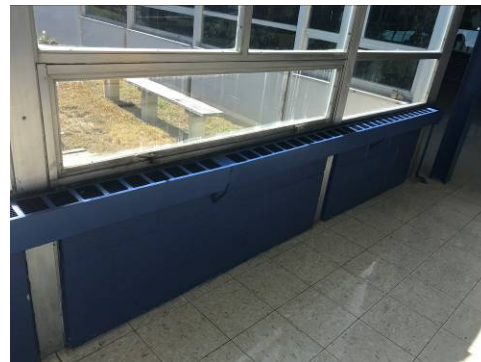
The various circulating corridors throughout the building do not appear to be provided with code required ventilation air. Ventilation air is required by code in corridors, therefore this condition should be corrected. Majority of corridors are heated by hot water fin tube radiation equipment which appears to be originally installed equipment that has exceeded its expected service life.

Corridor – Fin Tube Radiation Heating

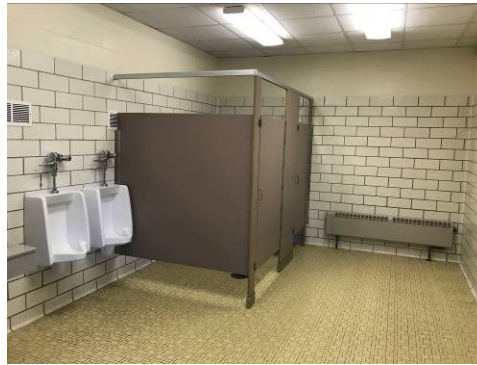
The restrooms observed during our site visit appear to be properly exhausted with exhaust air fan systems. Make up air for larger restrooms is typically provided by door grilles. Restrooms are typically heated by fin tube radiation heating. The exhaust air and heating systems appear to be original to the building, circa 1957, and therefore should be replaced.

Restroom – Exhaust Grille and Fintube Radiation Heating

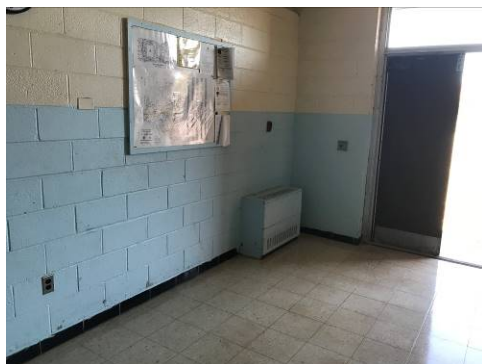
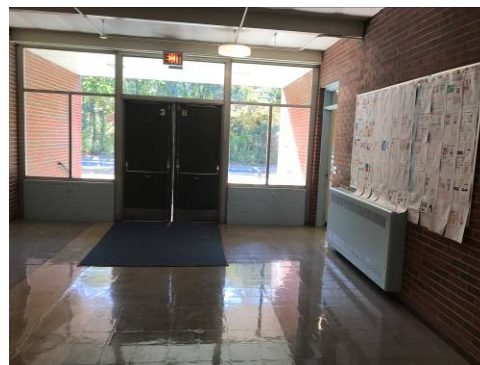
The individual entranceways throughout the building are typically heated by a combination of hot water cabinet style unit heaters, convectors, or hot water fin tube radiation heating. These cabinet heaters and fintube enclosure generally were noted to be slightly dirty and some had damaged casing; however, we understand most of the units do operate. The entranceways are not provided with any vestibule interlocks and therefore infiltration air does circulate throughout when the doors are open. It is recommended that vestibule interlocks be provided at each doorway and all cabinet heaters be replaced with a higher output unit.

Entryway – Hot Water Cabinet Unit Ventilator (left) and Convector(right)

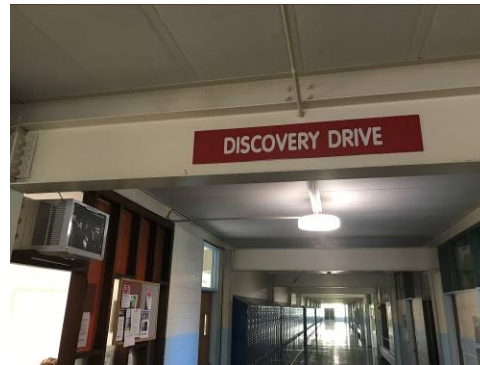
The main administration office area is heated and ventilated by an indoor heating and ventilation unit, HV-7 – 870 cfm) that is located in the crawlspace below the office area. The administration area is also heated by supplemental fin tube radiation heating and is primarily air conditioned by window AC units. The HV unit and fin tube radiation are originally installed equipment, circa 1957. One of the teacher's offices is air conditioned by a Window AC unit that is installed in an interior wall. This unit can cause condensate to drop from the unit and on to the floor during humid days. The Nurse's office is air conditioned by a ductless split system AC unit.

Office with Window AC installed in Interior Wall

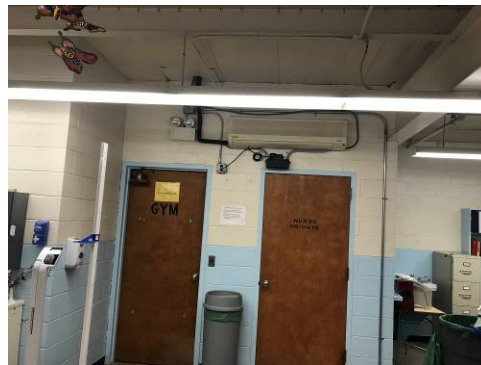
Nurse's Office Ductless AC unit

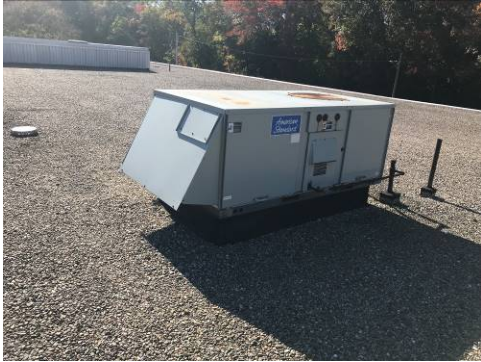
The Buildings and Grounds office area is primarily heating, ventilated and air conditioned by a packaged rooftop unit equipped with gas fired heating and direct expansion electric cooling. The unit was manufactured by Trane, has a capacity of 5 tons and was installed circa 2001. The unit appears to be in fair condition, but is nearing the end of its expected useful service life of 15-20 years. The B&G office area is also heated by supplemental hot water fin tube radiation.

B&G Office - Packaged Rooftop Unit

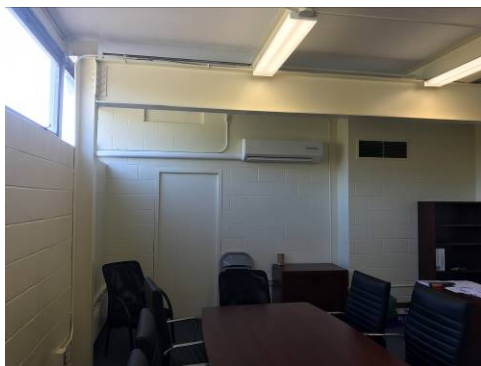
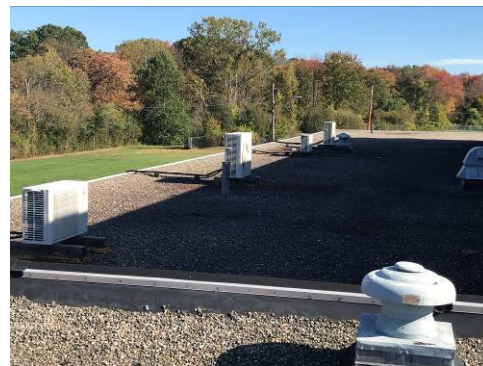
The Community Health area is primarily heated by perimeter fin tube radiation heating, and is air conditioned by a combination of Window AC and ductless split system AC units. Ventilation air is provided by a combination of operable windows and a ceiling suspended energy recovery (ERV) unit. The ductless split system unit and ERB unit appear to have been installed approximately 3-4 years ago.

Community Health – Ductless AC Unit and Associated Roof Condensing Units

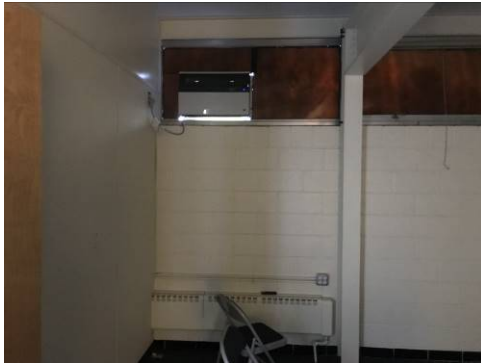
*Community Health - Window AC Unit
and Fintube Radiation*

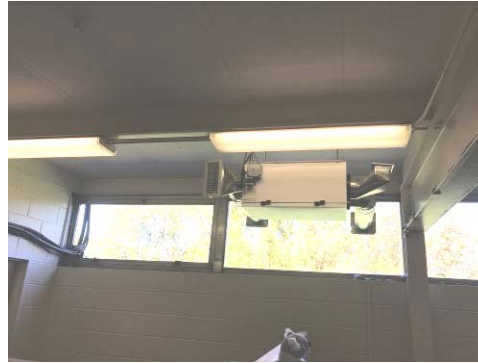
Community Health – ERV Unit

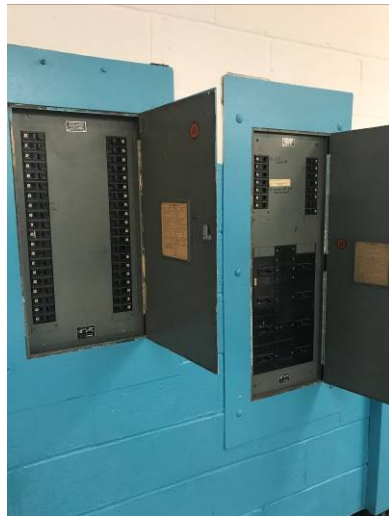
Typical Corridor Panels

Local and remote panels, generally installed flush in Corridors, are of the breaker type, are generally full and in poor condition. Most panelboards are original General Electric panels.

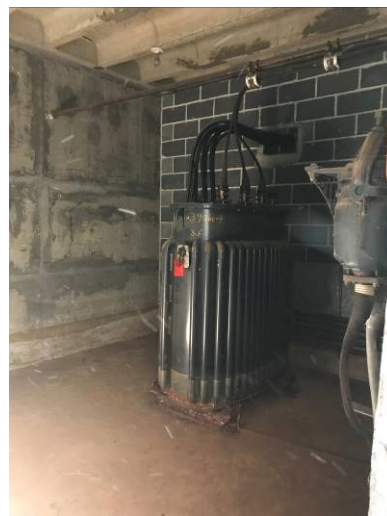
The vault mounted transformers are owned by the utility company and due to their age are likely to contain PCBs.

Vault Transformer

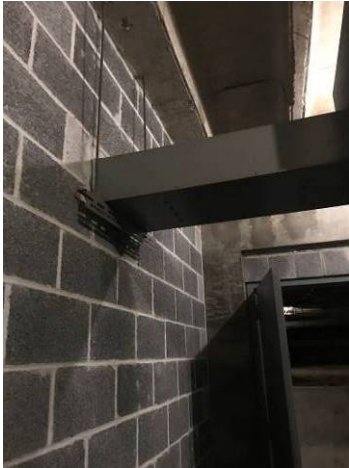
The busduct and switchboards were manufactured by General Electric and are generally in fair to poor condition.

Busduct to Vault

Most switchgear is original to the building and is obsolete. Replacement parts are scarce as switchgear is no longer manufactured. The switchgear, due to its age and condition, should be replaced under a renovation program.

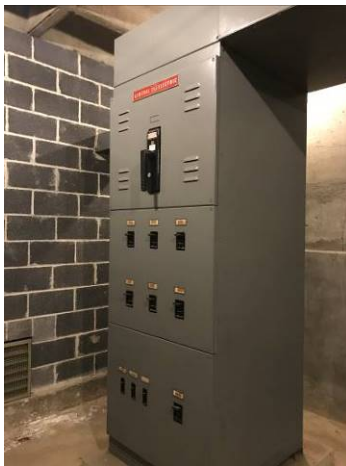
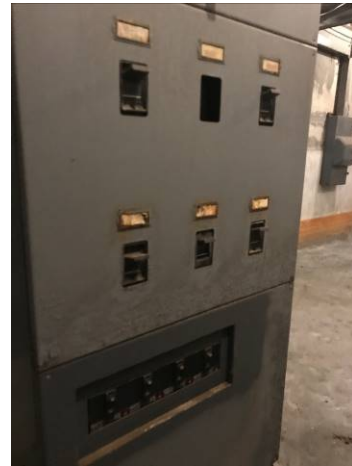
Switchboard

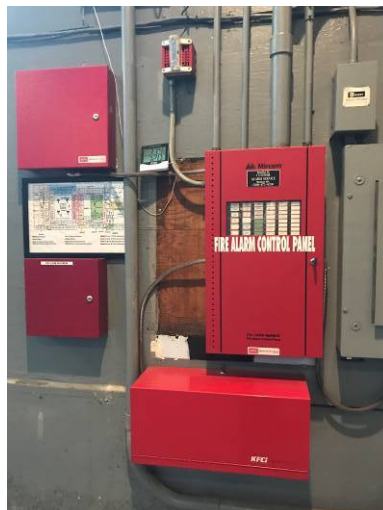
The fire alarm system for the facility consists of a newer replacement zoned (non-addressable) Mircom FA-1000 series fire alarm control panel located in the Boiler Room. A remote LED annunciator is located outside the Main Lobby. The newer panel replaced the former FACP now used as a splice box. The existing zones were extended and monitored with addressable modules. The existing horn circuits were reconnected to the new panel.

Fire Alarm Control Panel

The existing fire alarm system does not meet current codes and should be replaced under a renovation program.

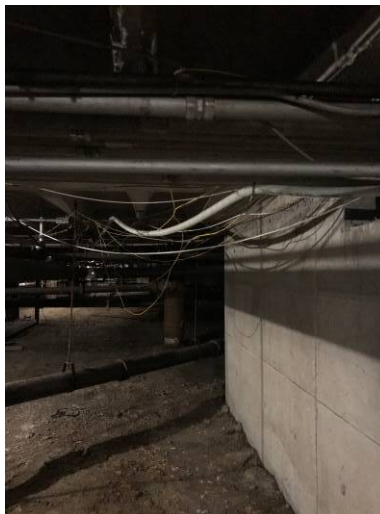
Most wiring runs within crawl space.

Crawl Space Wiring

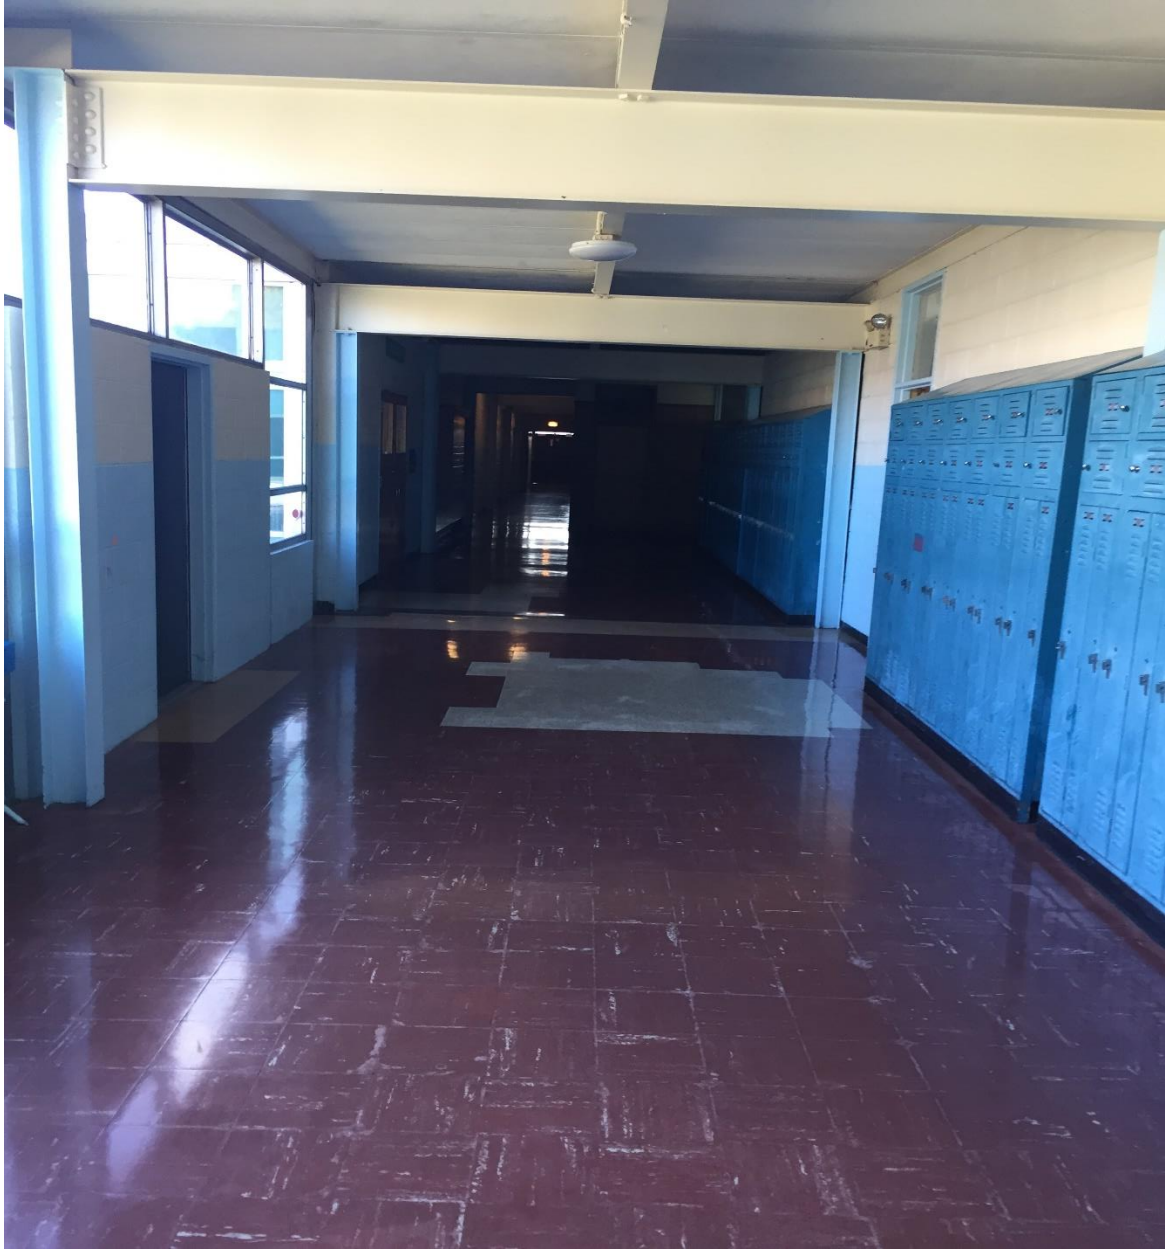
Typical 9x9 ACM Floor Tile, Differing Colors Throughout
