CHAPTER 34 NARRITIVE

FRAMINGHAM FULLER SCHOOL
FRAMINGHAM, MA

SUBMITTED: NOVEMBER 8, 2017

**FULLER MIDDLE SCHOOL
FRAMINGHAM, MASSACHUSETTS
STRUCTURAL EXISTING CONDITIONS REPORT
NOVEMBER 1, 2017**

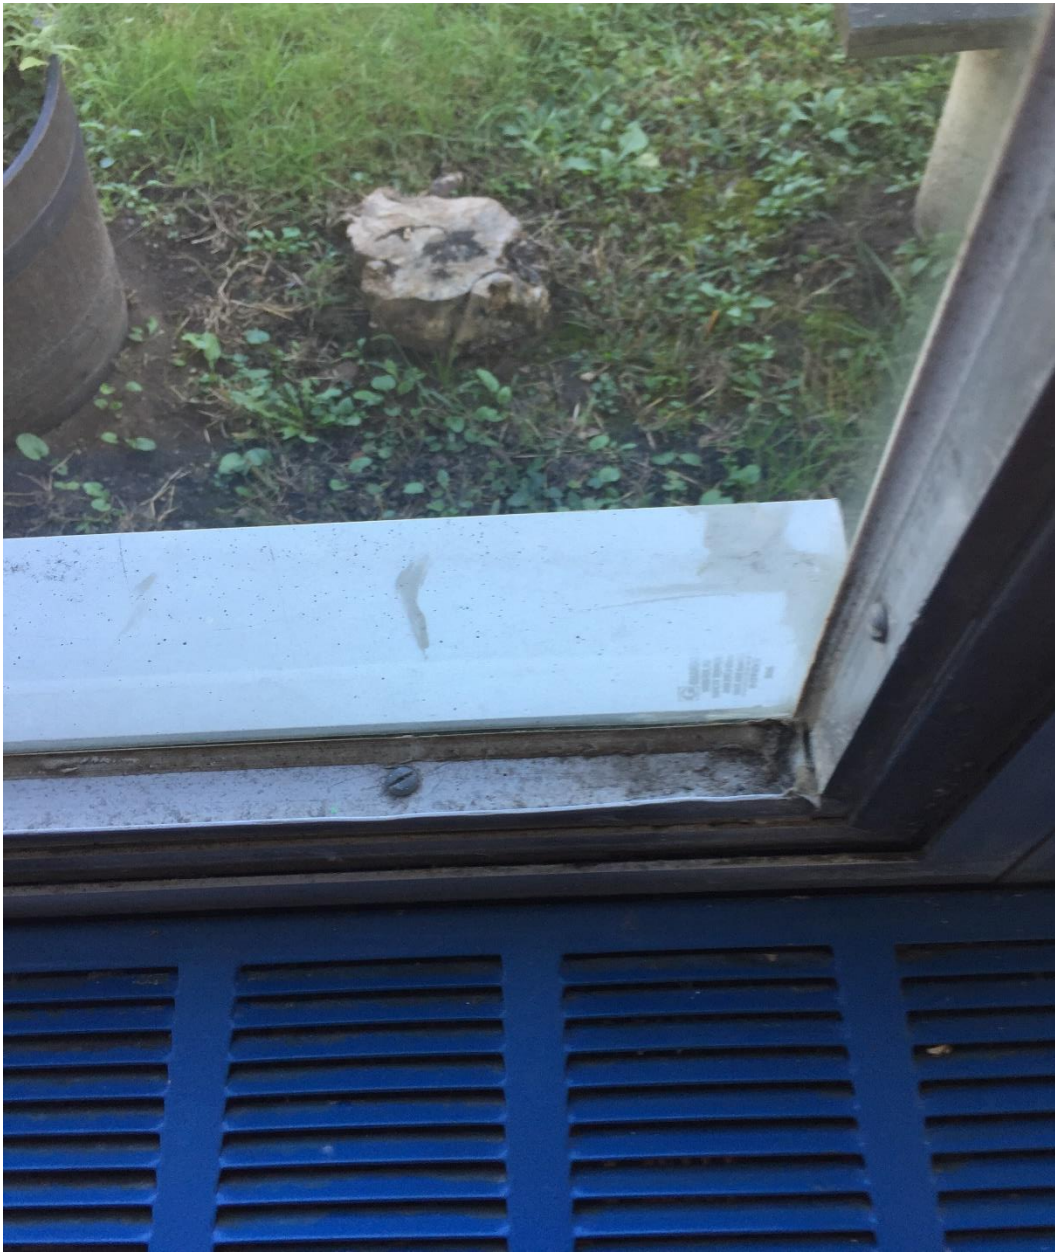
ACM Window Glaze, Interior Side of Exterior Window

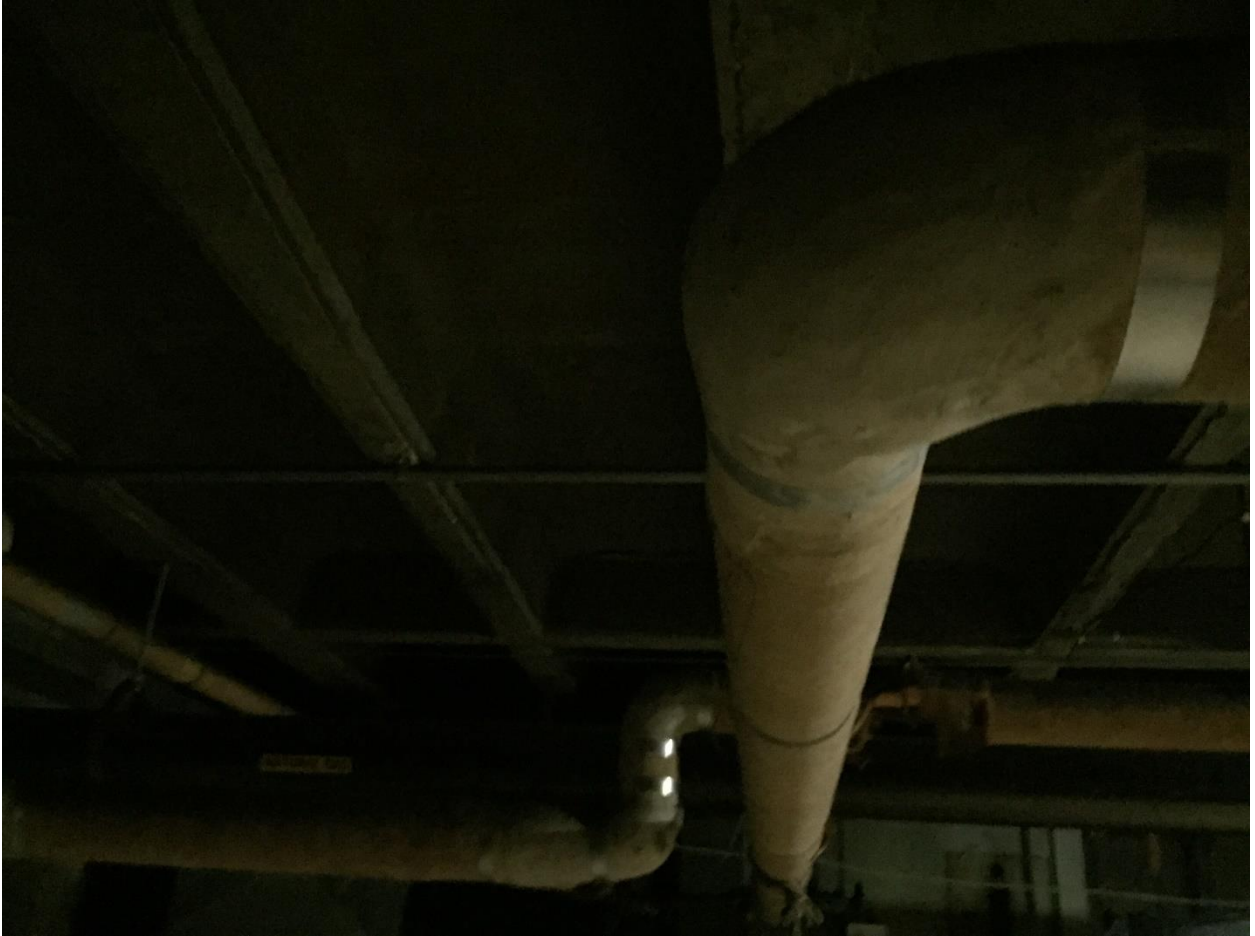
Typical ACM Pipe Fitting

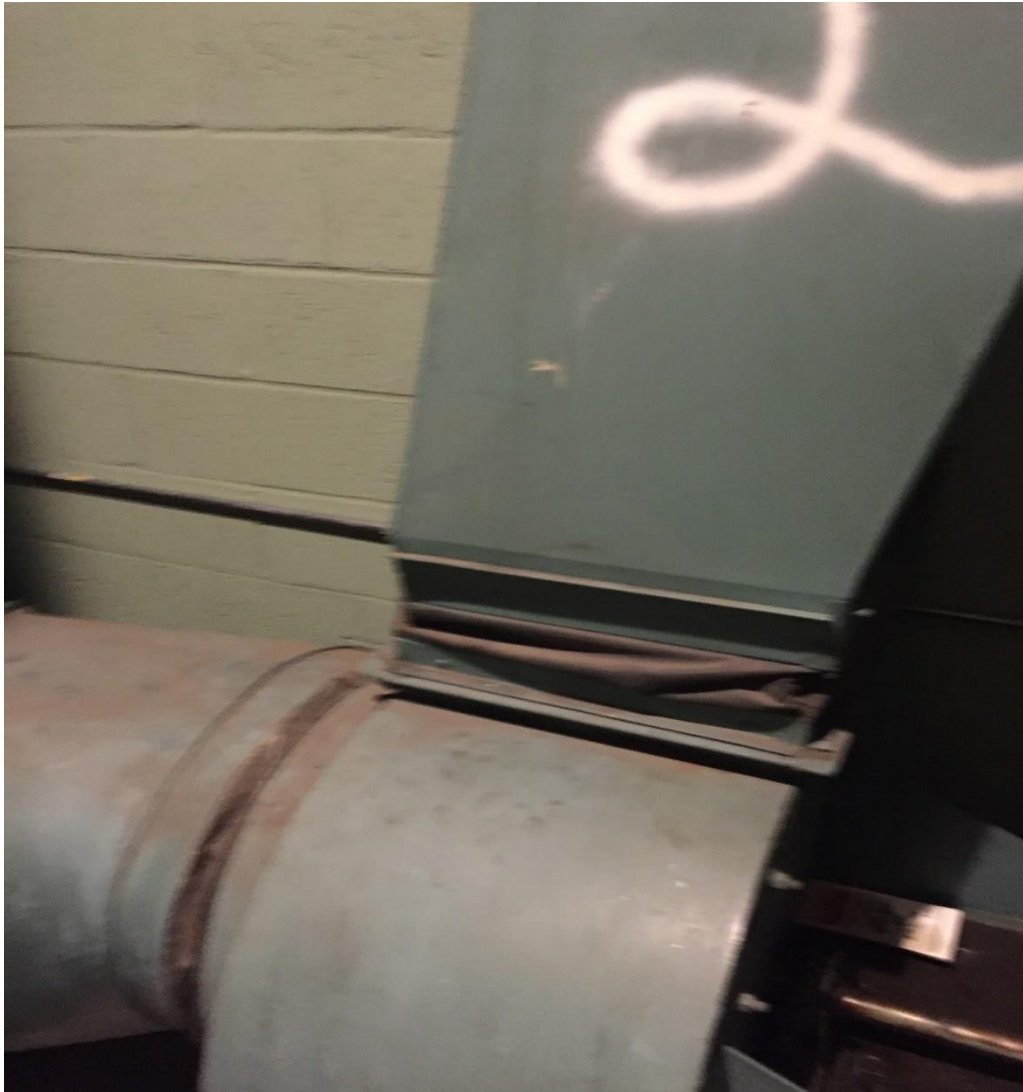
Typical Suspect ACM Vibration Isolator on HVAC

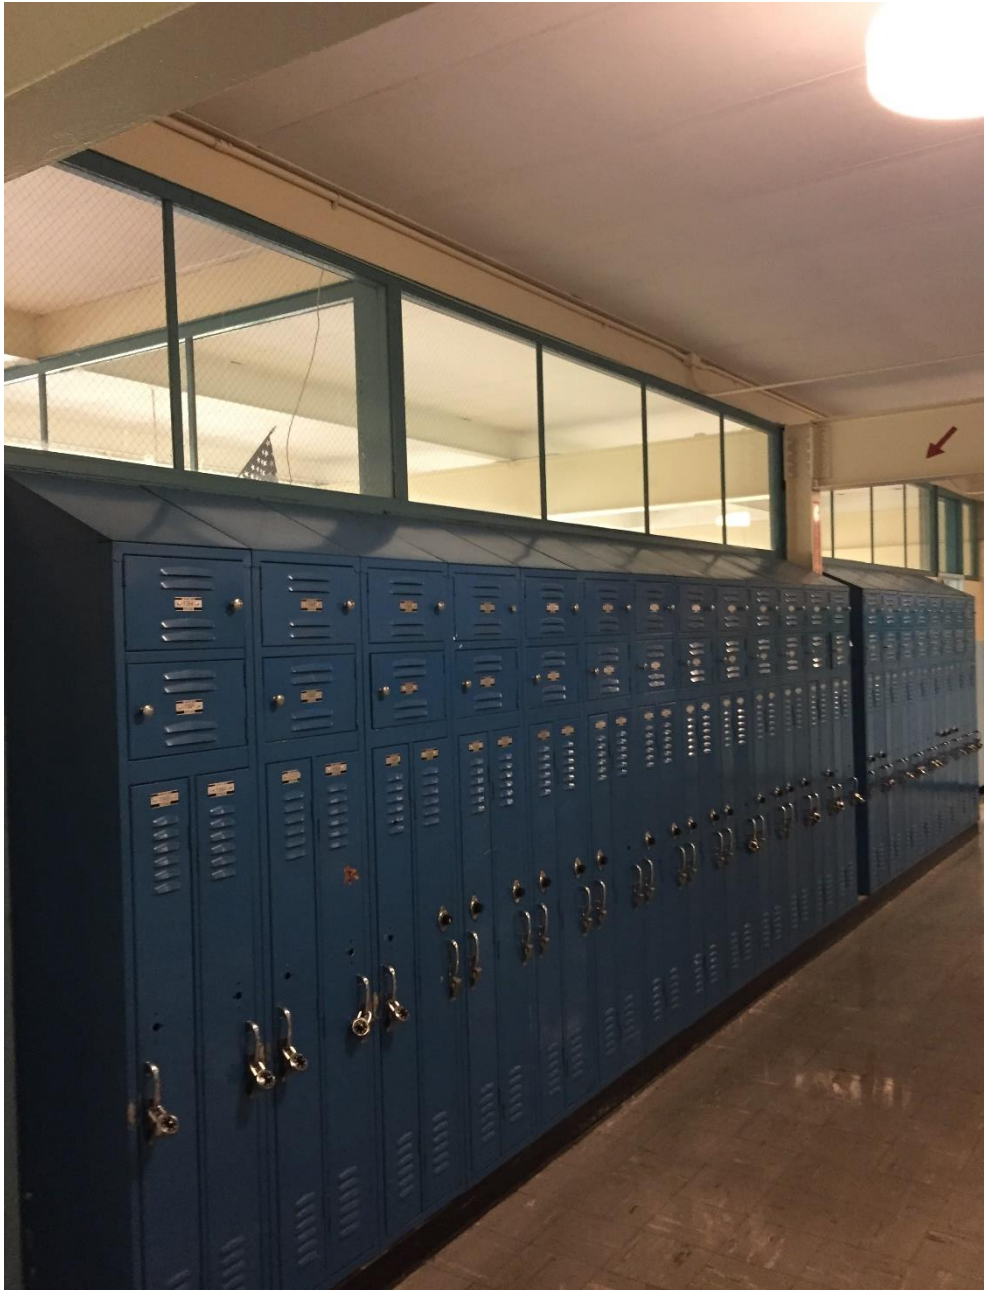
Interior Window Glaze Associated with Classrooms

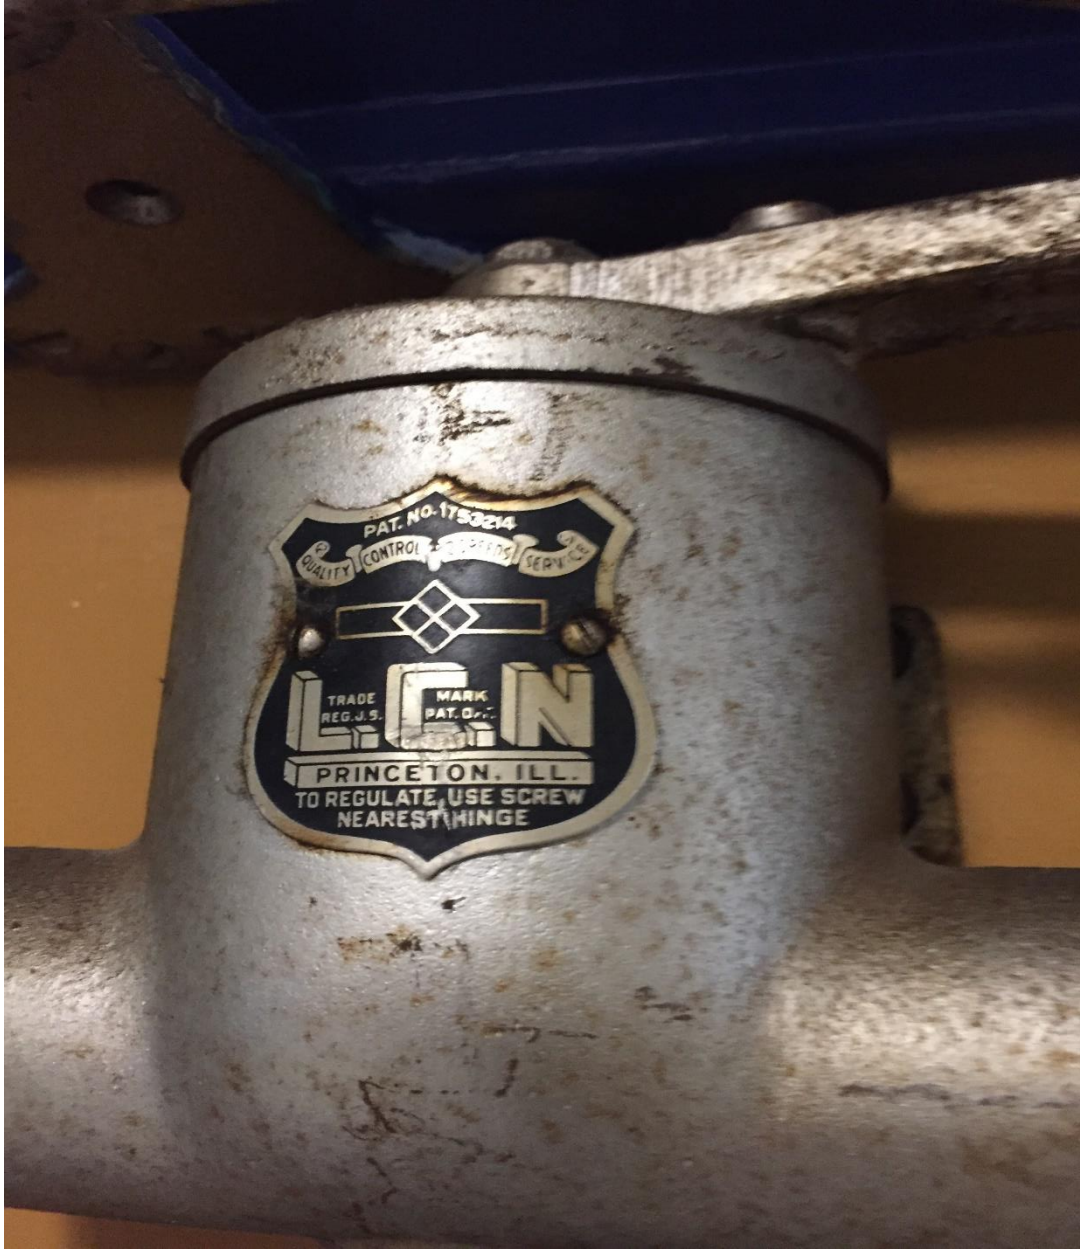
Old Door Retractor, Located throughout (Hydraulic Oil)

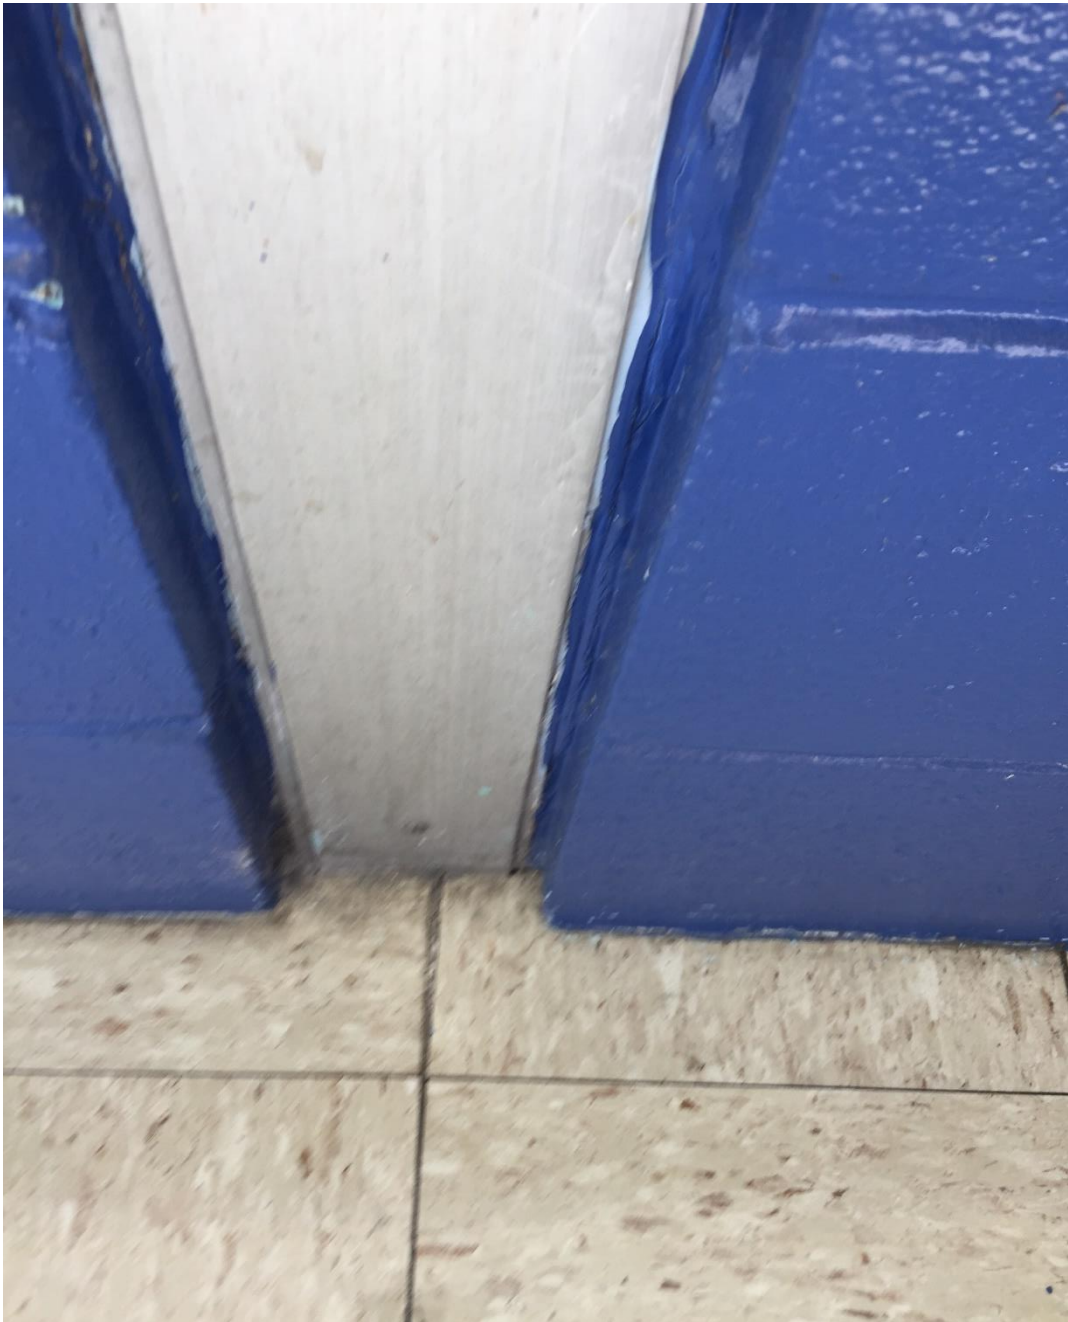
ACM Caulk Located at Steel Beams and ½ Wall CMU Interior of Courtyard

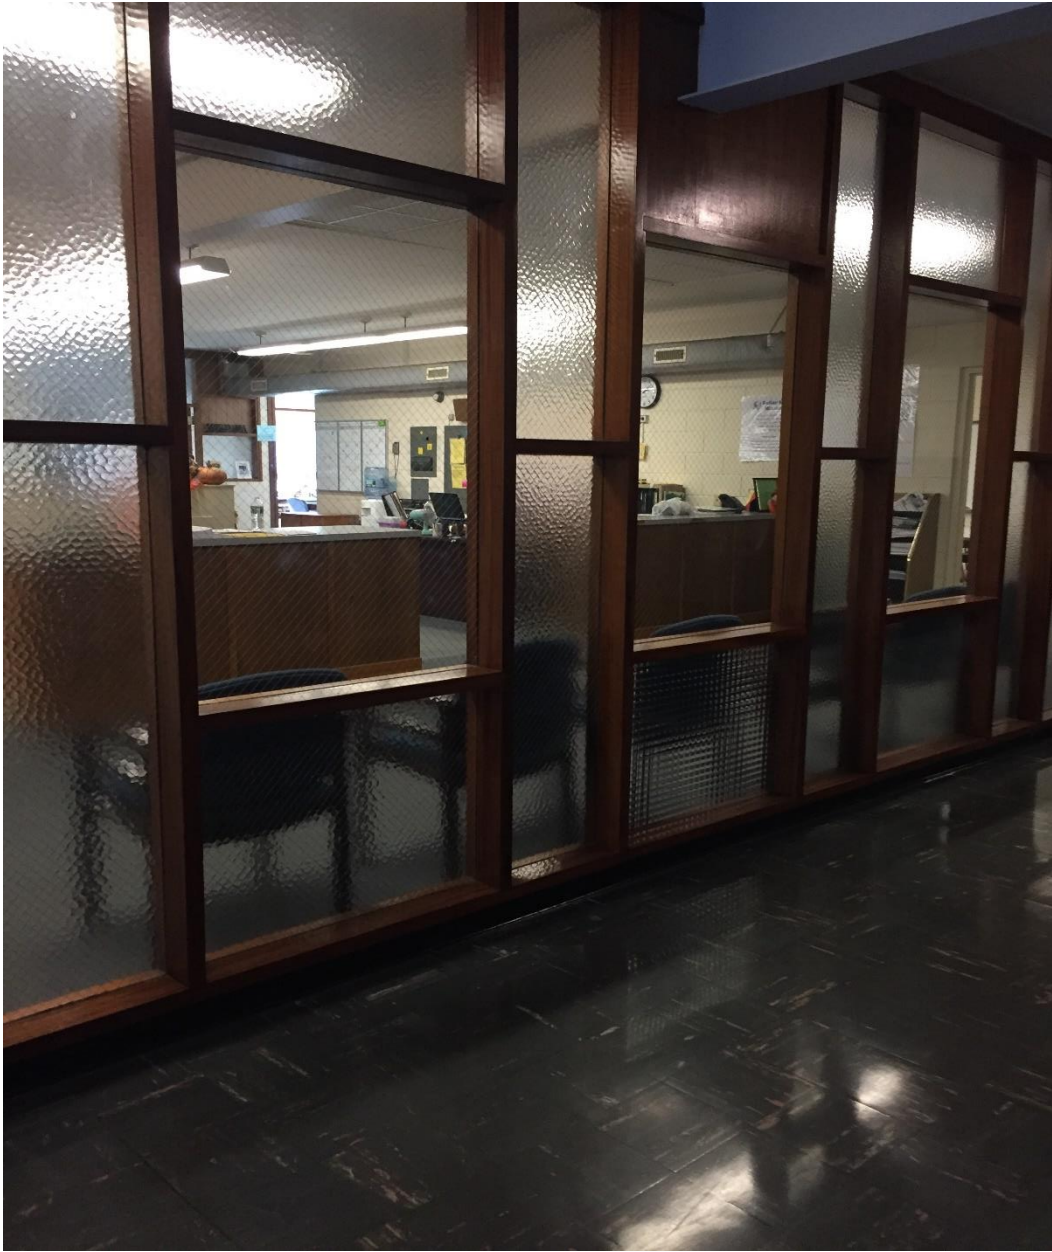
Interior ACM Window Glaze Associated with Wood Framed Windows

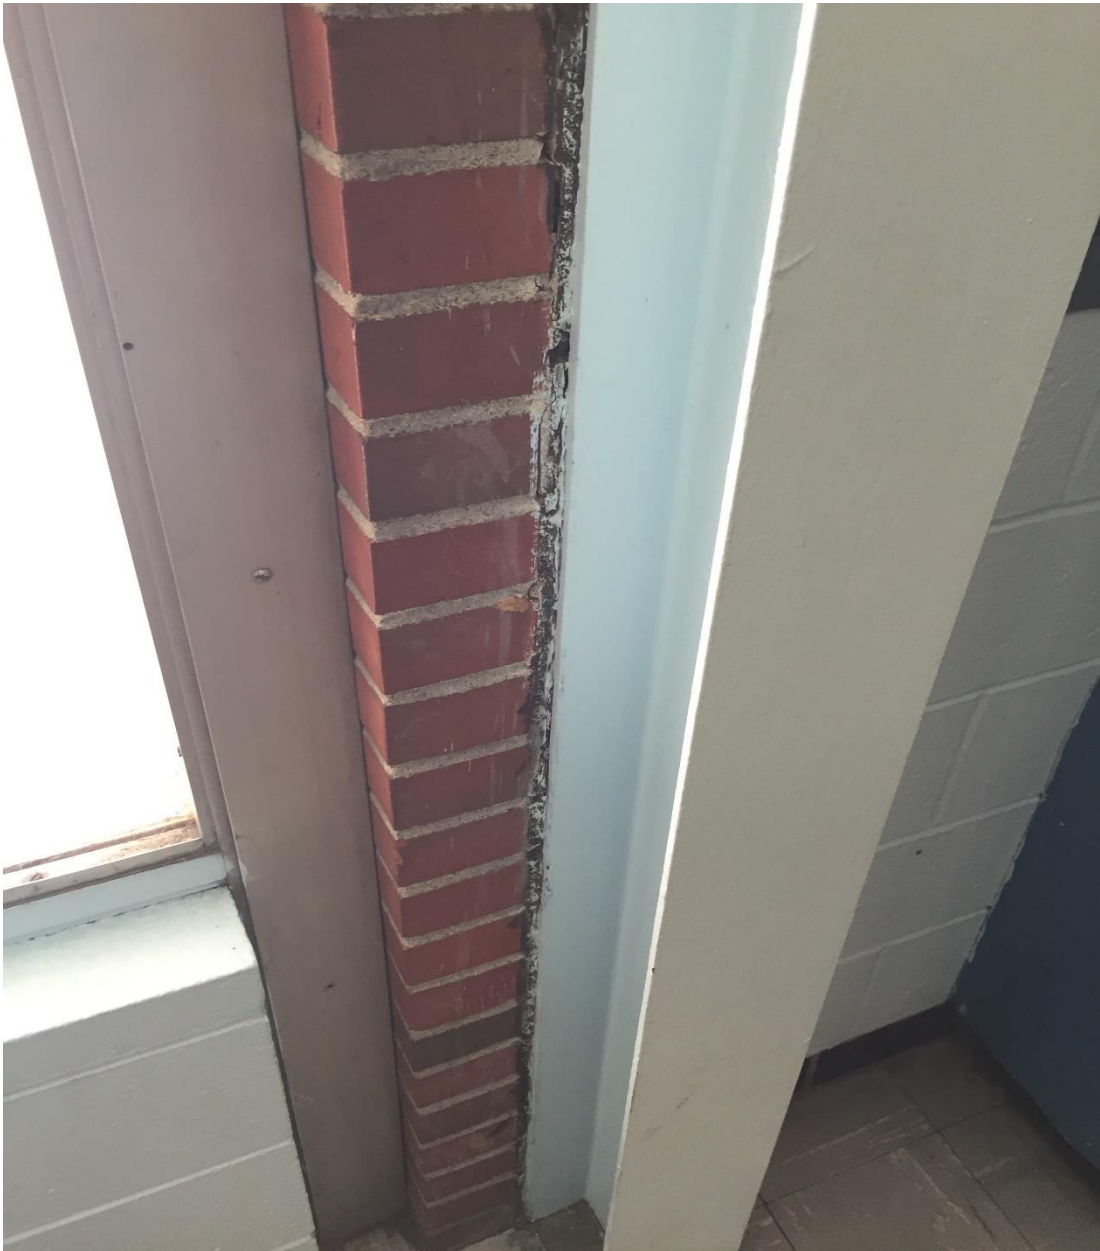
ACM Caulk Associated with Steel Beams (Intermittent)

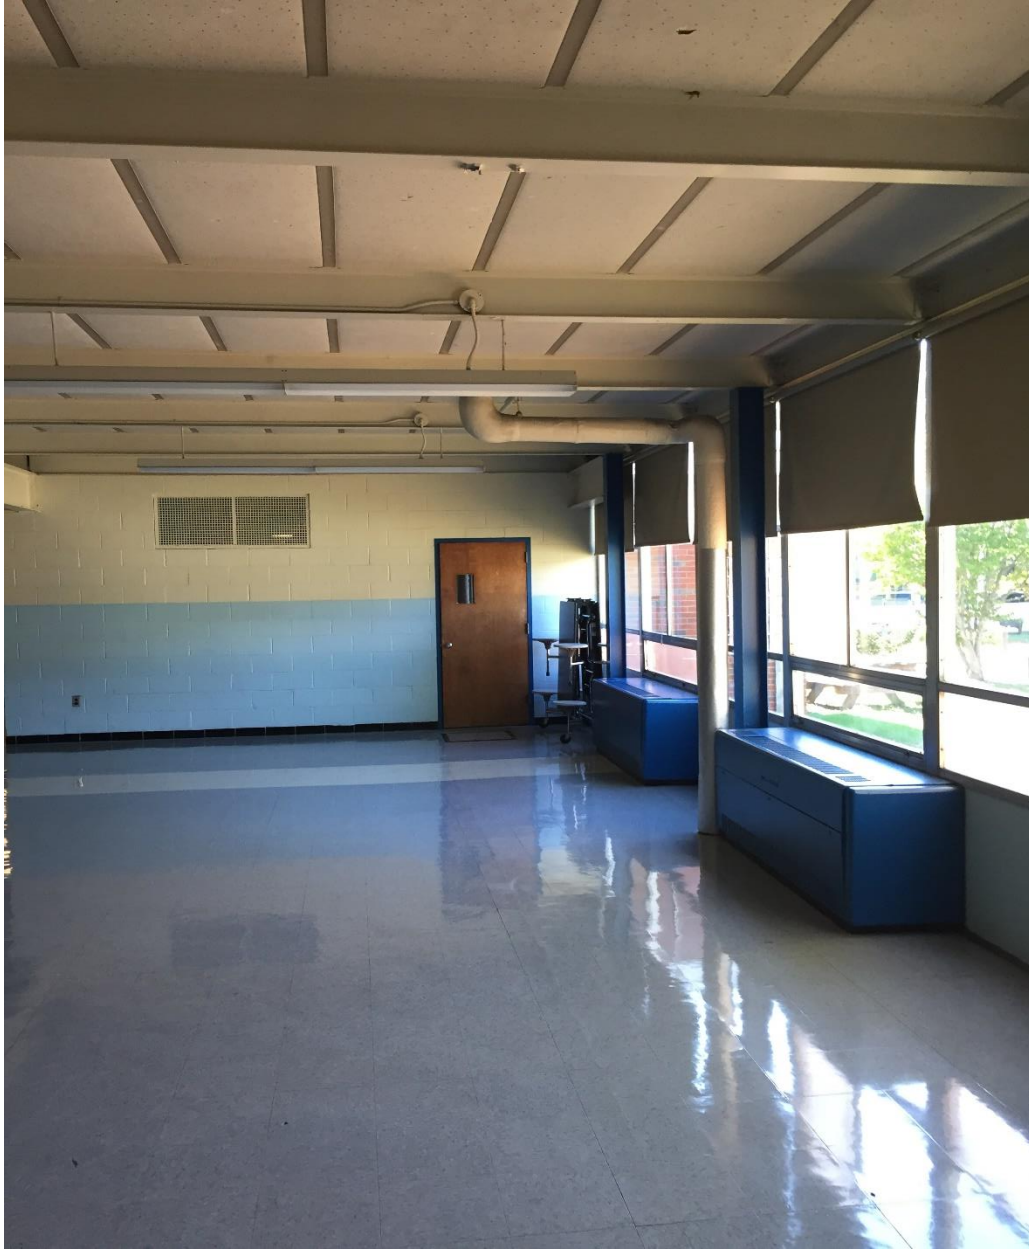
Roof Drain with ACM Fittings

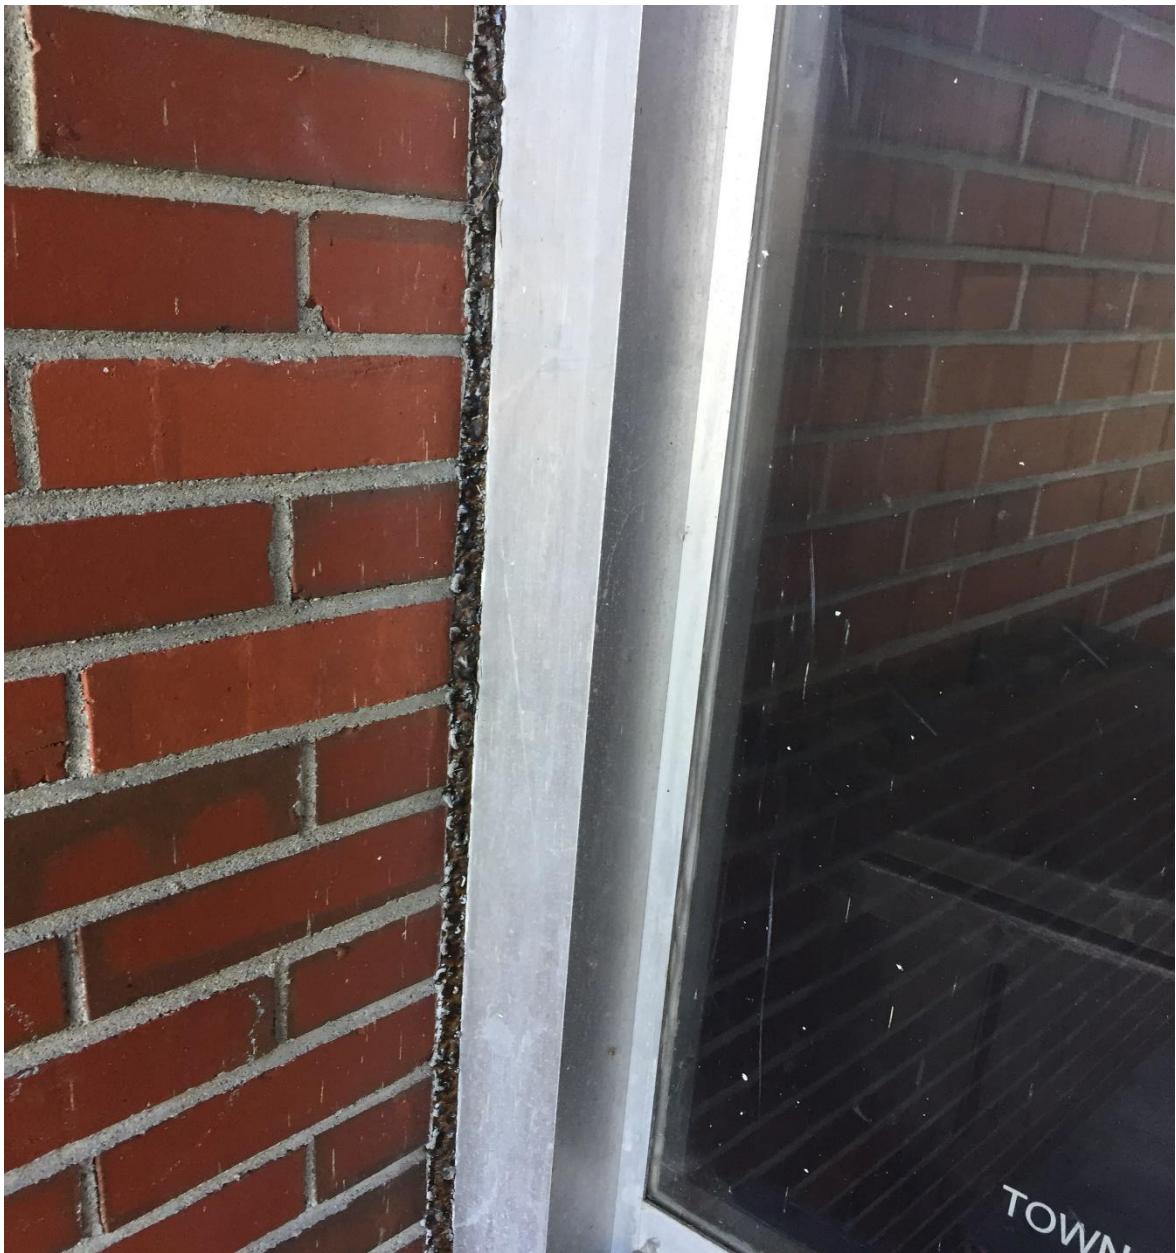
ACM Door Caulk

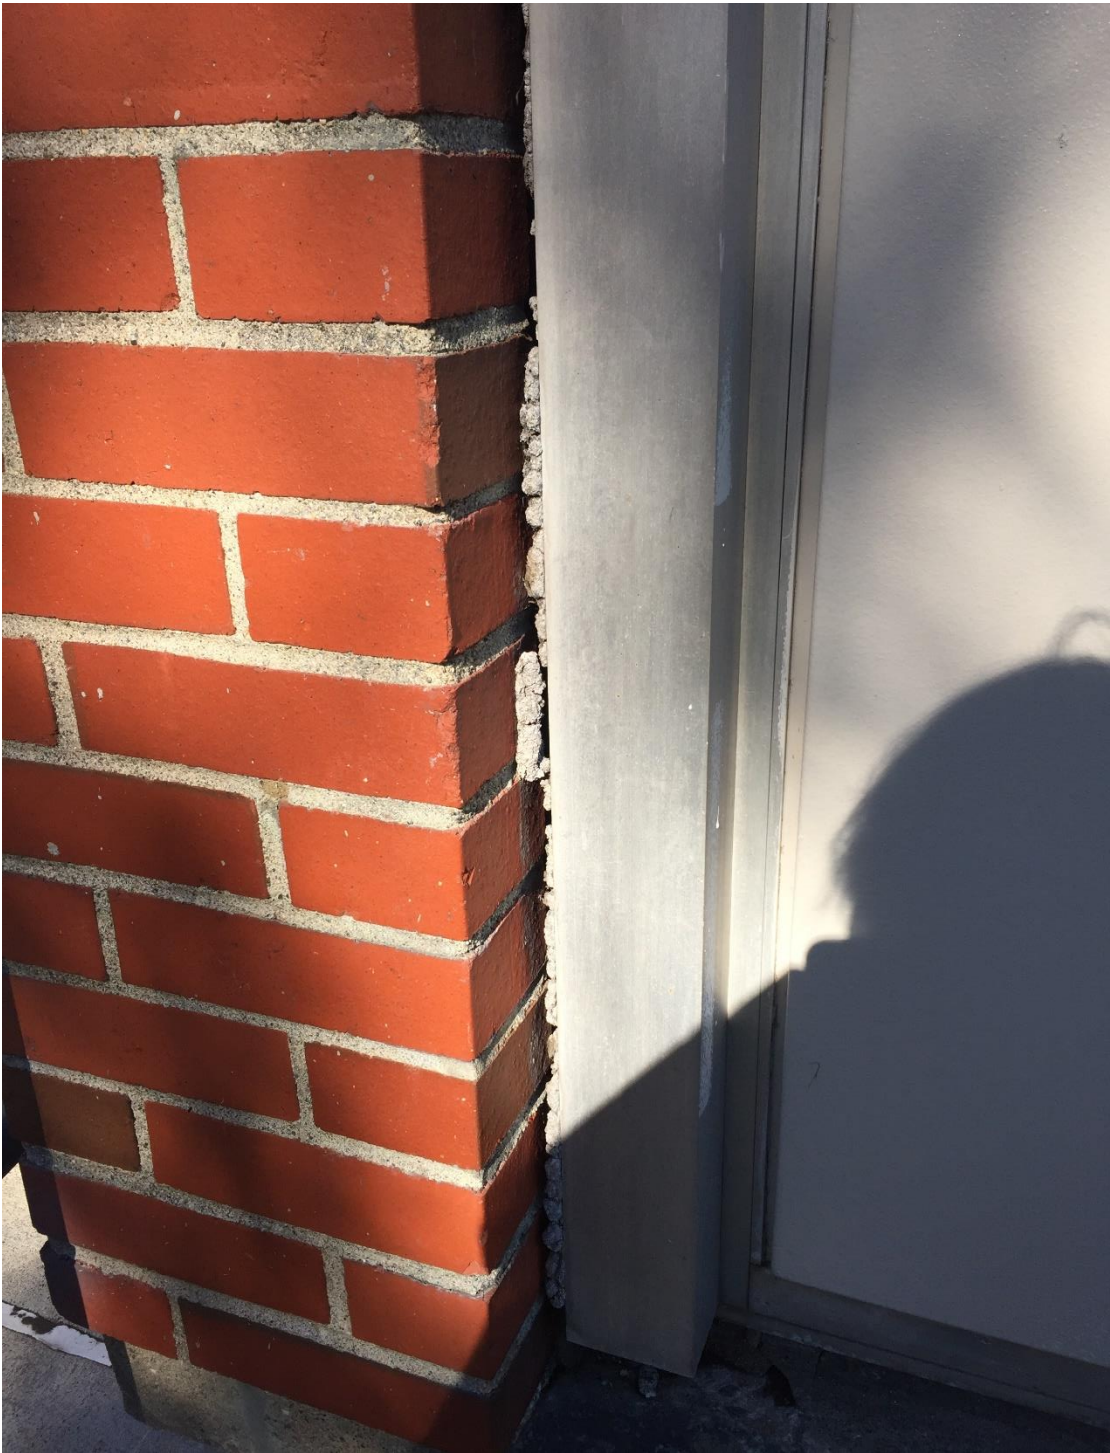
Exterior ACM Window Caulk at Edges of Window Banks

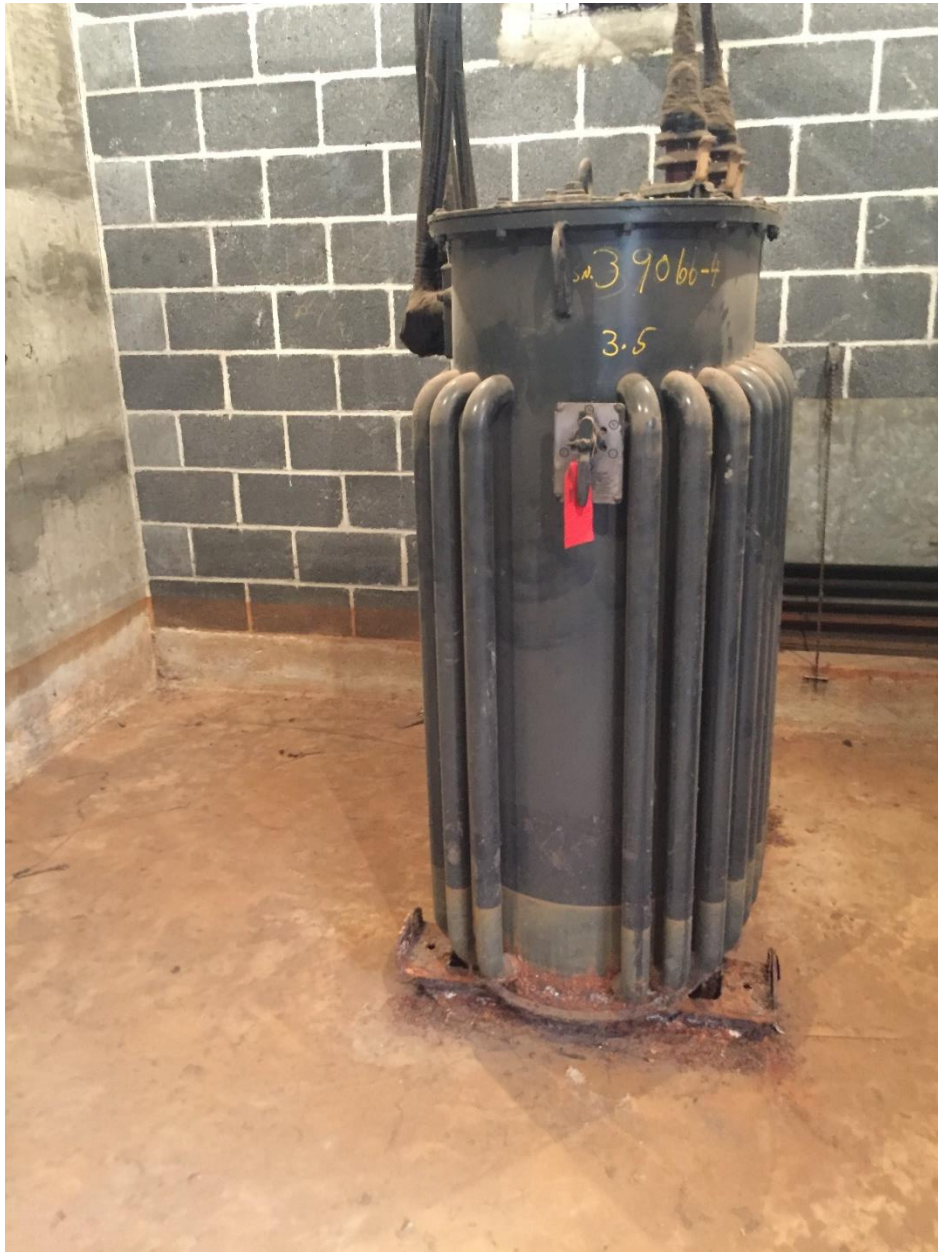
Old Transformer with PCB Fluid
