Pre-Feasibility Study

Fuller Middle School and Farley Building
Framingham Public Schools

Framingham, Massachusetts

February 27, 2013

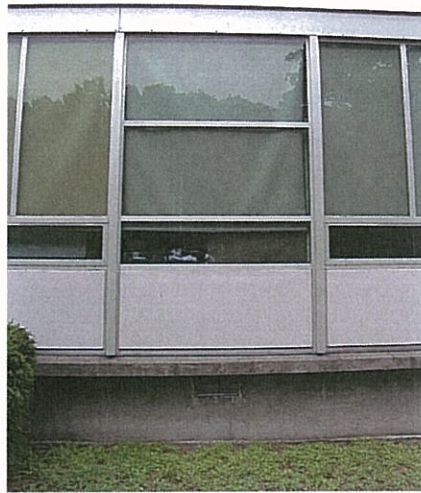
Storefront at core wing – south elevation

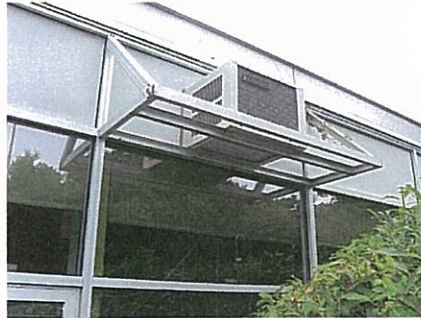
Typical AC installation

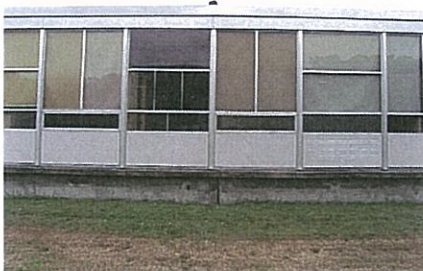
Typical storefront on north elevation

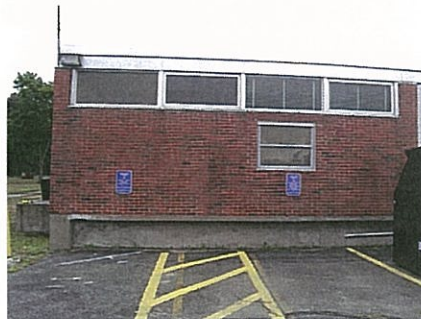
Clerestory windows on east elevation
(Lower window is a later renovation)

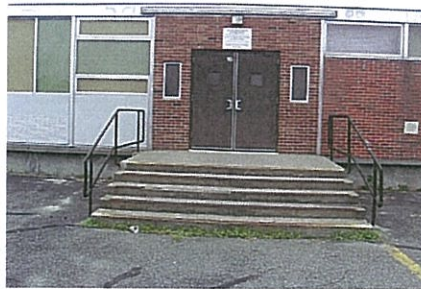
Service doors at east elevation

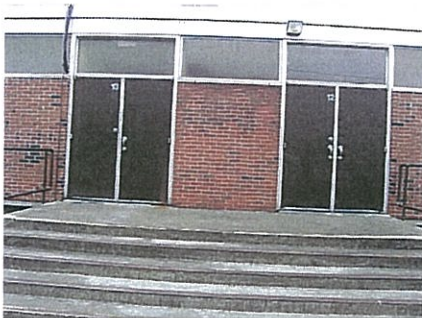
Exit doors at gymnasium

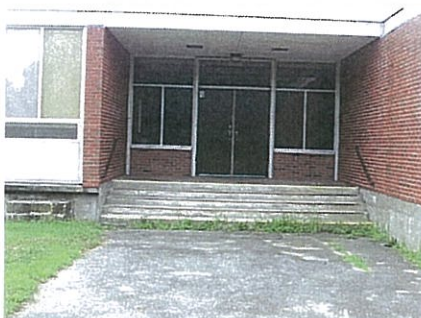
Typical exit doors at north elevation

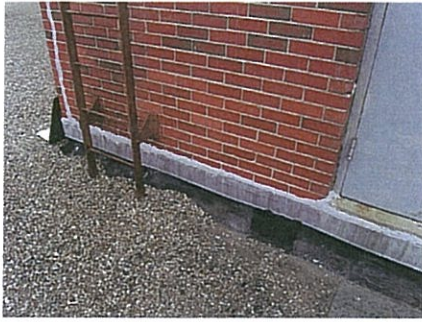
Sealant above base flashing

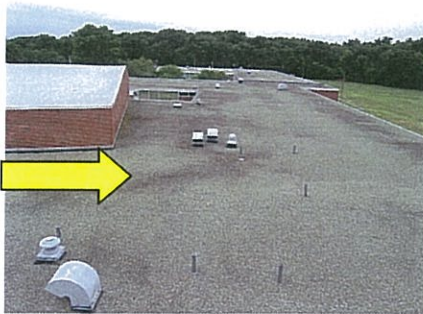
Discoloration shows slow to poor drainage

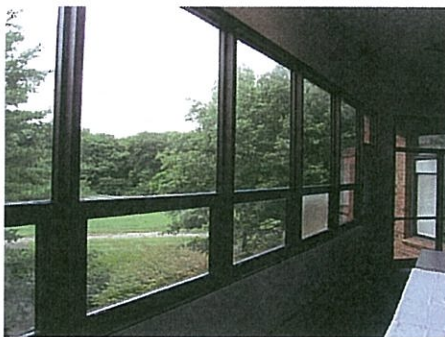
The windows are well maintained and in good working order. Some glass units have deteriorated surfaces; no active leaks were reported.

Windows at cafeteria

Glass units with deteriorated surfaces should be replaced.

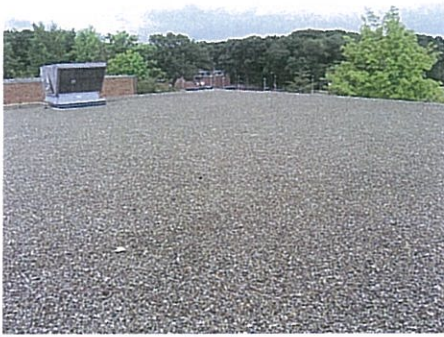
General condition of roofing

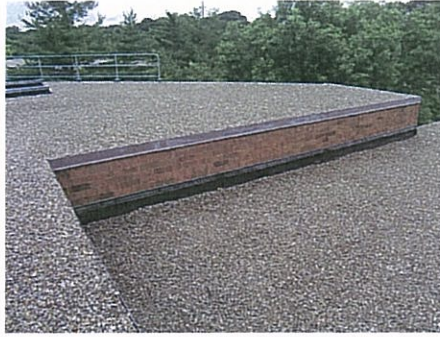
Flashing in good condition; fall protection in place at roof edge.

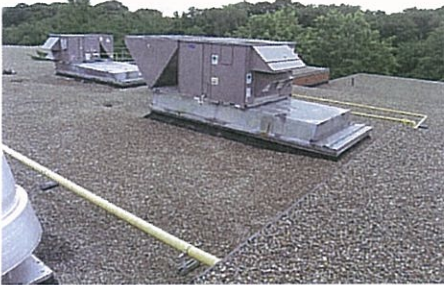
Equipment properly flashed and gas piping properly secured

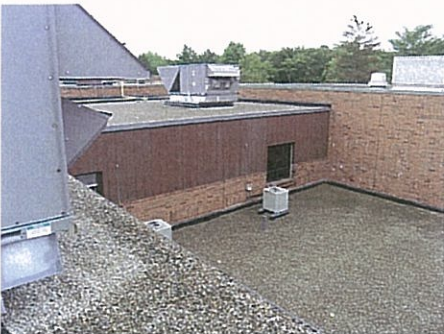
Lower roof areas in good condition

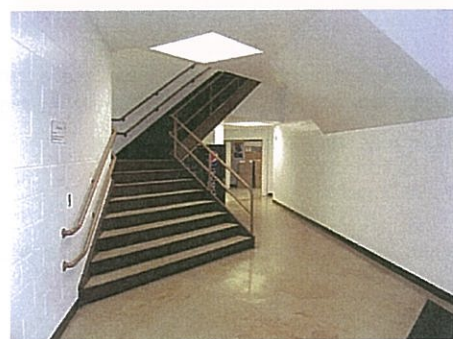
Typical stair finishes

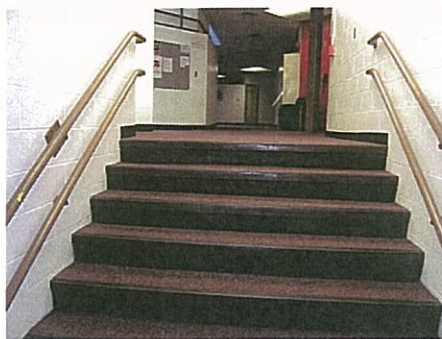
Stairs to upper level
