MILL VALLEY SCHOOL DISTRICT FACILITIES ASSESSMENT 2018

MILL VALLEY MIDDLE SCHOOL

FACILITY CONDITION ASSESSMENT

Mill Valley Middle School
425 Sycamore Avenue
Mill Valley, California 94941

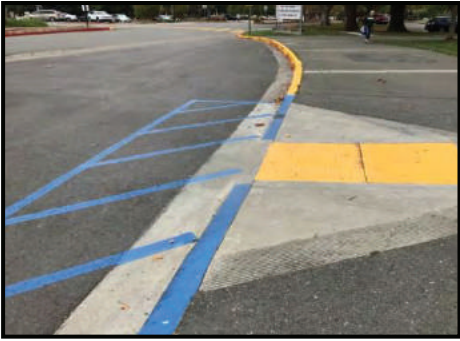
**PHOTO - 1
PARKING LOT CURB**

Progressive settling throughout campus has likely had an impact on accessibility

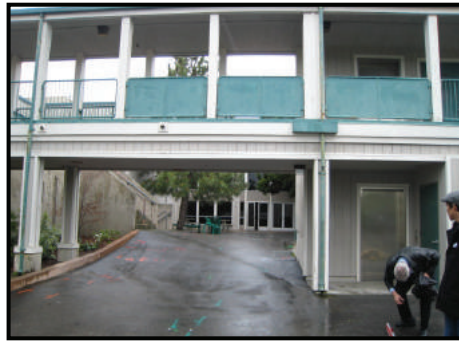
**PHOTO - 2
MAIN BUILDING EXTERIOR**

The steps to the Main Building are difficult to navigate with deliveries

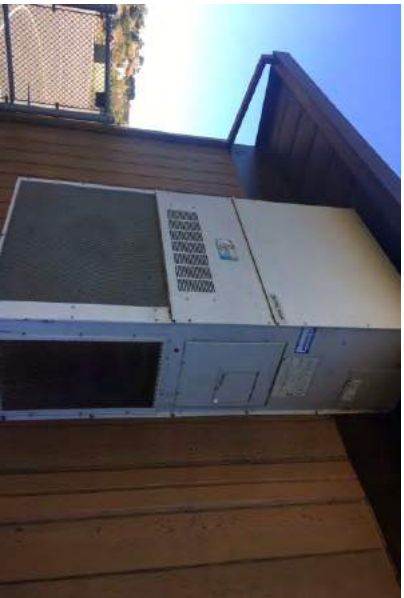
#40	AIR HANDLER
-----	-------------

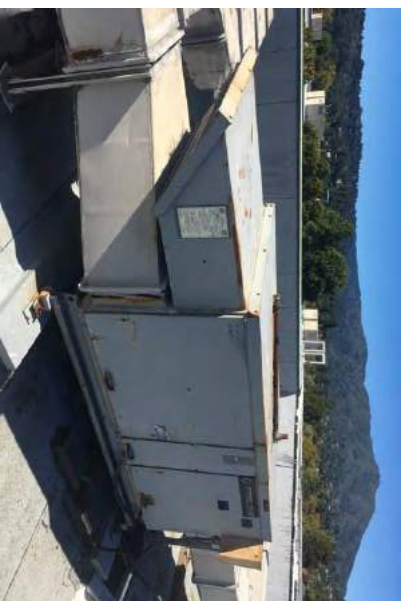
#41	HEAT PUMP, PACKAGED
-----	---------------------

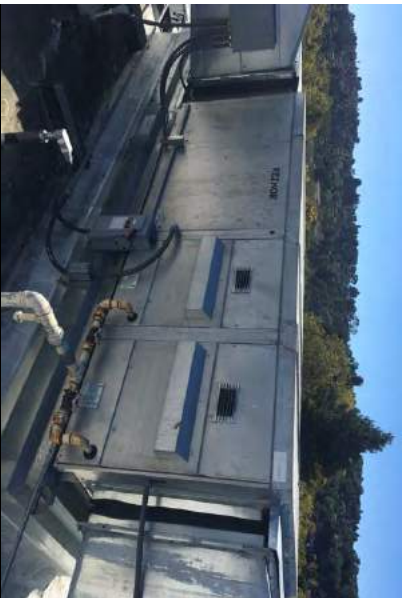
#42	UNIT HEATER, NATURAL GAS
-----	--------------------------

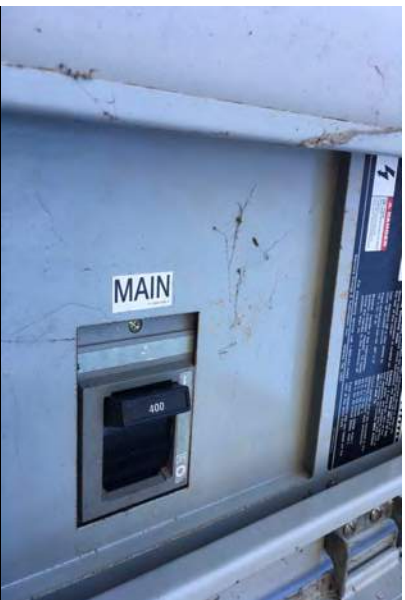
#48	DISTRIBUTION PANEL
-----	--------------------
