MILL VALLEY  
SCHOOL DISTRICT  
FACILITIES  
ASSESSMENT  
2018

# OLD MILL ELEMENTARY SCHOOL

# FACILITY CONDITION ASSESSMENT

Old Mill Elementary School  
352 Throckmorton Avenue  
Mill Valley, California 94941

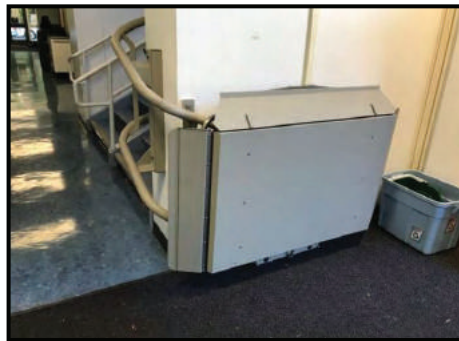
PHOTO - 6  
WHEELCHAIR LIFT

Wheelchair lift connecting the Main Building and the Lower Level

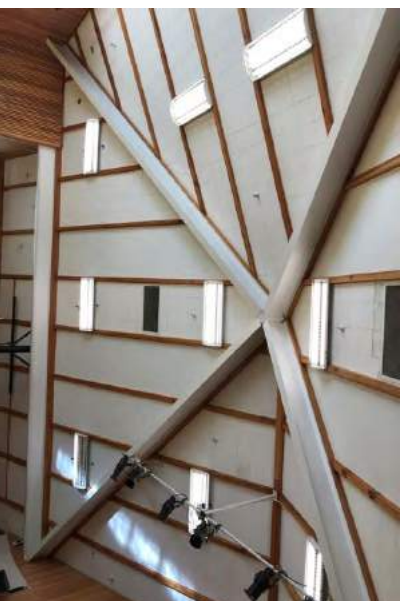
#20  
STEEL ROOF BEAMS IN MULTIPURPOSE BUILDING

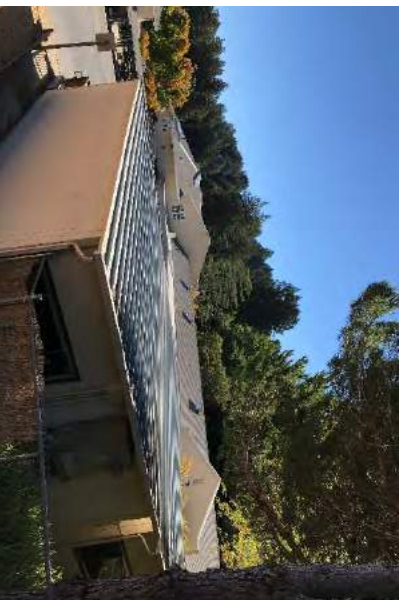
#23  
ROOF, PORTABLES. ASPHALT SHINGLES ON MAIN BUILDING BEYOND
