MILL VALLEY SCHOOL DISTRICT FACILITIES ASSESSMENT 2018

PARK ELEMENTARY SCHOOL

FACILITY CONDITION ASSESSMENT

Park Elementary School
360 East Blithedale Avenue
Mill Valley, California 94941

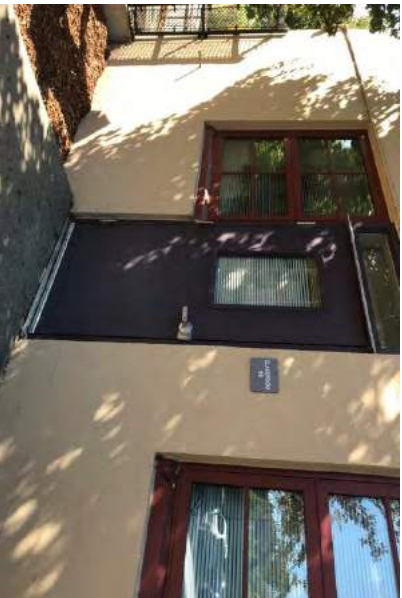
#8 EXTERIOR WOOD WALL

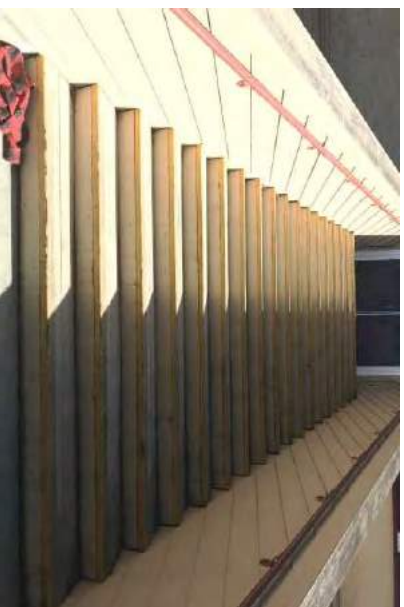
#27	ANNEX BUILDING CLASSROOM
-----	--------------------------

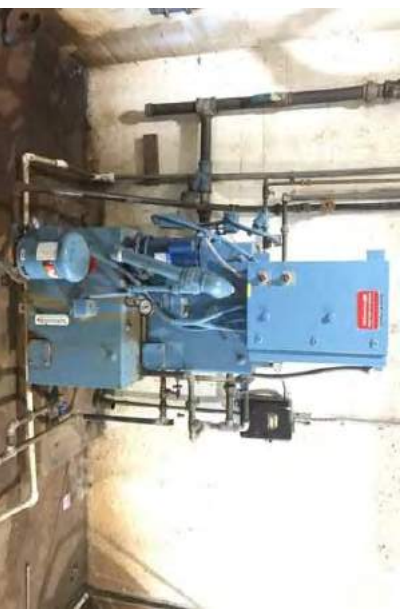
#33	BOILER
-----	--------

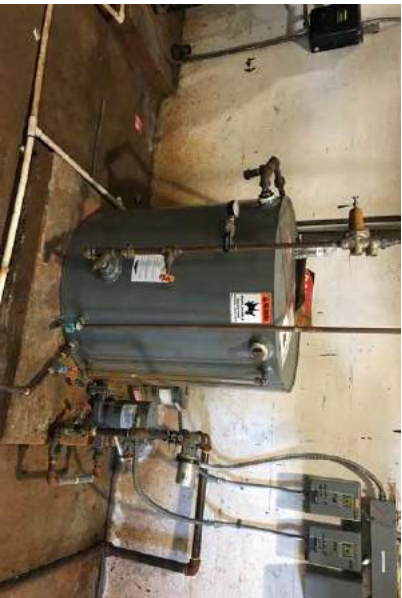
#34	BOILER VACUUM HEATING PUMP
-----	----------------------------

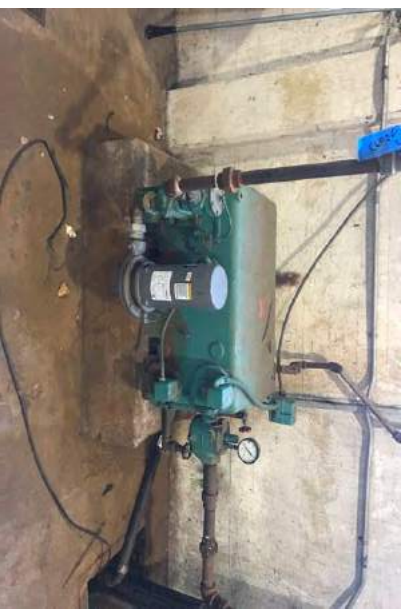
#35	BOILER FEED TANK
-----	------------------

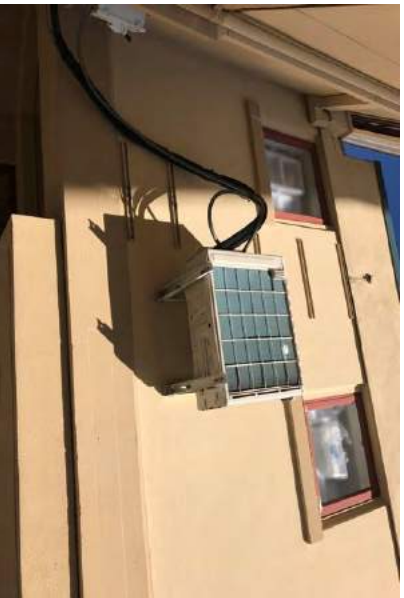
#38	UNIT HEATER
-----	-------------

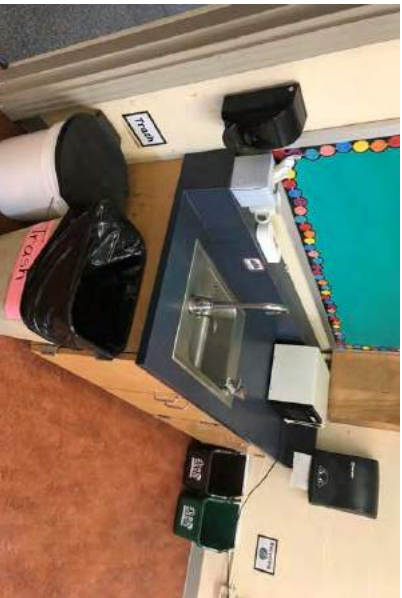
#44 SINKS WITH MISSING DRAIN WRAP

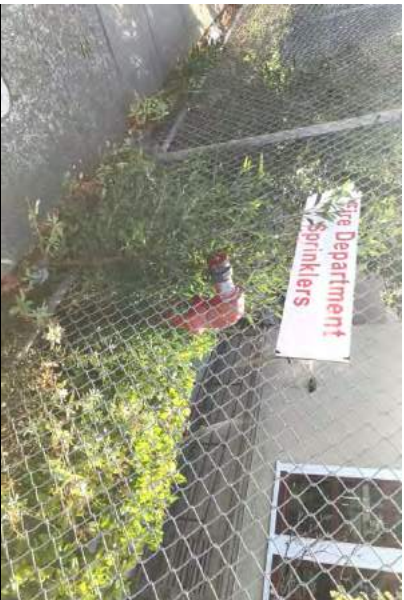
#57 FIRE DEPARTMENT CONNECTION

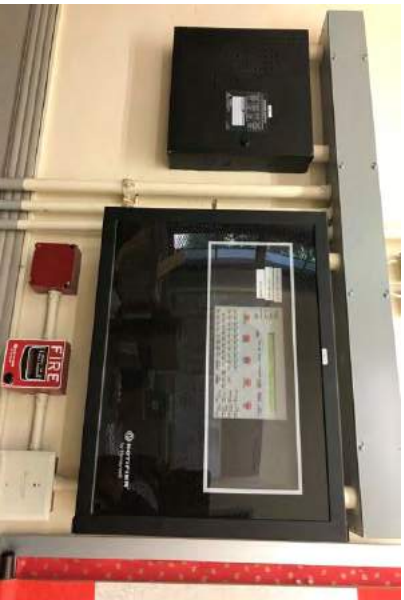
#59 FIRE ALARM CONTROL PANEL

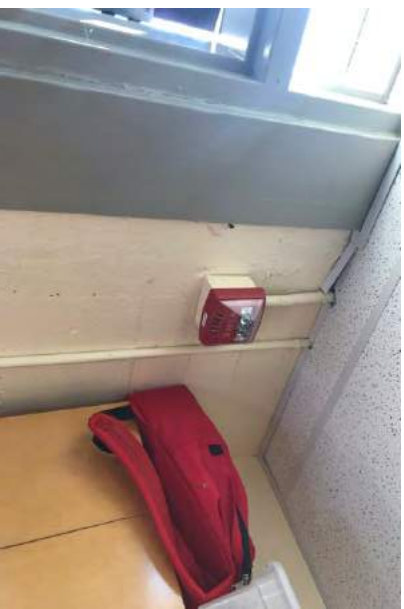
#60 FIRE ALARM SYSTEM

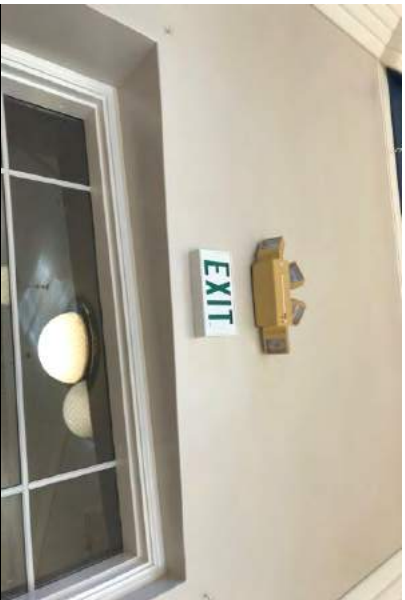
#61

EXIT LIGHTING AND
EMERGENCY LIGHTING
