# MILL VALLEY SCHOOL DISTRICT FACILITIES ASSESSMENT 2018

# PARK ELEMENTARY SCHOOL

# FACILITY CONDITION ASSESSMENT

Park Elementary School  
360 East Blithedale Avenue  
Mill Valley, California 94941

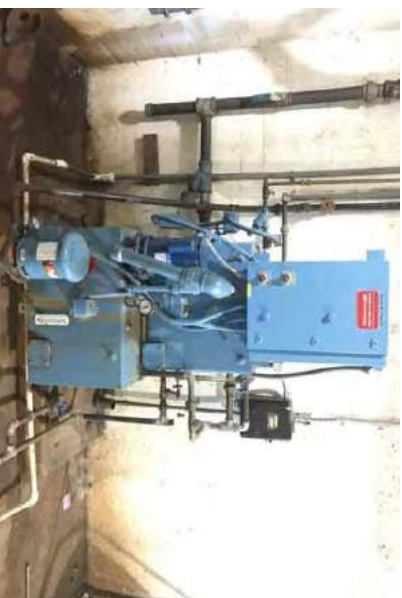
#34	BOILER VACUUM HEATING PUMP
-----	----------------------------

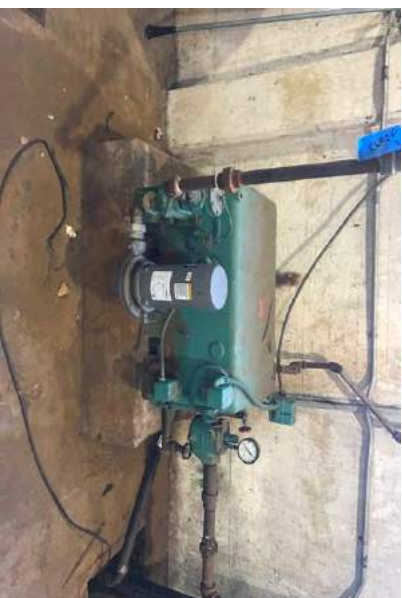
#36	BOILER VACUUM PUMP
-----	--------------------
