MILL VALLEY SCHOOL DISTRICT FACILITIES ASSESSMENT 2018

TAM VALLEY ELEMENTARY

TAM VALLEY ELEMENTARY : PRE-PLANNING SURVEY

FACILITY CONDITION ASSESSMENT

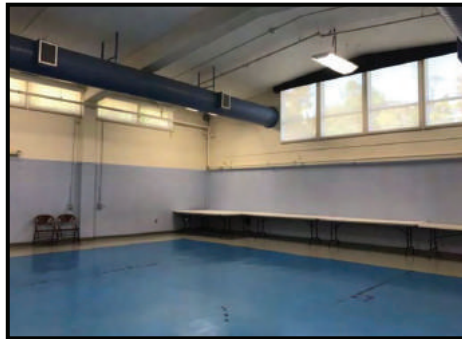
- 6 The existing Multipurpose Room (MPR) is undersized and showing signs of wear. On rainy days, the auditorium becomes the de facto lunchroom and is too small to host all students simultaneously.

**PHOTO - 5
MPR**
MPR is undersized and becomes crowded during lunchtime on rainy days

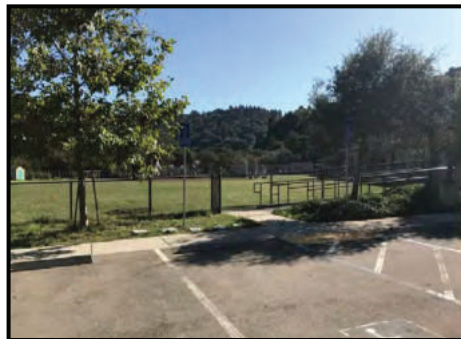
**PHOTO - 6
FIELD**
The campus features generous vegetated areas of play, including a field and a garden

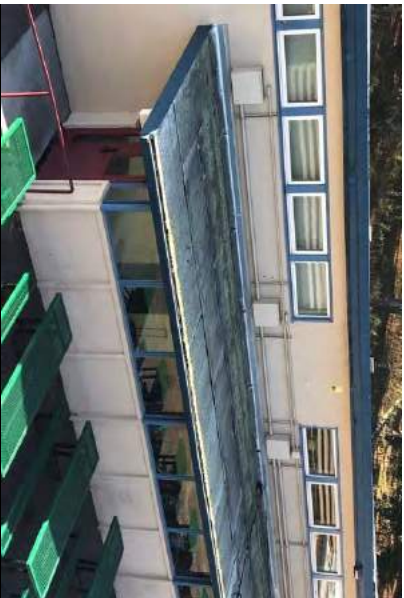
#9
NEW WINDOWS ABOVE, OLD WINDOWS BELOW

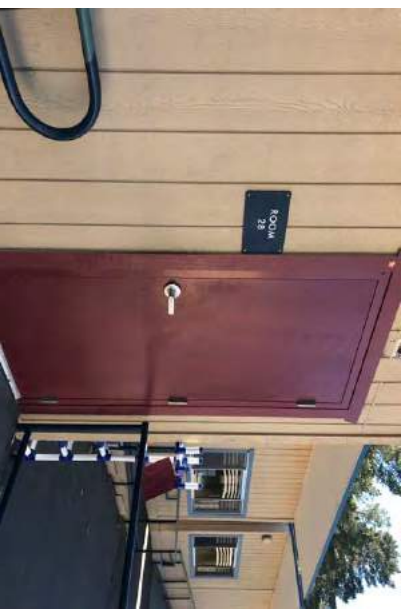
#12
E-K EXTERIOR METAL DOOR

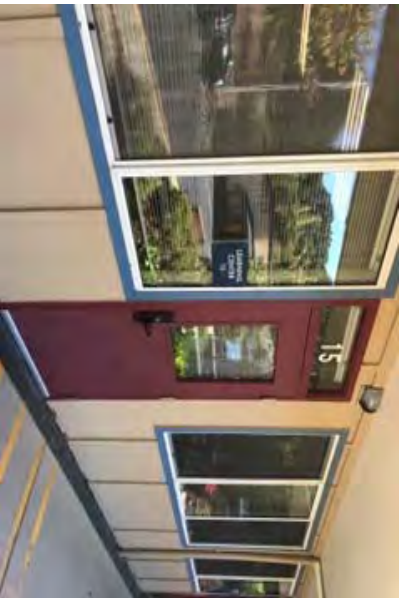
#13	C-D EXTERIOR DOORS WITH REPORTED ALIGNMENT ISSUES
-----	---

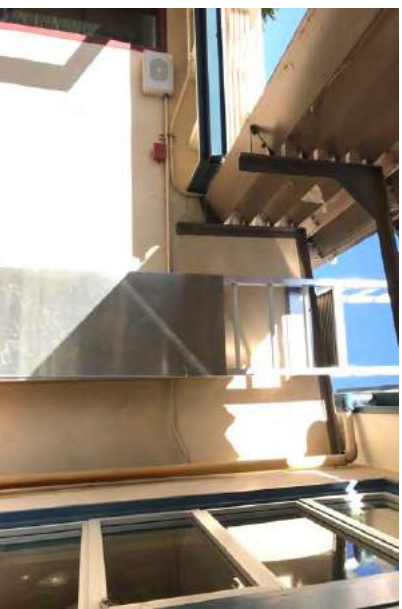
#14	A-B ROOF ACCESS
-----	-----------------

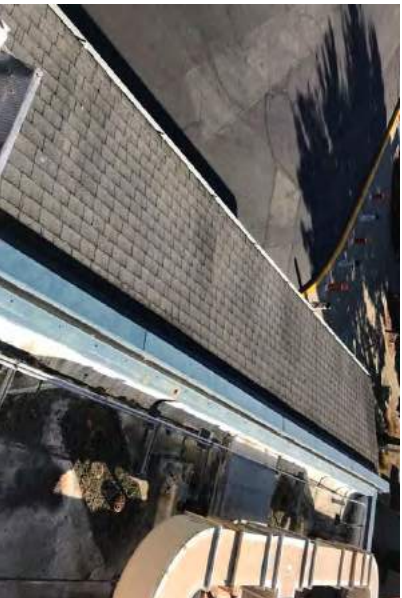
#15	A-B ASPHALT SHINGLE ROOF
-----	--------------------------

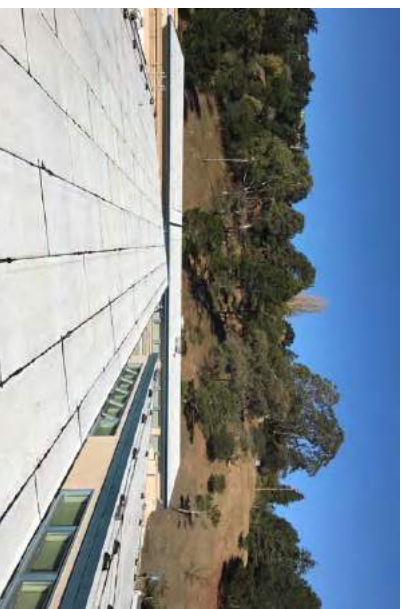
#16	A-B MODIFIED BITUMINOUS ROOF
-----	------------------------------

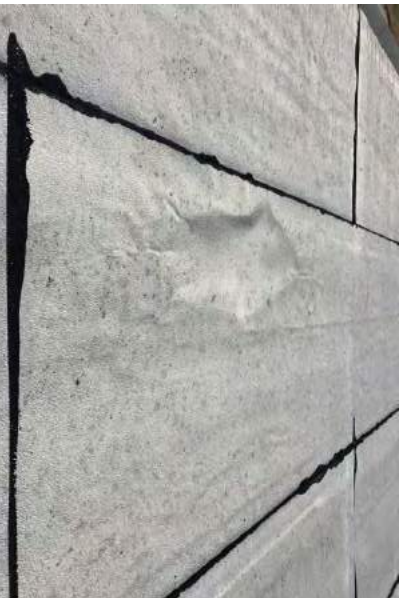
#17	BUBBLES FORMING UNDER ROOF MEMBRANE
-----	-------------------------------------

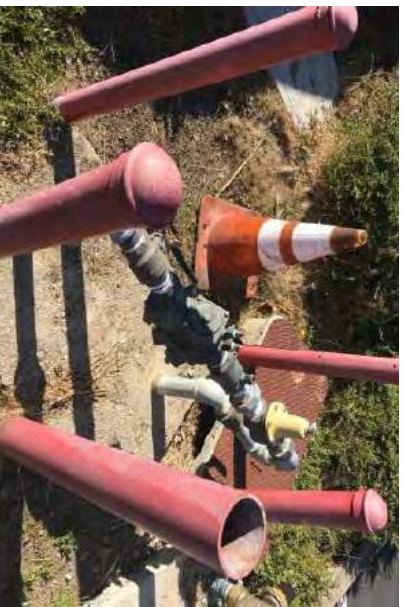
#38
BACKFLOW PREVENTER WITH GALVANIZED PLUMBING

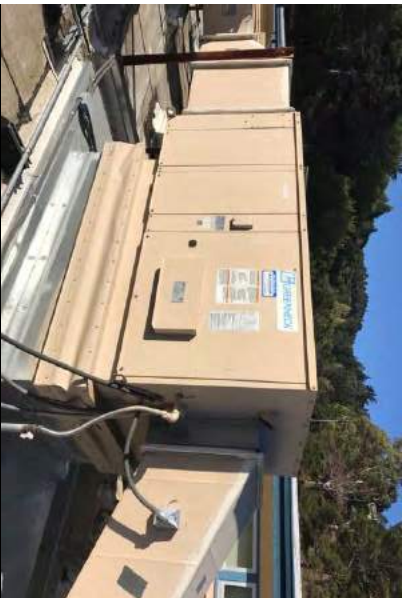
#49
A-B OFFICE ROOFTOP FURNACE

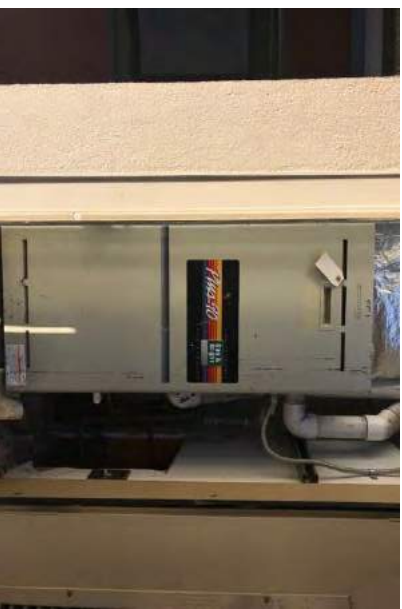
#52
A-B CLASSROOM FURNACE

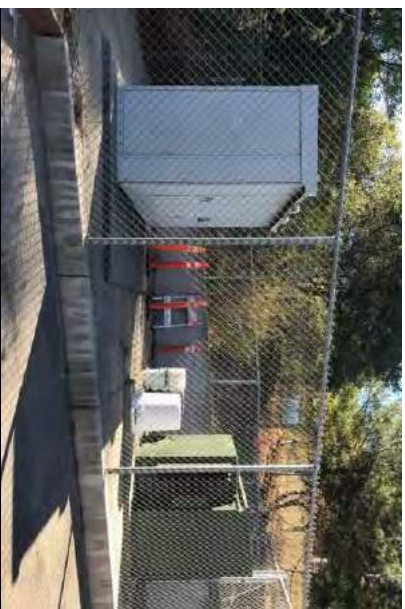
#62	SITE 2,000 AMP SWITCHBOARD
-----	----------------------------

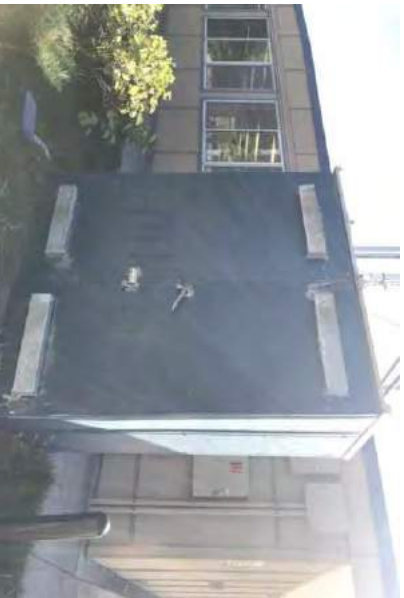
#63	C-D 600 AMP SWITCHBOARD
-----	-------------------------

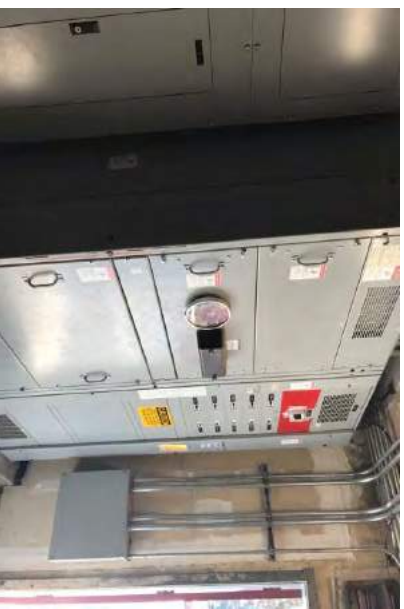
#64	A-B SWITCHBOARD CONVERTED TO 800 AMP DISTRIBUTION PANEL
-----	---

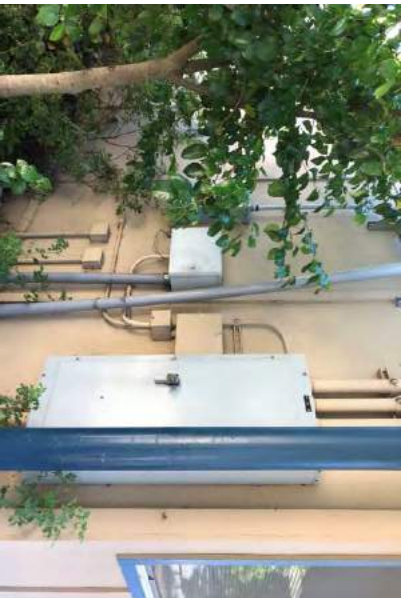
#65	C-D DISTRIBUTION PANEL
-----	------------------------

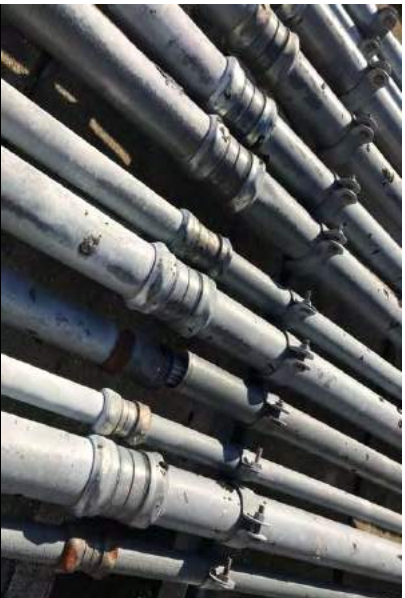
#67
OPEN ELECTRICAL CONDUIT

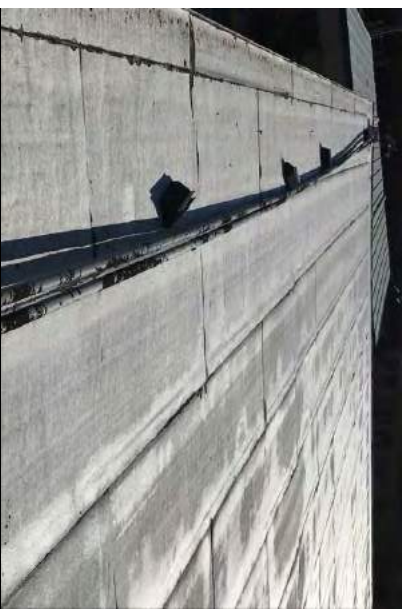
#68
CONDUIT -NOT SUPPORTED BY SLEEPERS

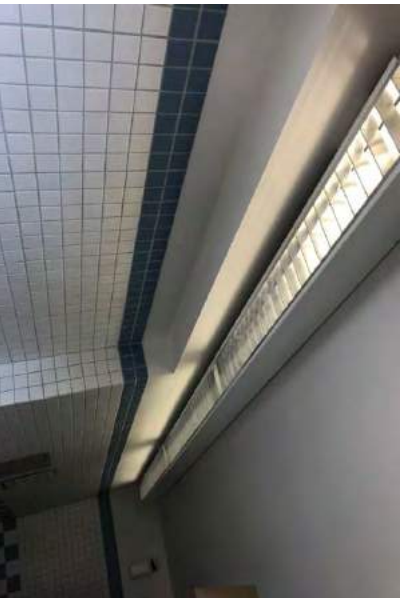
#69
LED INTERIOR LIGHTING

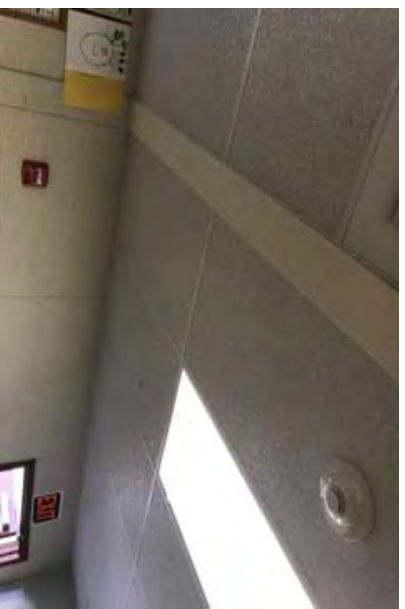
#72
FIRE ALARM SYSTEM HORN/STROBE AND SMOKE DETECTOR

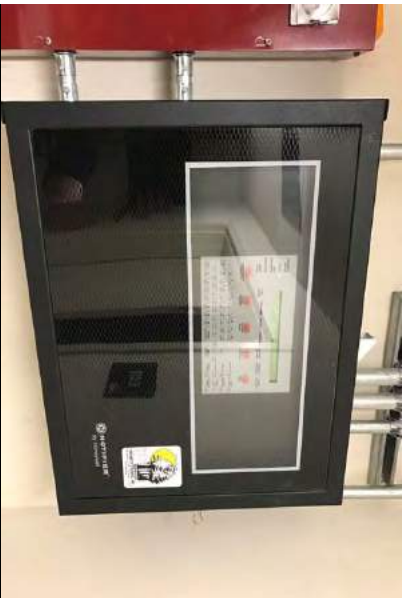
#73 FIRE ALARM CONTROL PANEL

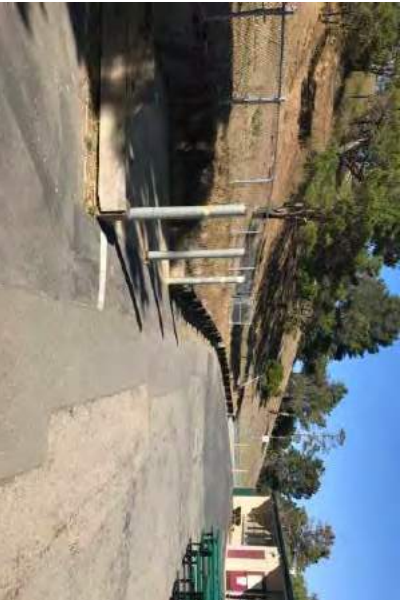
#81	TREATED TIMBER RETAINING WALL
-----	-------------------------------
