ORCUTT UNION SCHOOL DISTRICT SITE ASSESSMENT & MASTER PLAN

SVA ARCHITECTS, INC.

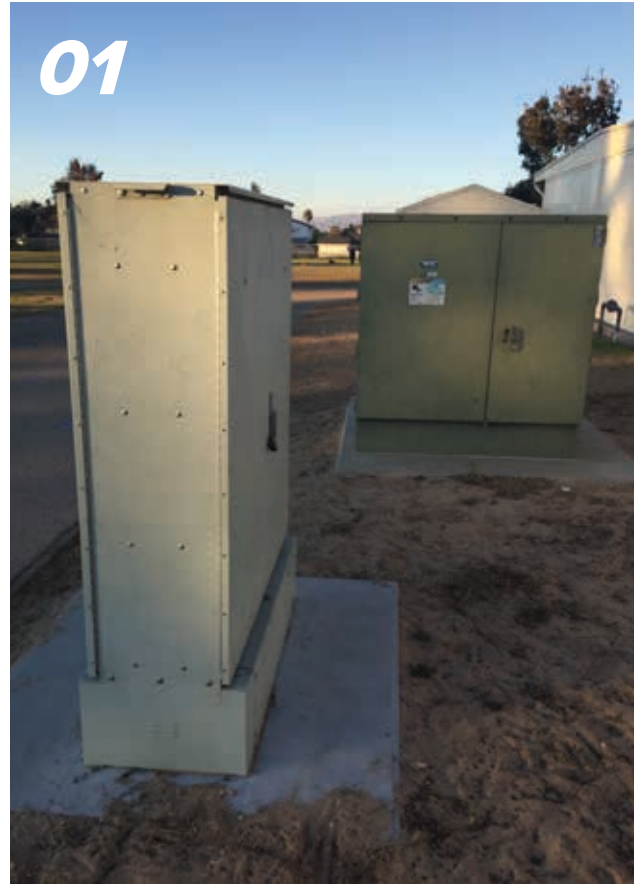
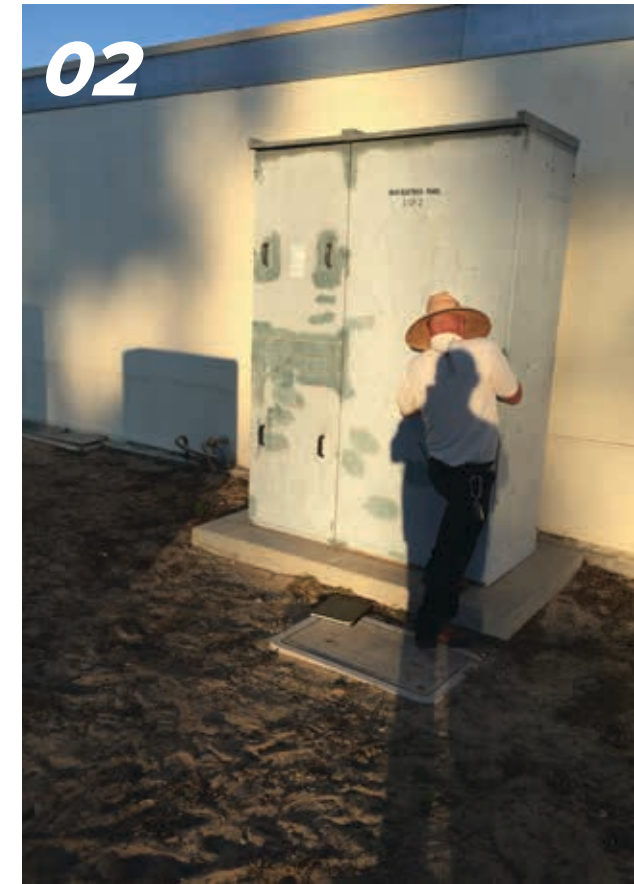
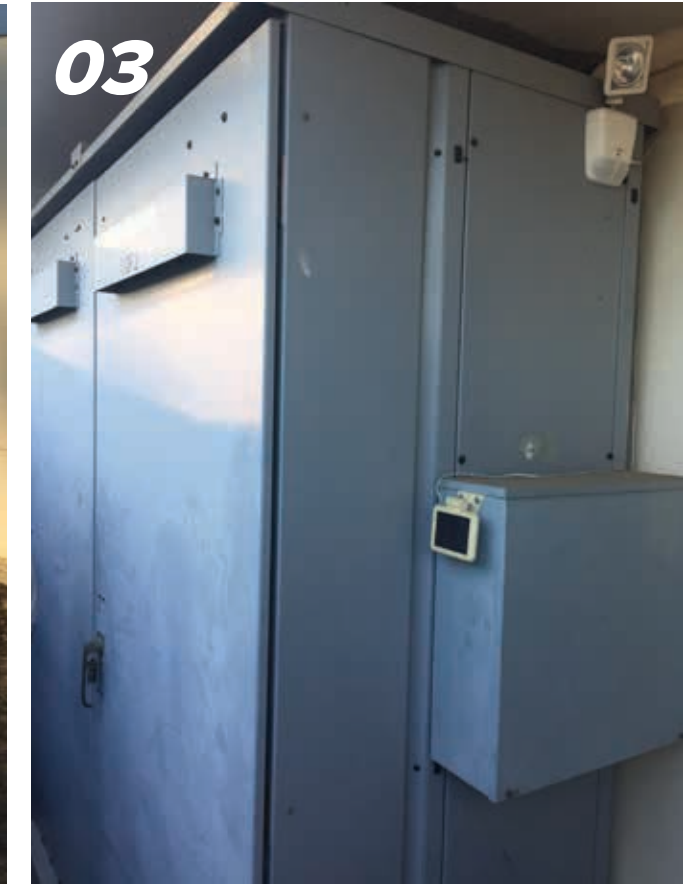
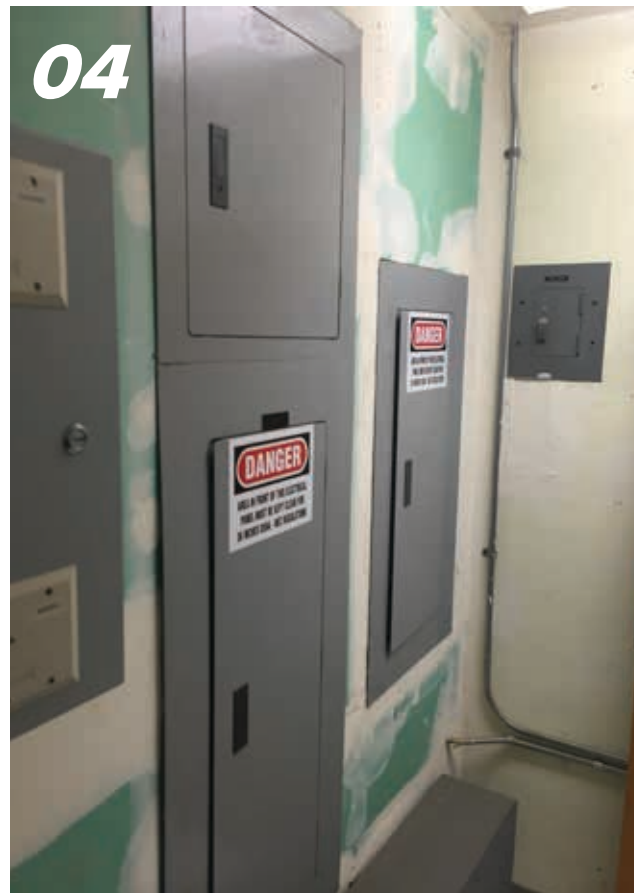
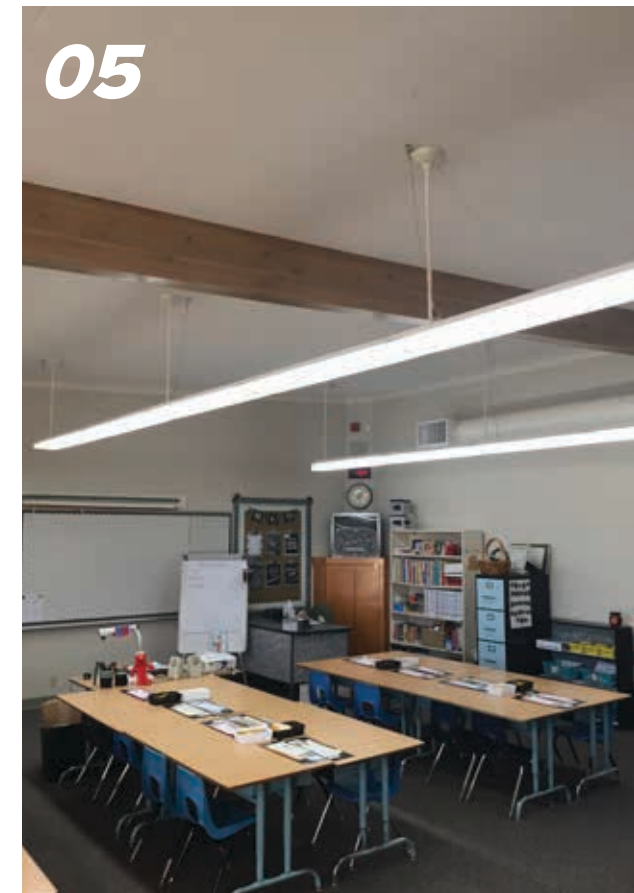
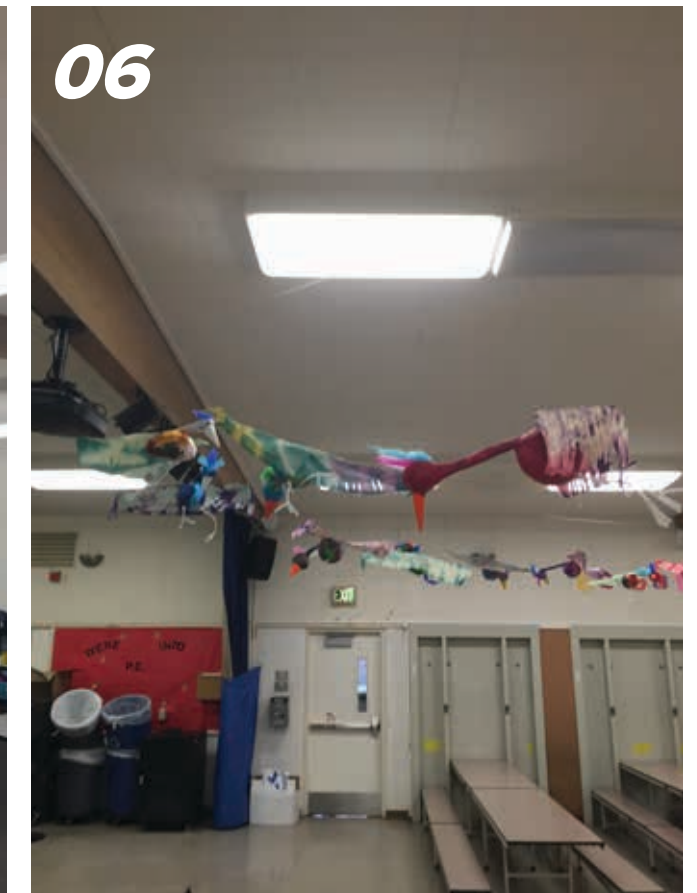
FIGURES	
01	Remote low voltage equipment enclosure
02	Meter switchboard #2
03	Main switchboard
04	Typical panelboard
05	Typical classroom lighting
06	Typical lighting
07	Typical emergency lighting
08	Exterior lighting
09	Parking lot lighting
10	Intrusion Detection System headend
11	Desk mounted projector
12	Surface mounted cabling across floor
13	MDF Rack
14	Typical low voltage equipment
15	Fire Alarm control panel

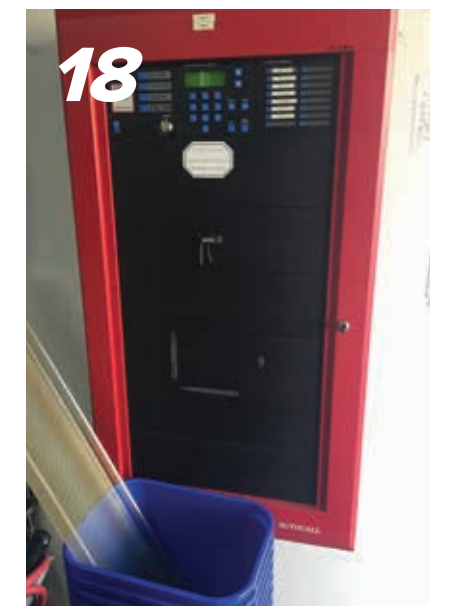
18

- There are no existing CCTV or audio/visual systems.
- There is an existing Honeywell Ademco security system.
- There is an existing Rauland Telecenter ICS PA rack.
- Classrooms contain wall mounted CATV outlets, speakers and clocks.
- There is an existing MDF rack and phone switch at the Main Signal Room. The phone system is Avaya Lucent with NEC phones. There are some wireless access points in every building, but not every classroom.
- The existing fire alarm control panel is a Simplex Autocall 4100. The Campus has a manual system.

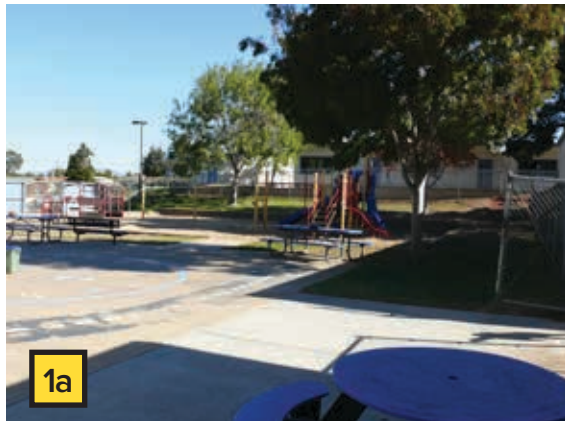
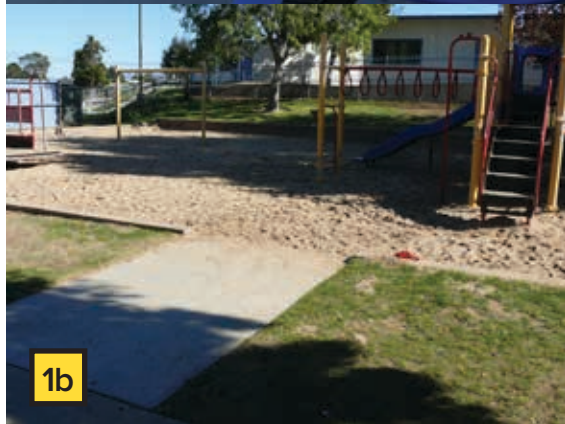
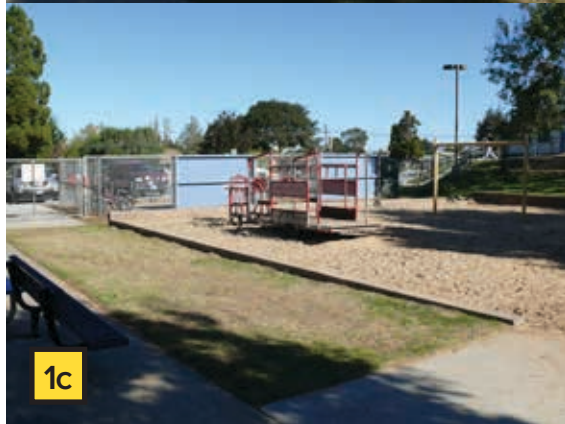
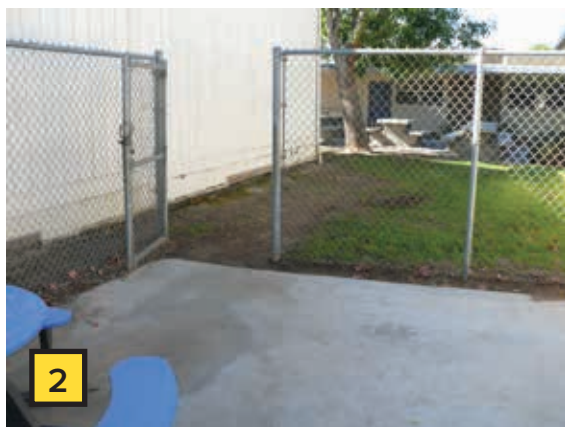
1a-1c & 2. KINDERGARTEN PLAY AREA

Add rubberized fall zone material that is accessible from the entry ramp to the transfer station and to the slide areas and other equipment, or change all material to an accessible material like Fibar etc. Till, amend repair irrigation systems and re-sod and or re-seed. Install accessible gate hardware on all gates and install new concrete at all entries to meet code.

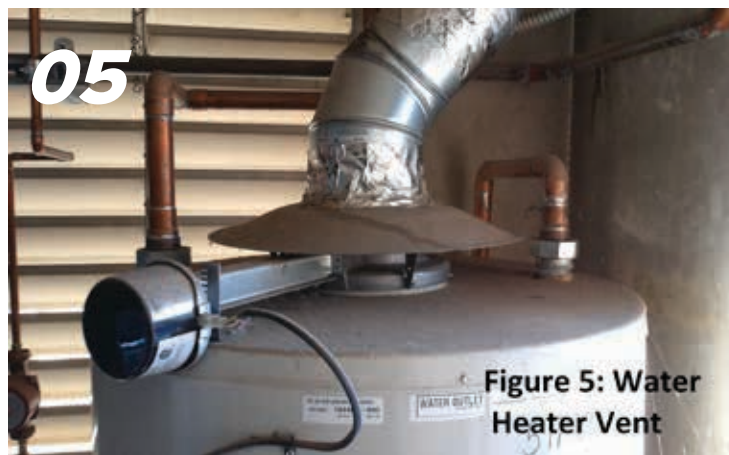
Figure 5: Water Heater Vent

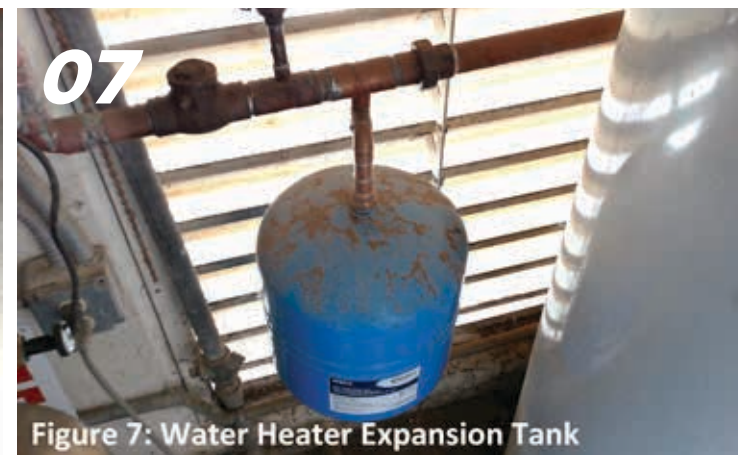
Figure 7: Water Heater Expansion Tank

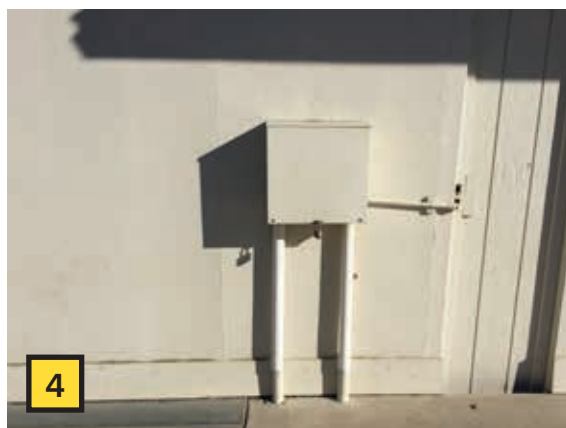
4. EXISTING IRRIGATION CONTROLLER

Outdated irrigation controller that's not weather or moisture sensor based.

Replace with compliant stand-alone or central control system.

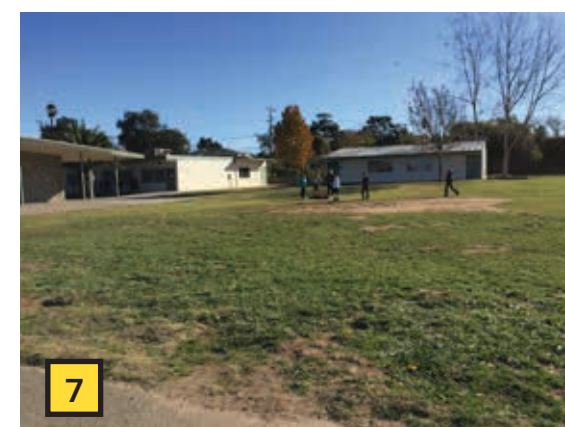
7. OPEN TURF PLAY AREA

Open play turf area needs repairs. Rodent and gopher holes through out and lack of irrigation coverage.

Need rodent eradication set up on a monthly contract with exterminator company. Till and amend the soil, repair irrigation systems and re-sod and/or re-seed if it is intended for practice use.
