**6. OLGA REED**  
ELEMENTARY SCHOOL &  
**ORCUTT ACADEMY K-8 (OAK-8)**

## OLGA REED ELEMENTARY SCHOOL

## ARCHITECTURAL ASSESSMENT

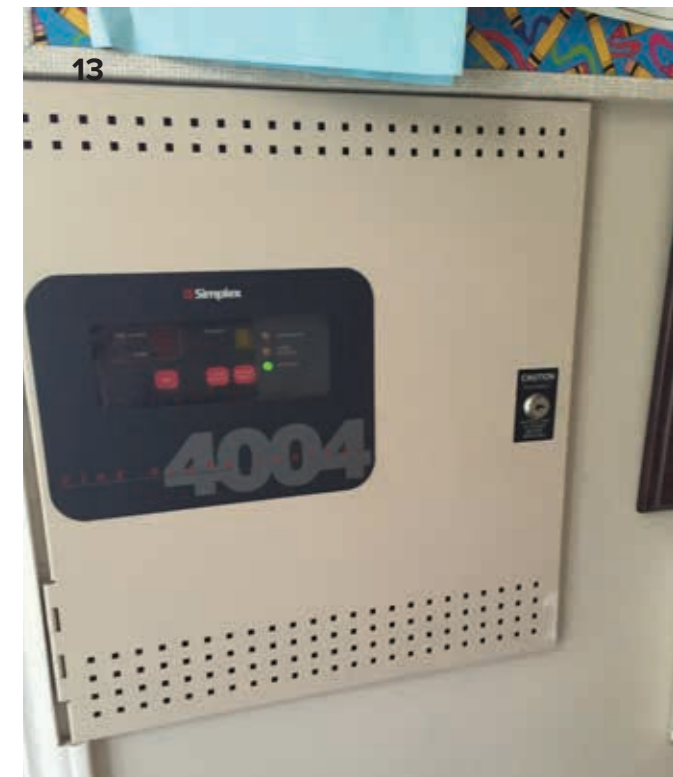
- There is currently no security, CCTV, audio visual or CATV systems on the Campus.
- There is an existing Lathem Clock system that is not being used. 120V battery clocks are installed.
- Existing speakers are wall mounted.
- There is an existing MDF and telephone company switch in the Main Signal Room. The existing phone/PA system is Toshiba Strata and is located in the Main Electrical Room. There are some wireless access points in every building, but not every classroom.
- There is an existing manual fire alarm system on Campus. The existing fire alarm control panel is a Simplex 4004.

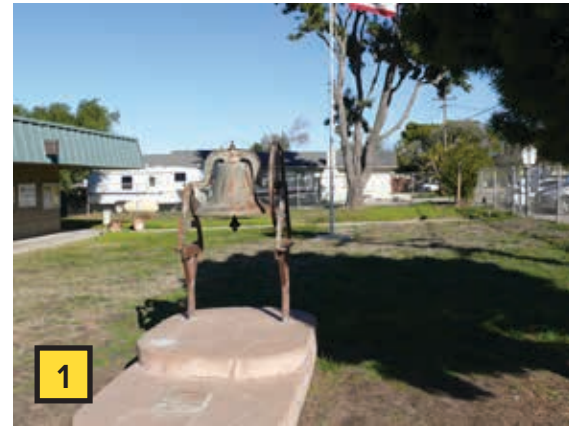
**1. LANDSCAPE AREA AT FRONT OF BUILDING**

**Existing Condition:**  
Dilapidated turf area with no shrub planting. Turf appears in poor condition.

**Recommendation:**  
Add low-water use plant material as a compliment to the existing turf. Add new drip irrigation system for shrub planting and reconfigure spray system for the turf.

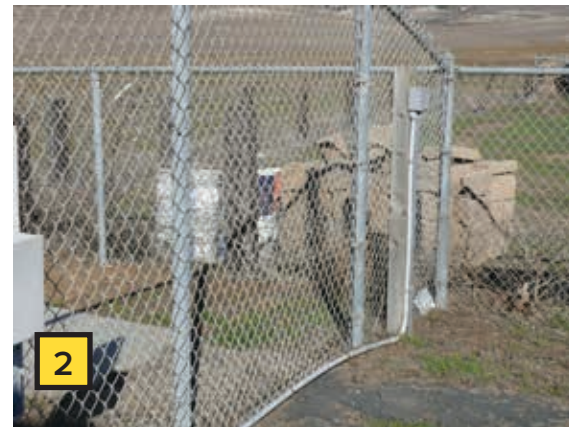
**2. EXISTING IRRIGATION CONTROLLER**

**Existing Condition:**  
Outdated irrigation controller that's not weather or moisture sensor based.

**Recommendation:**  
Replace with new compliant stand-alone or central control system.

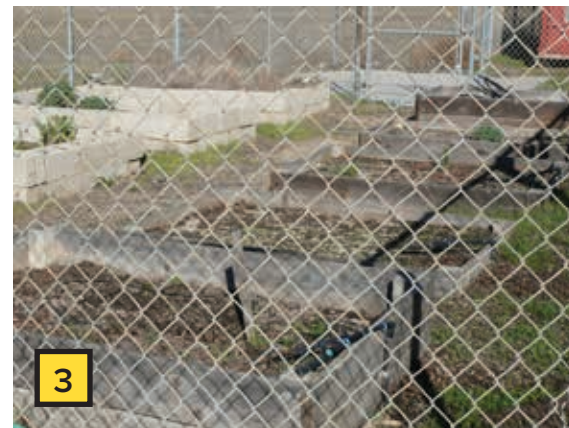
**3. STUDENT GARDEN AREA**

**Existing Condition:**  
Dilapidated garden area with wood and concrete block boxes. Limited accessibility due to surface materials.

**Recommendation:**  
Renovate with new concrete or ACQ wood boxes. Repair irrigation systems and expand if necessary to each box. Replace unpaved areas with accessible surfacing such as decomposed granite.

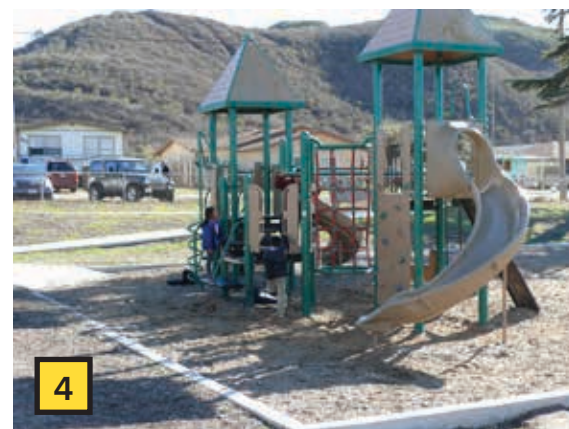
**4. PRIMARY PLAY AREA**

**Existing Condition:**  
Area is not accessible with only sand for the fall protection. There is no access to the transfer station on the play equipment and from the slides or other equipment back to the transfer station.

**Recommendation:**  
Add rubberized fall zone material that is accessible from the entry ramp to the transfer station and to the slide areas and other equipment, or change all material to an accessible material like Fibar etc.

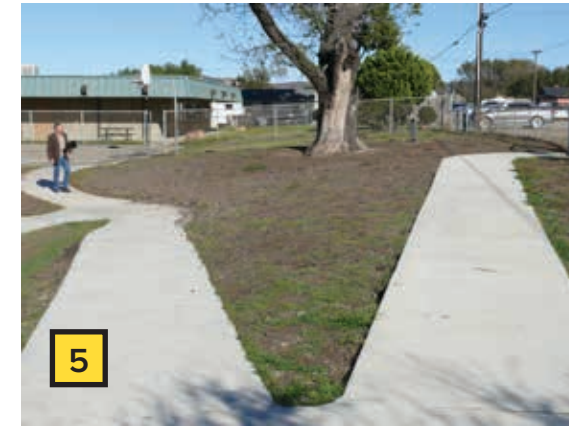
**5. LANDSCAPE AREA ADJACENT TO PLAY EQUIP. AREA**

**Existing Condition:**  
No existing landscaping surrounding the switchback walkways.

**Recommendation:**  
Install new low-water use accent planting and add new drip irrigation system.

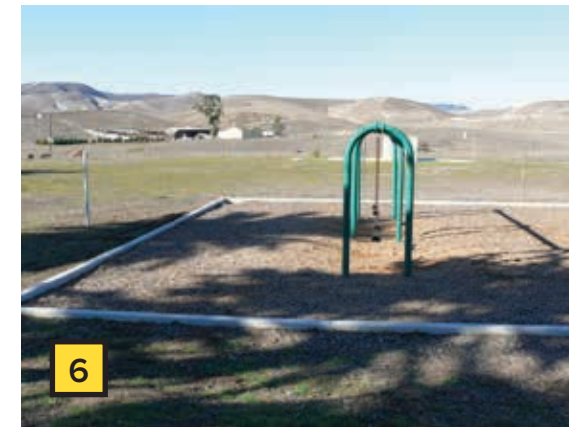
**6. PRIMARY PLAY AREA - SWINGS**

**Existing Condition:**  
Area is not accessible with only sand for the fall protection.

**Recommendation:**  
Add rubberized mats below each swing, and change all material to an accessible material like Fibar etc.

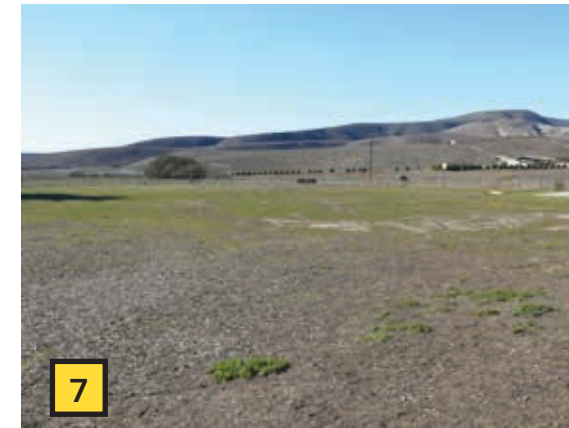
**7. OPEN PLAY ATHLETIC FIELDS**

**Existing Condition:**  
Dilapidated turf, compacted soil, and irrigation coverage is lacking.

**Recommendation:**  
Till and amend the soil, repair irrigation systems and re-sod and or re-seed the entire area.

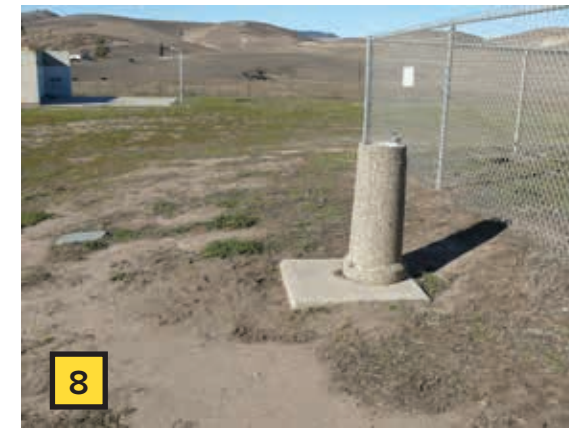
**8. EXISTING DRINKING FOUNTAIN AT FIELD**

**Existing Condition:**  
Existing non-accessible drinking fountain.

**Recommendation:**  
Replace with compliant "high-low" drinking fountain. Install accessible paving to fountain.

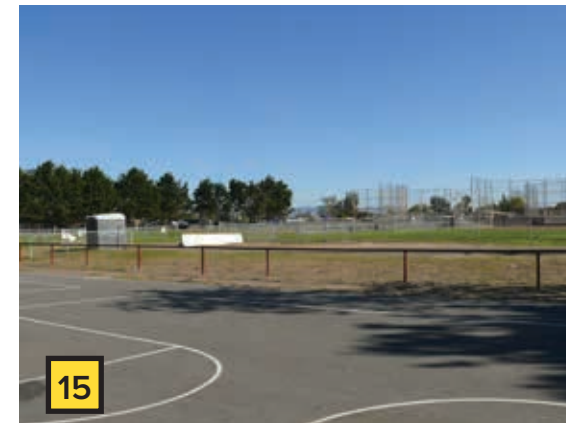
**15 & 16. BASEBALL AND SOFTBALL FIELDS**

Fields have gopher and rodent damage. Irrigation system and coverage appear adequate.

Need rodent eradication set up on a monthly contract with exterminator company. Till and amend the soil, repair irrigation systems and re-sod and/or re-seed.

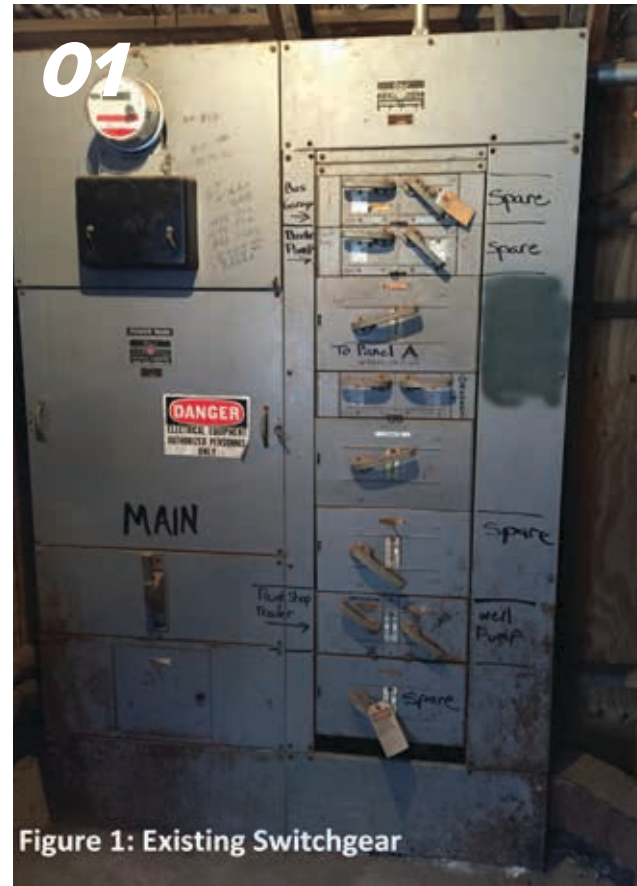
Figure 1: Existing Switchgear

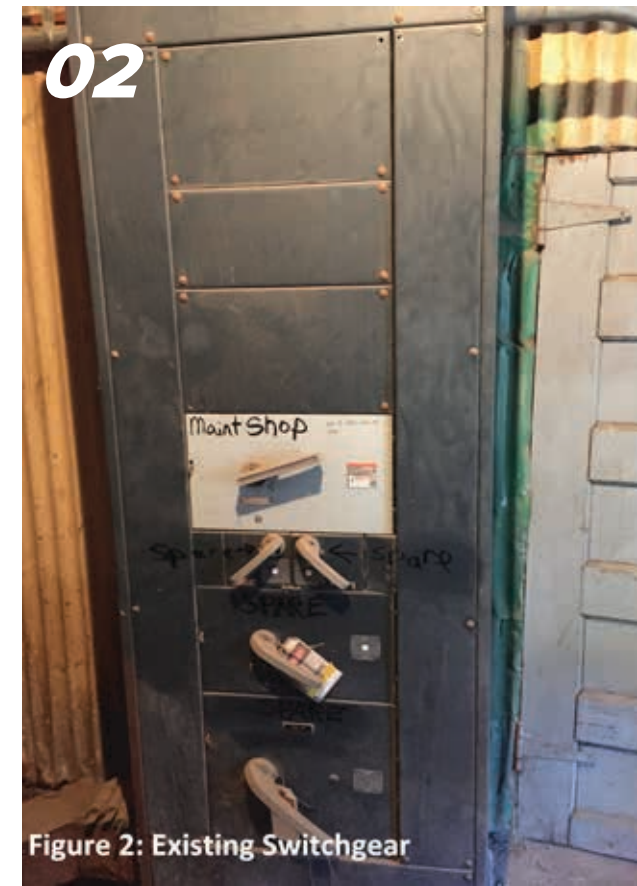
Figure 2: Existing Switchgear

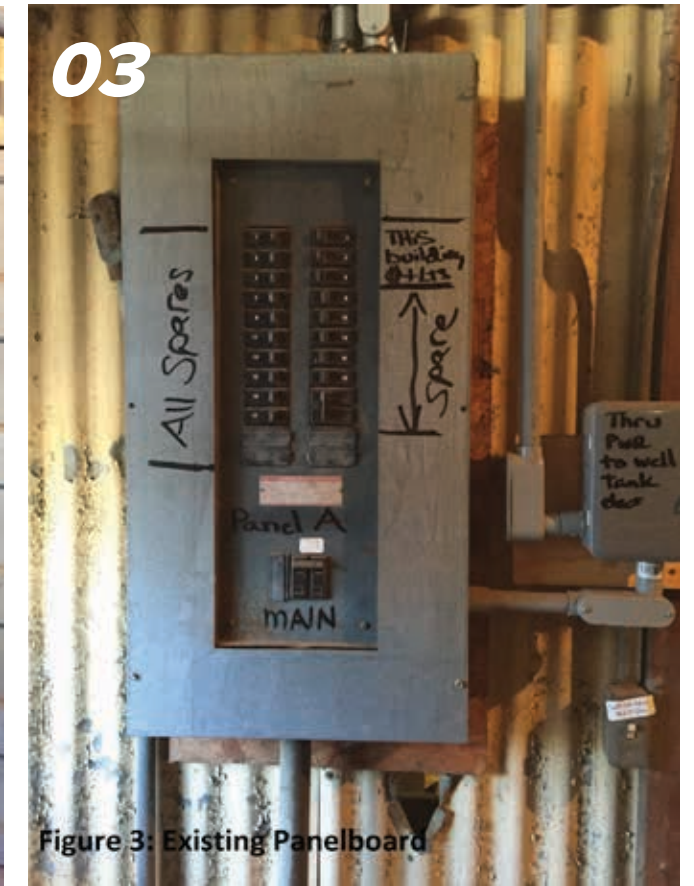
Figure 3: Existing Panelboard

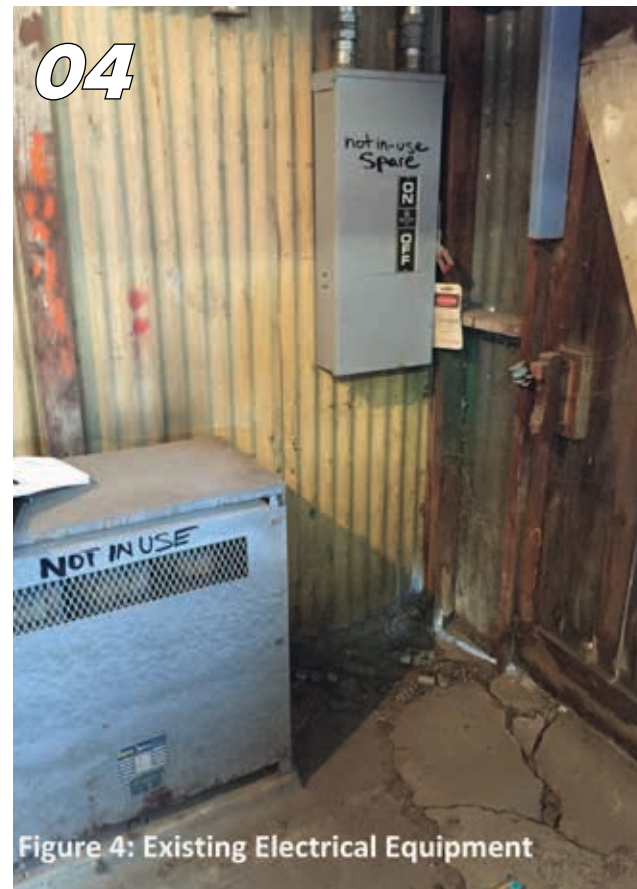
Figure 4: Existing Electrical Equipment

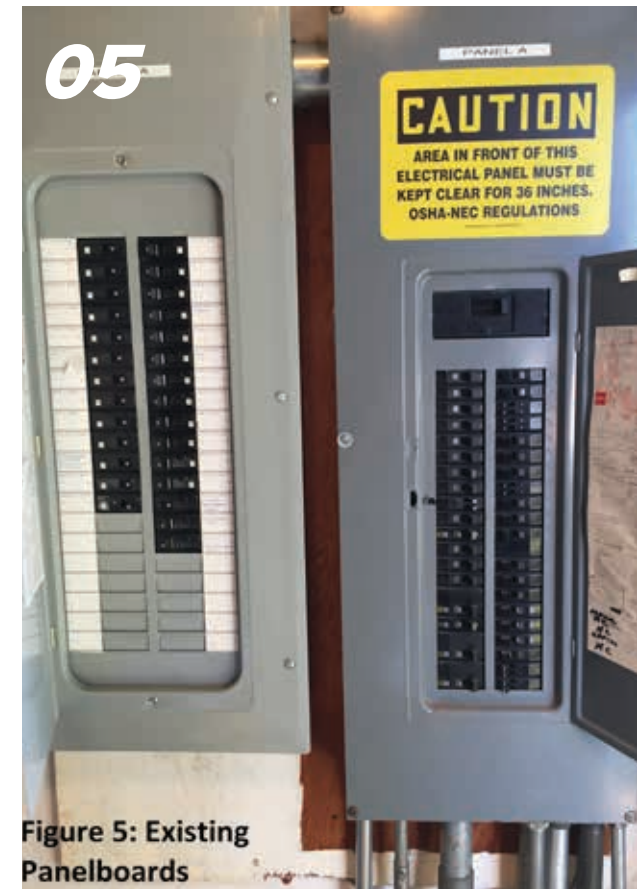
Figure 5: Existing Panelboards

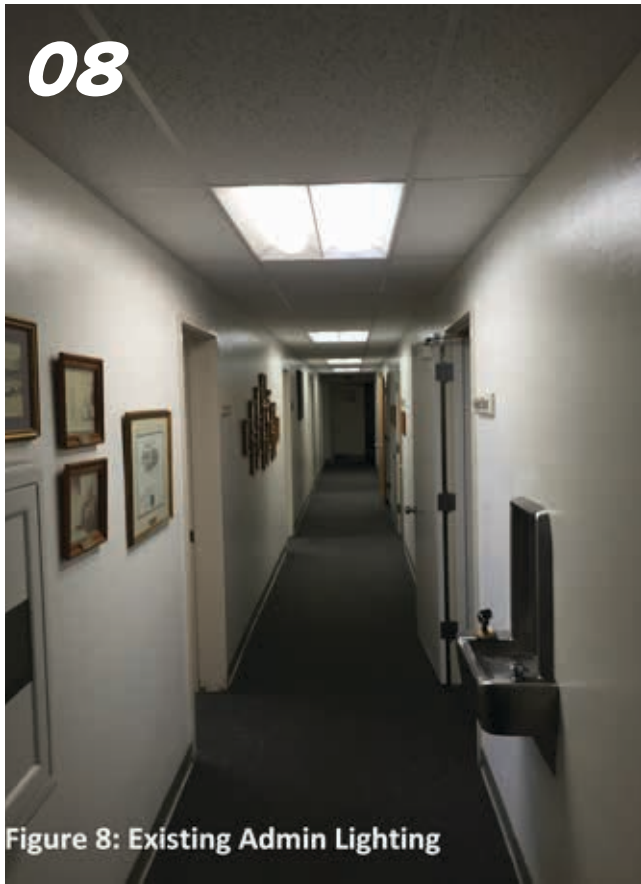
Figure 8: Existing Admin Lighting

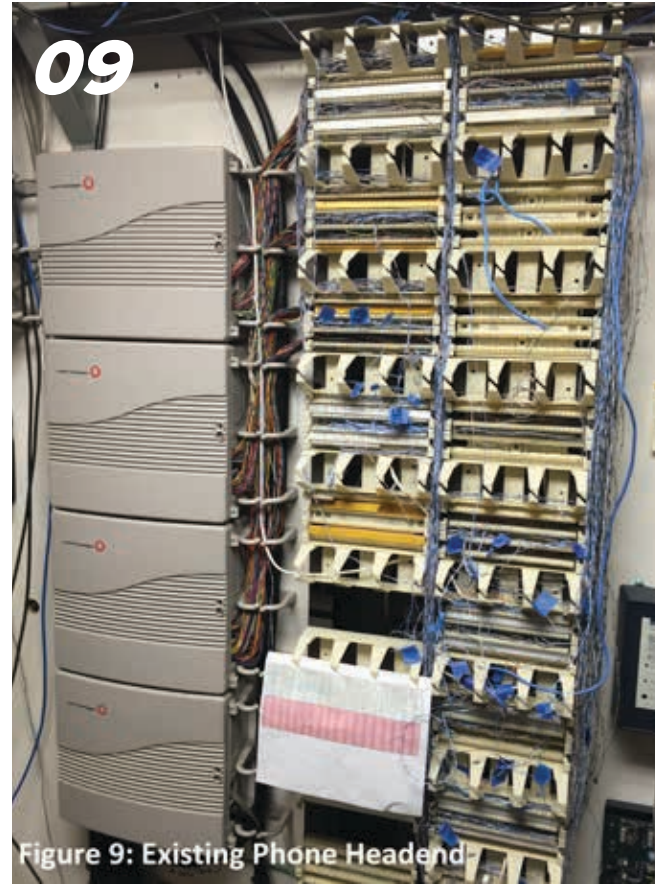
Figure 9: Existing Phone Headend

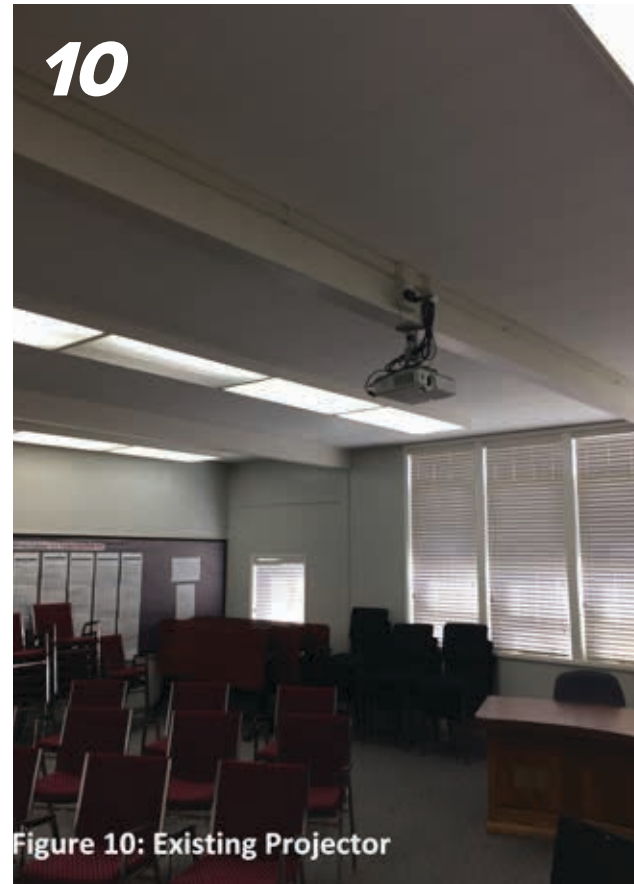
Figure 10: Existing Projector

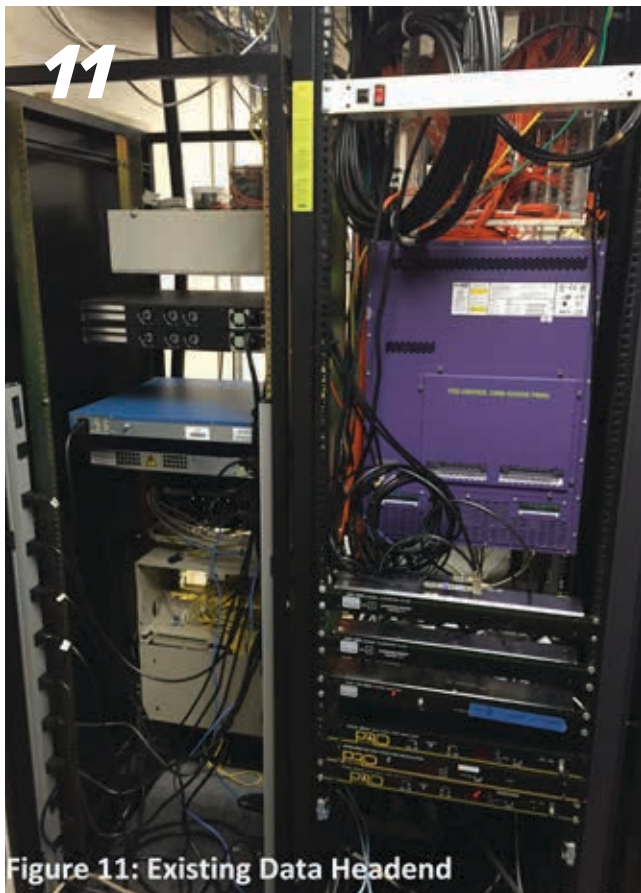
Figure 11: Existing Data Headend

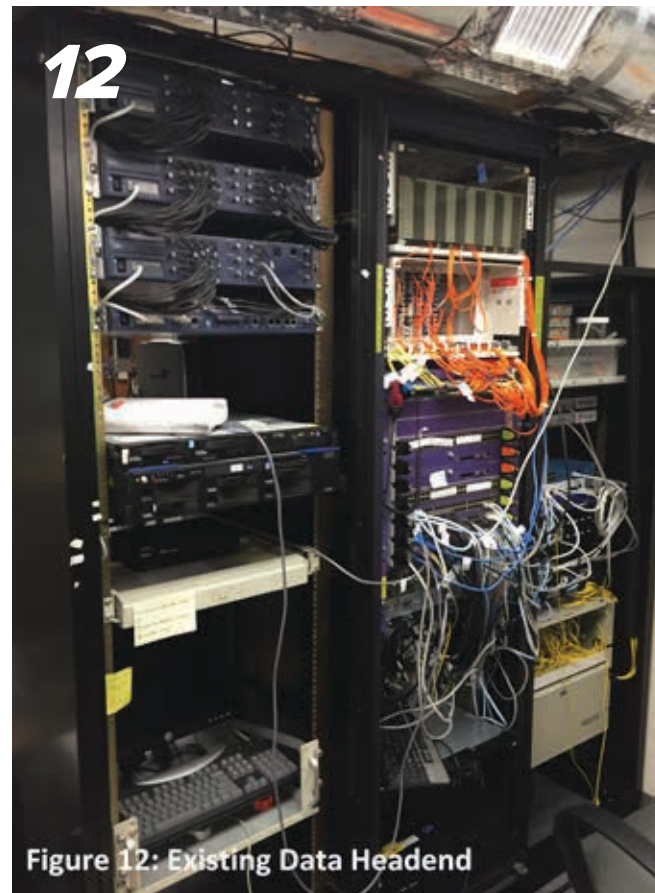
Figure 12: Existing Data Headend

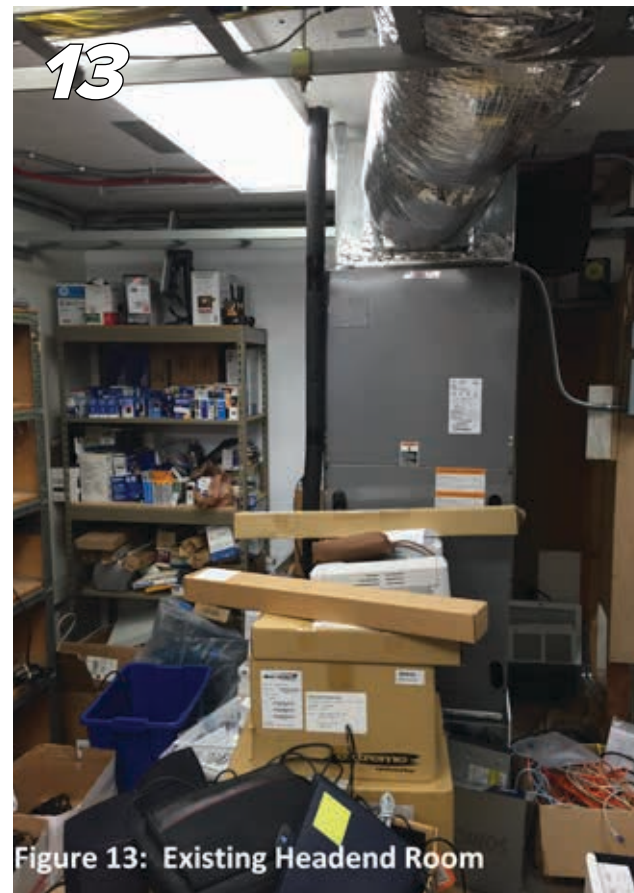
Figure 13: Existing Headend Room

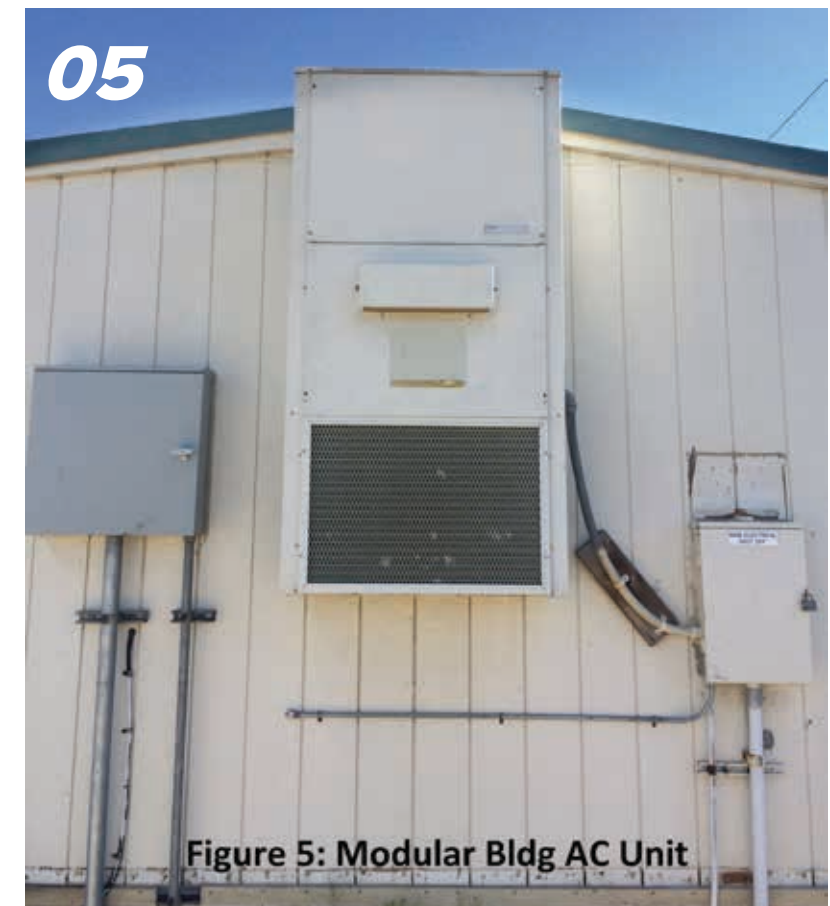
Figure 5: Modular Bldg AC Unit
