STUDY AND SURVEY
OSPI REPORT

BAINBRIDGE ISLAND
SCHOOL DISTRICT

AUGUST 2015

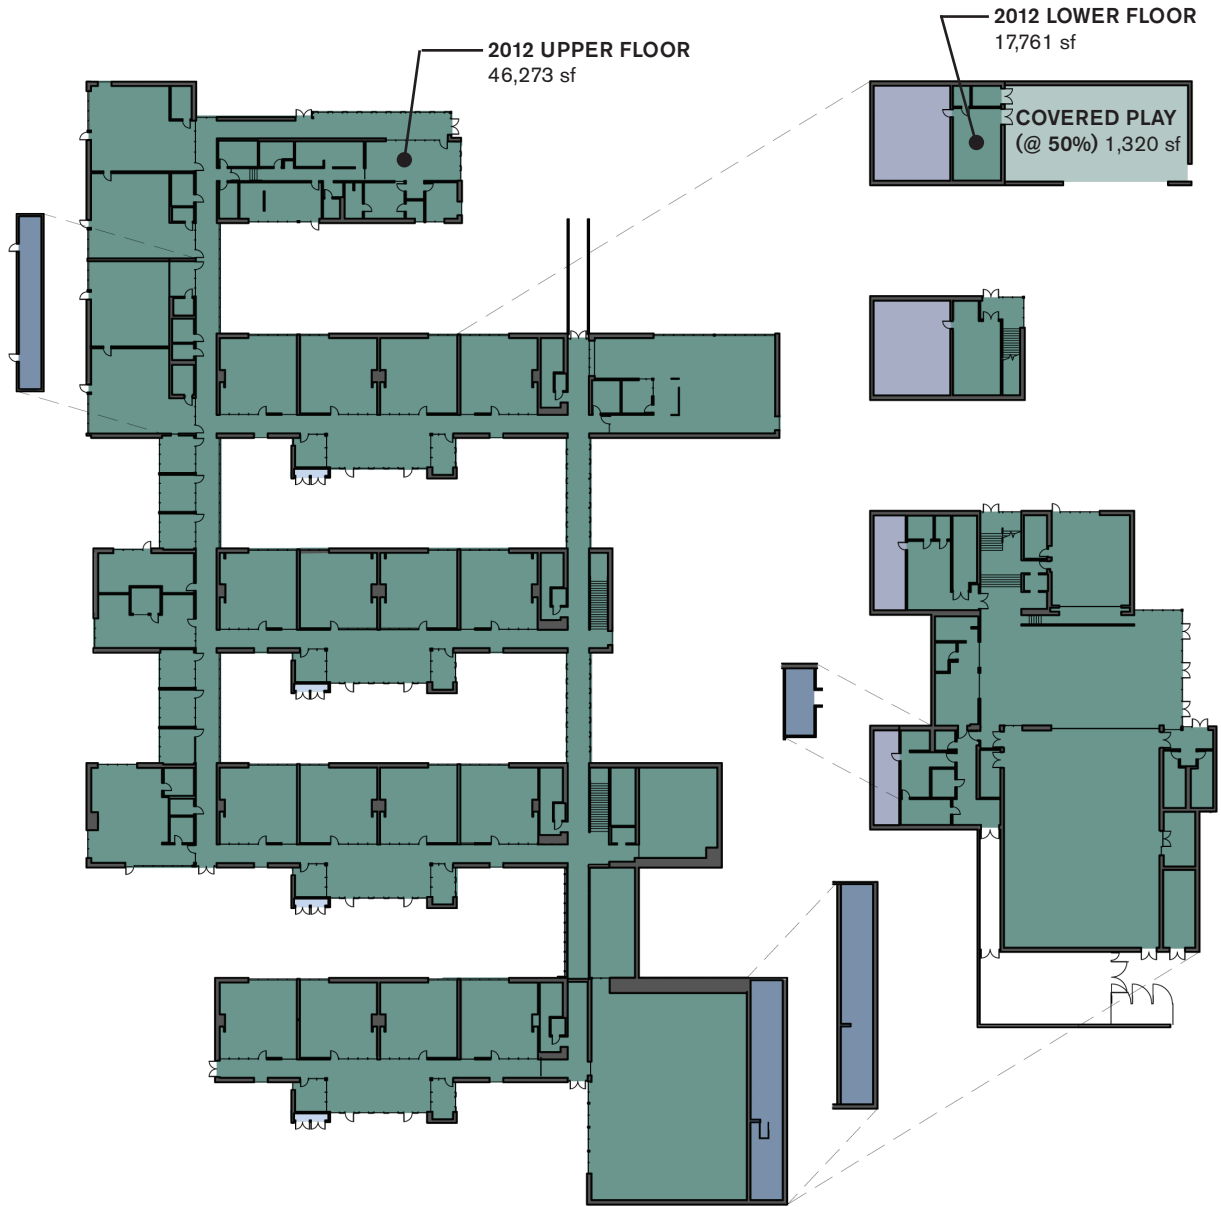
CONSTRUCTION HISTORY

- Crawlspace NIC
- Mechanical Mezzanine NIC
- Exterior Storage NIC

SQUARE FOOTAGE SUMMARY

2012		64,034 sf
2012		1,320 sf
Total SF:		65,354 sf

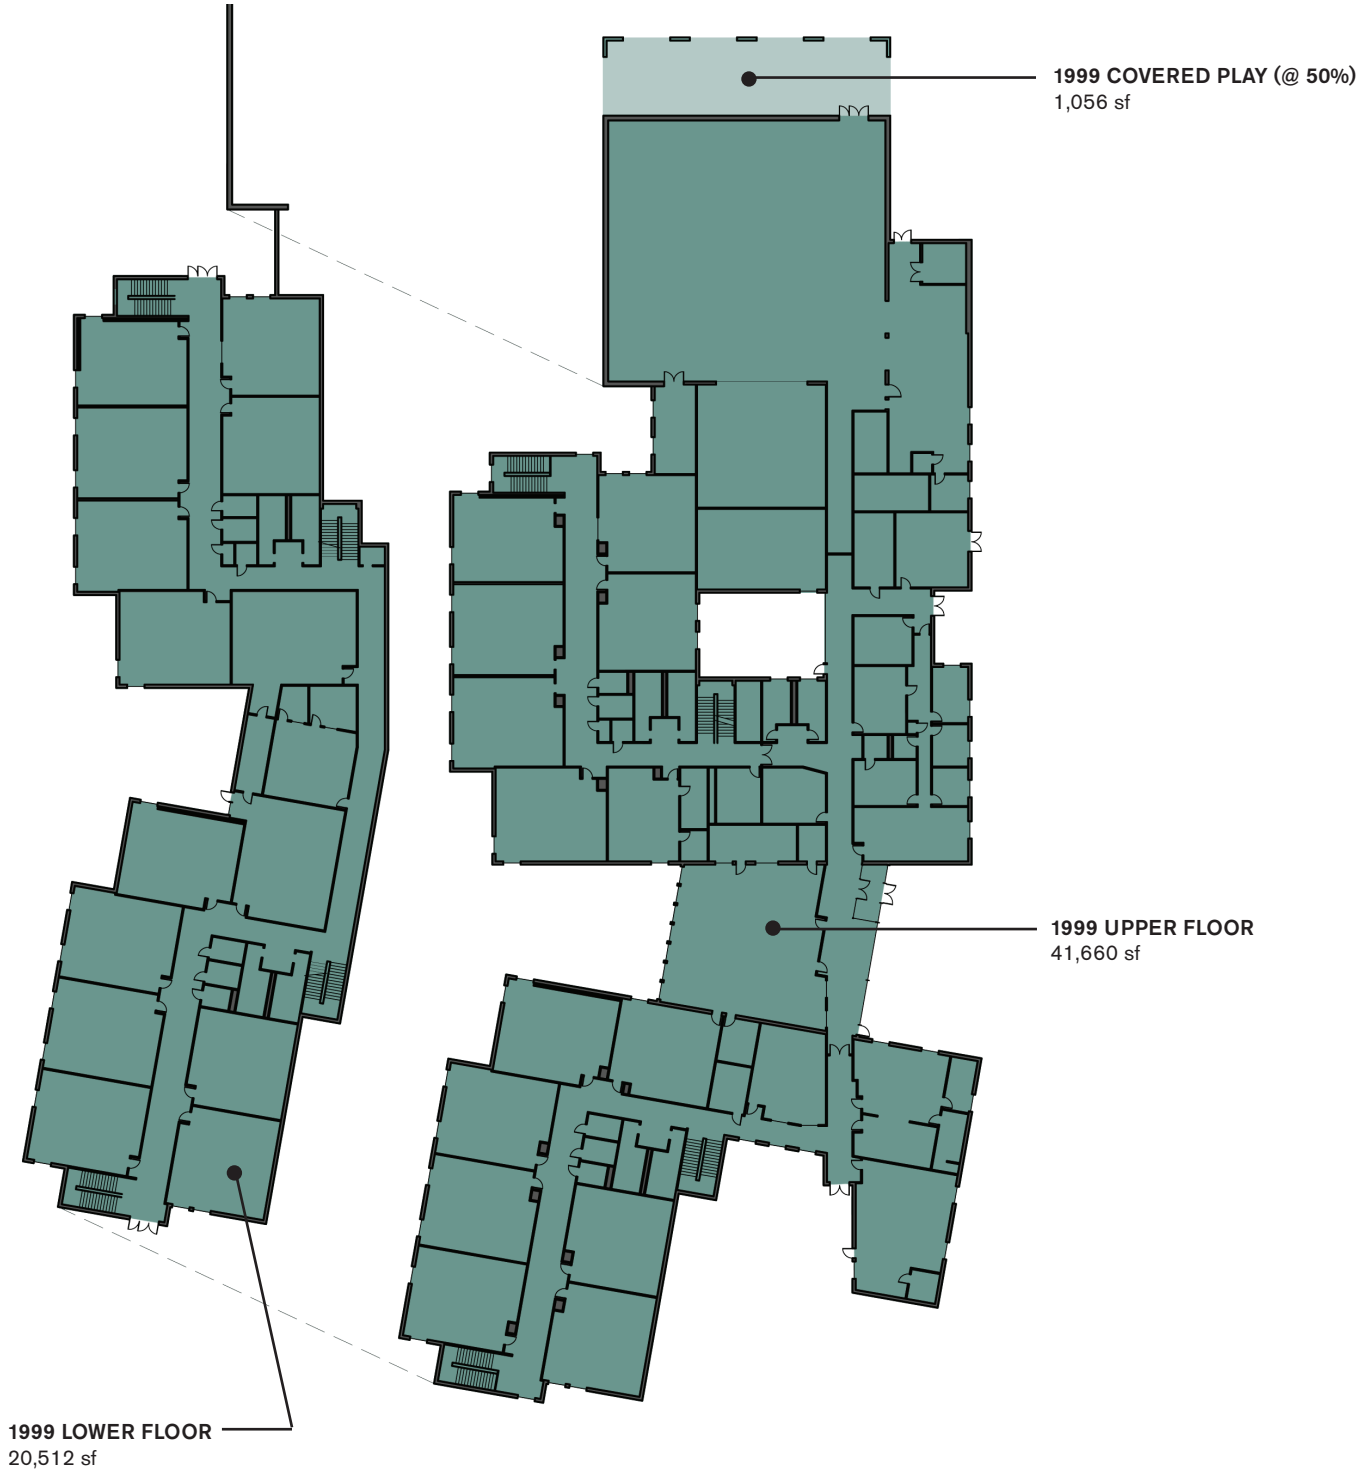
CONSTRUCTION HISTORY

SQUARE FOOTAGE SUMMARY

1999		62,172 sf
1999		1,056 sf @ 50%
Total SF:		63,228 sf
