SOWERS MIDDLE SCHOOL HUNTINGTON BEACH CITY SCHOOL DISTRICT

GEOLOGICAL AND GEOTECHNICAL CONSIDERATIONS WITH SCHOOL MODERNIZATION

May 25, 2021

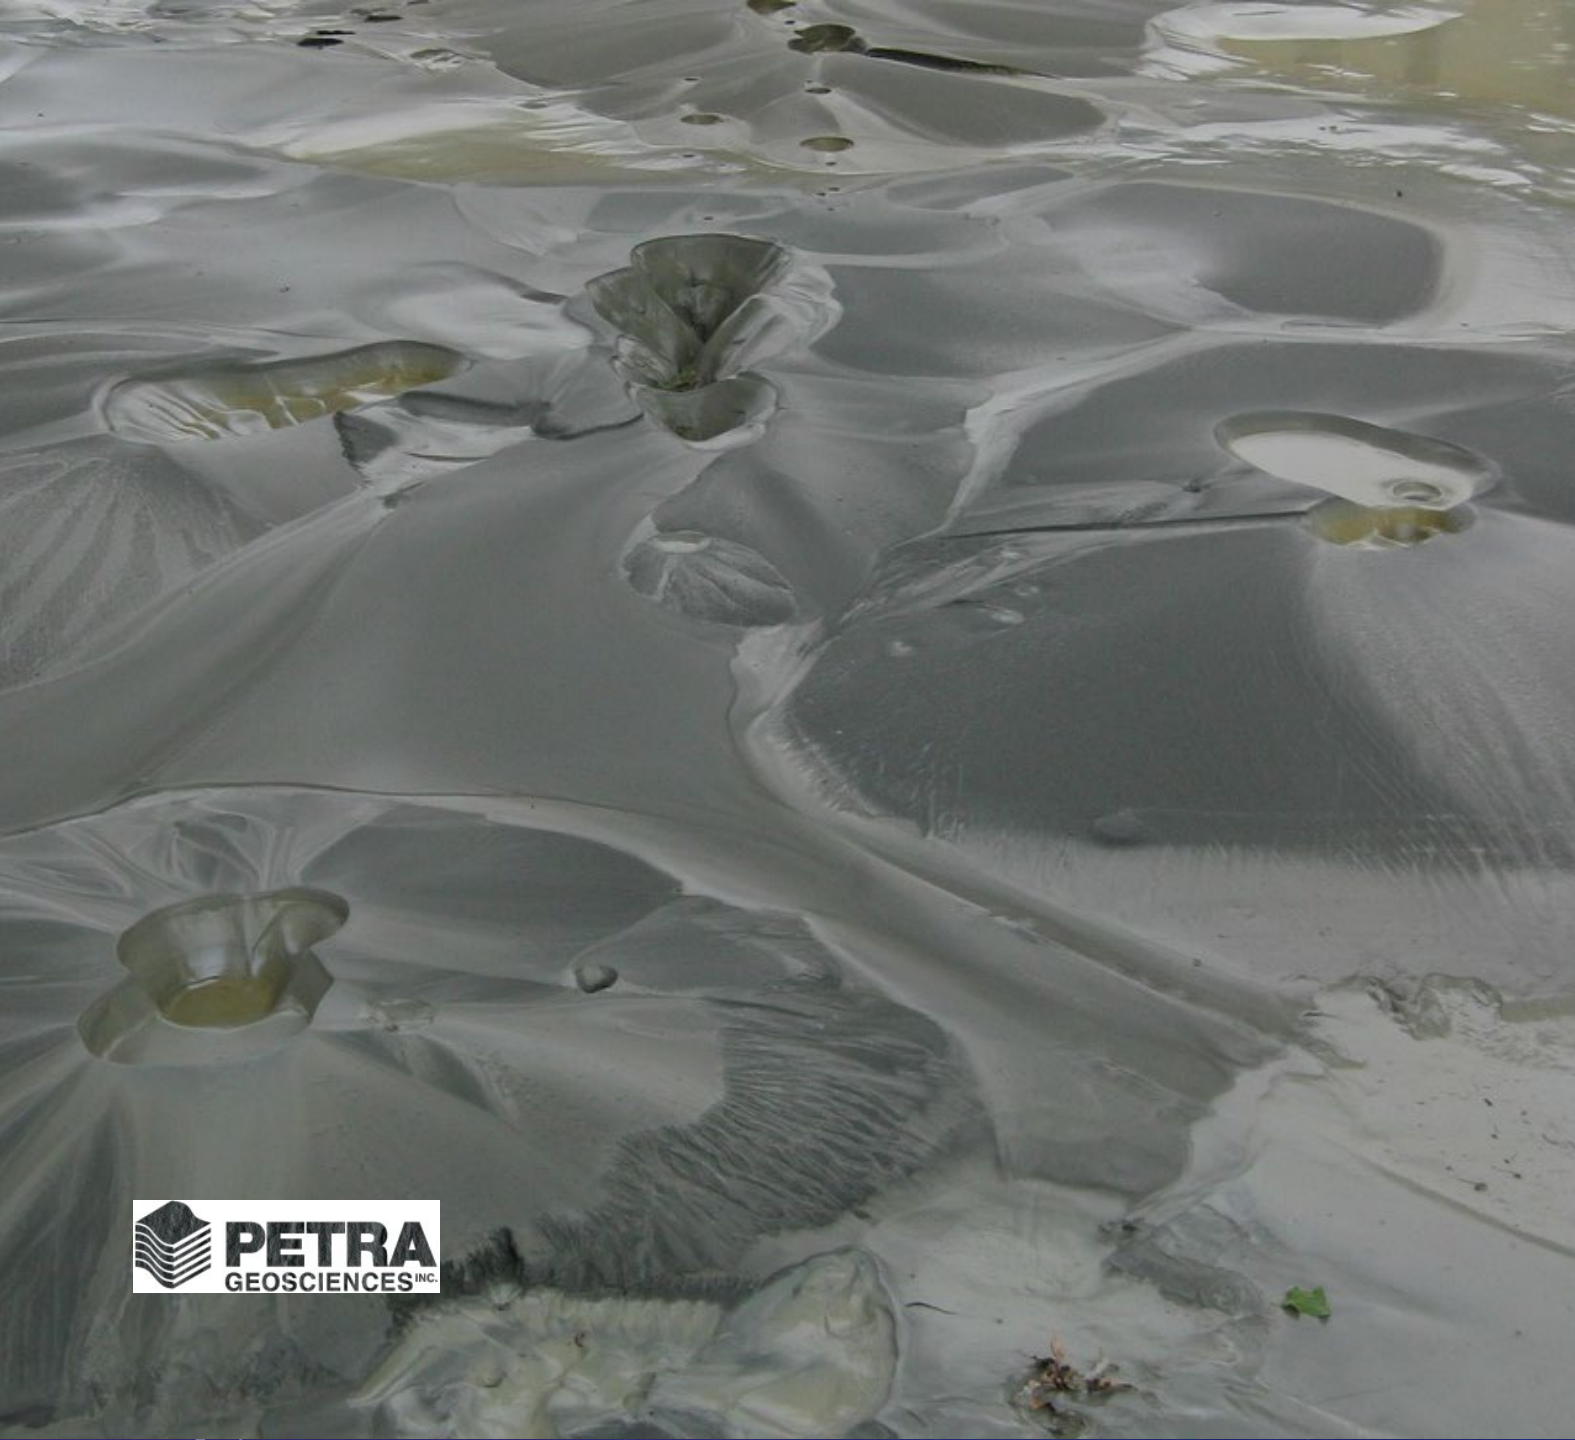
LIQUEFACTION HAZARD

Figure 4.68: Aerial view of liquefaction manifestation at the Blenheim Rowing Club looking east (18 Nov 2016, approx. centre of image: S41.4883, E174.0096, Marlborough Regional Council, 2016).

- Groundwater pressures build up during strong earthquake shaking. Soil grain to grain contact is lost. This causes the ground to turn from a solid to a semi-liquid state.
- Photo showing ground cracks and sand ejected from liquefaction in a New Zealand Earthquake in 2016.
- Reference: Geotechnical Reconnaissance of the 2016 Mw7.8 Kaikoura, New Zealand Earthquake, Cubrinovski & Bray, Editors, {GEER (2017)}

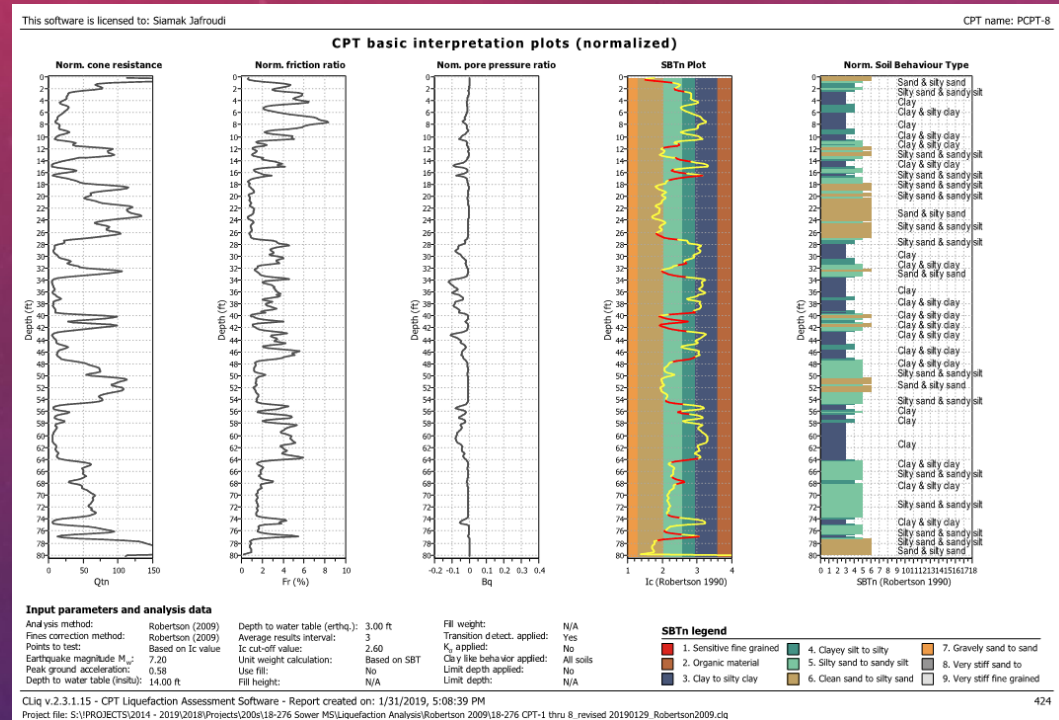
TYPICAL SOIL PROFILE

LIQUEFACTION ANALYSIS EXAMPLE FROM GYM/STEM PROJECT

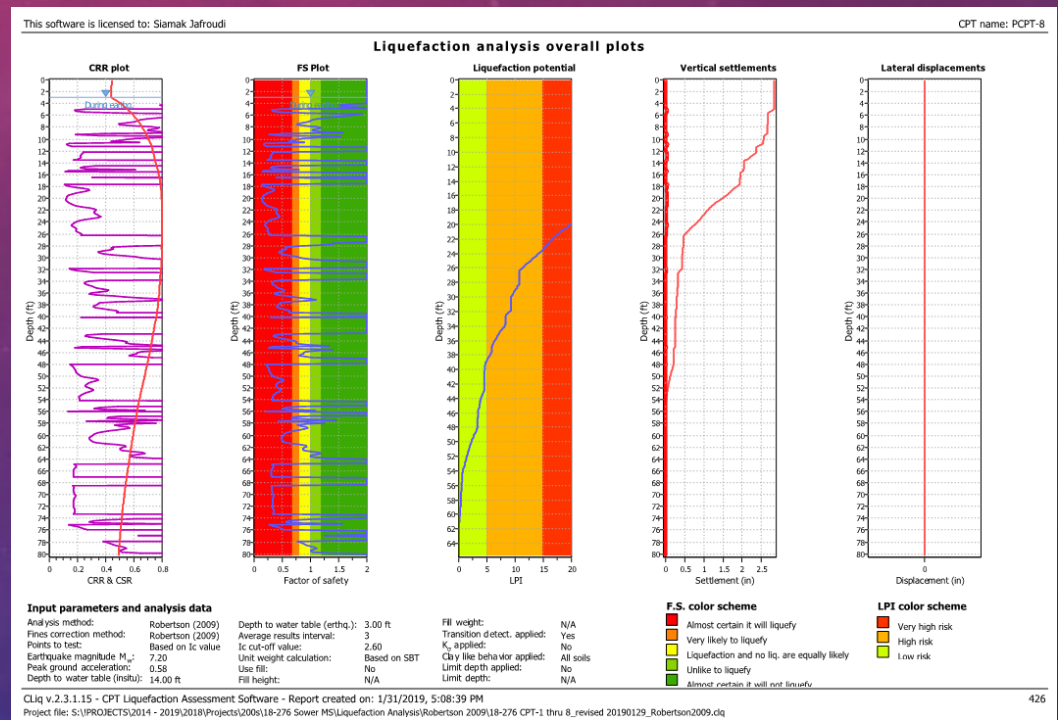
TYPICAL LIQUEFACTION ANALYSIS

Most damaging liquefaction concentrated approximately in the upper 25 to 30 feet of site profile.

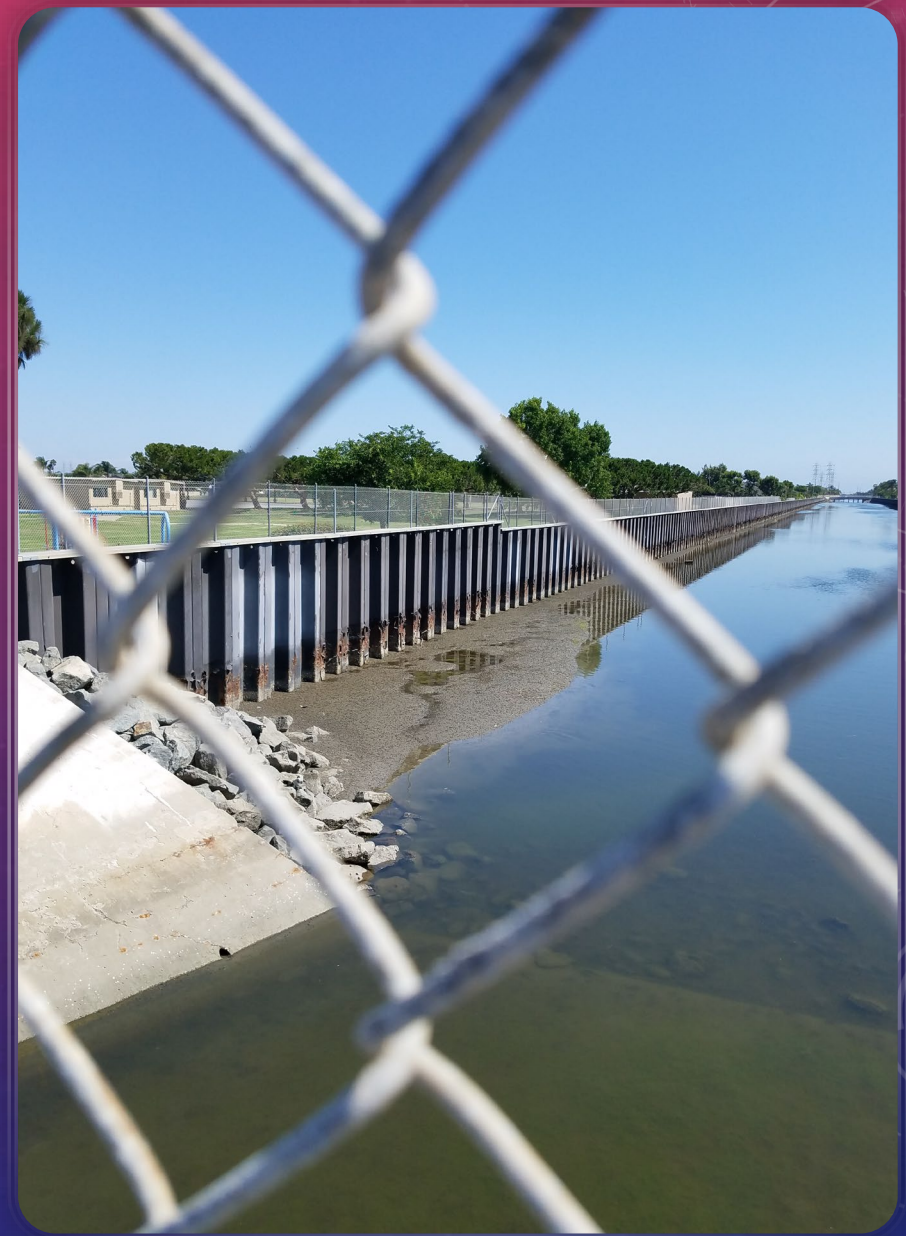
LATERAL SPREADING

Sheet pile lined canal likely inhibits lateral spreading at the site.

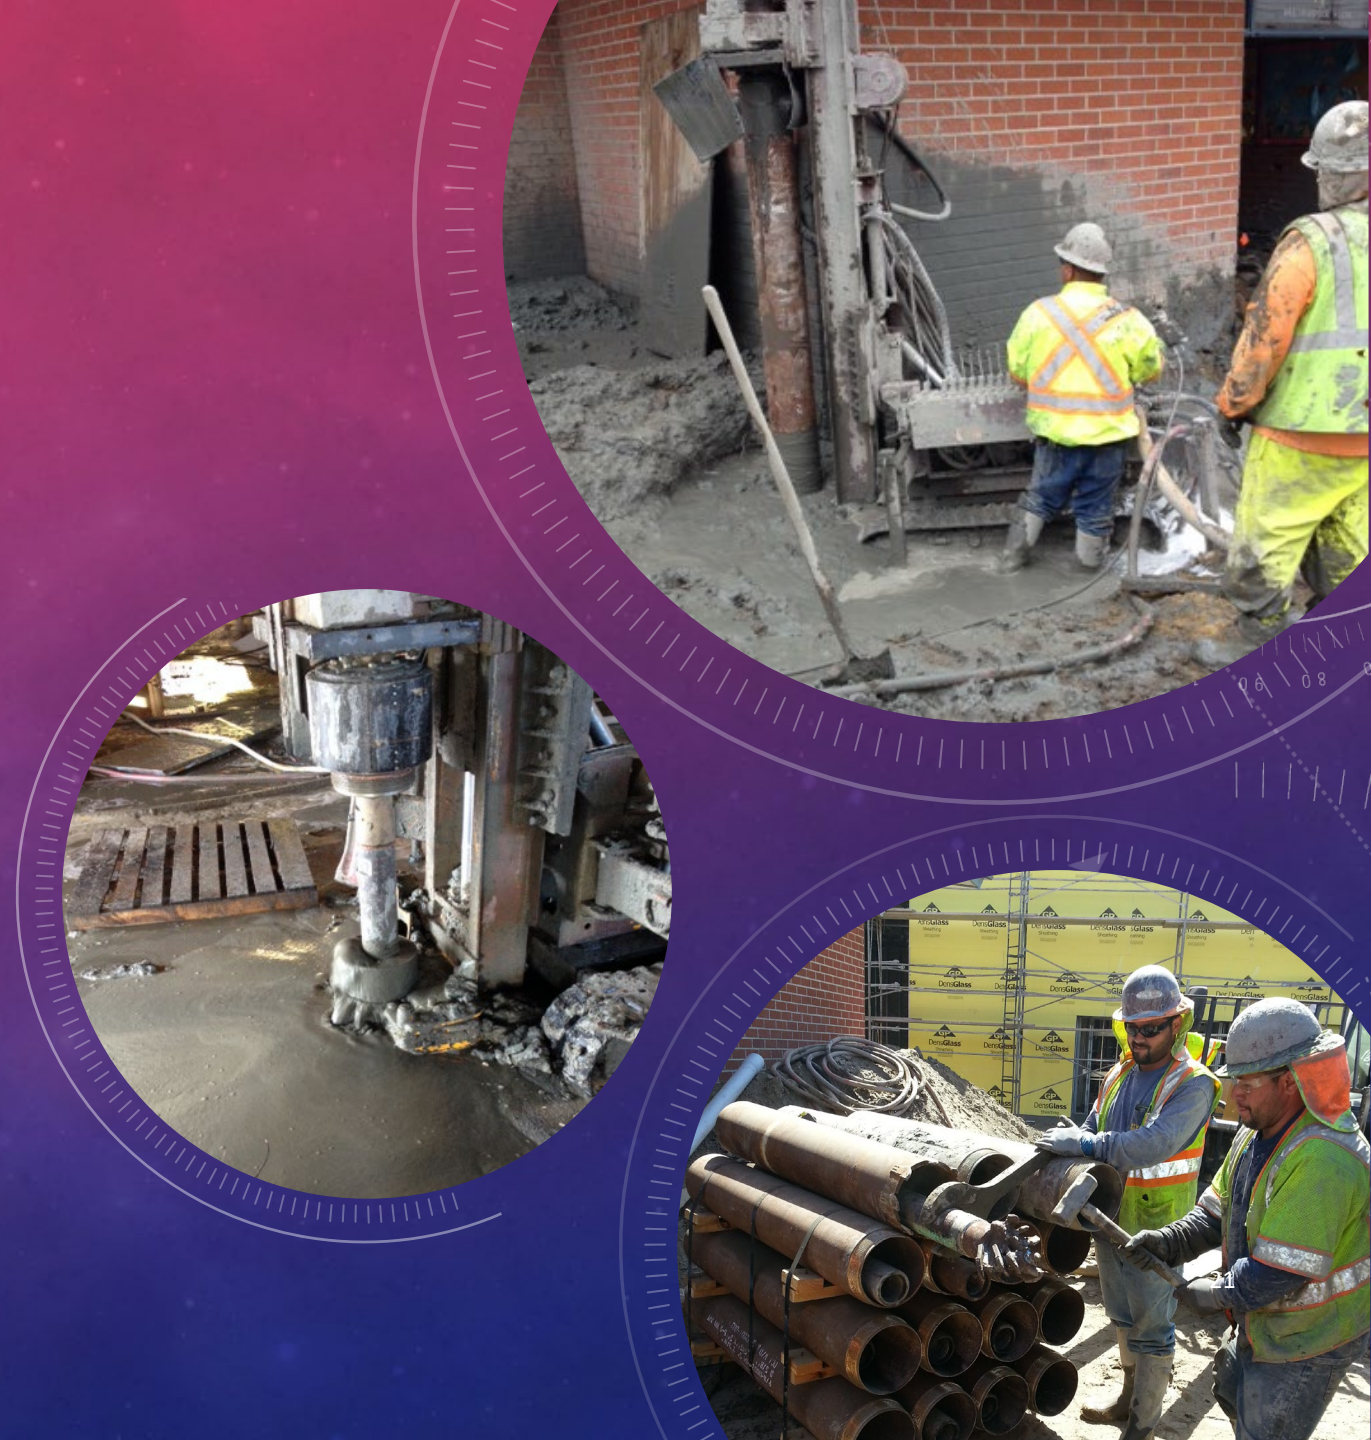
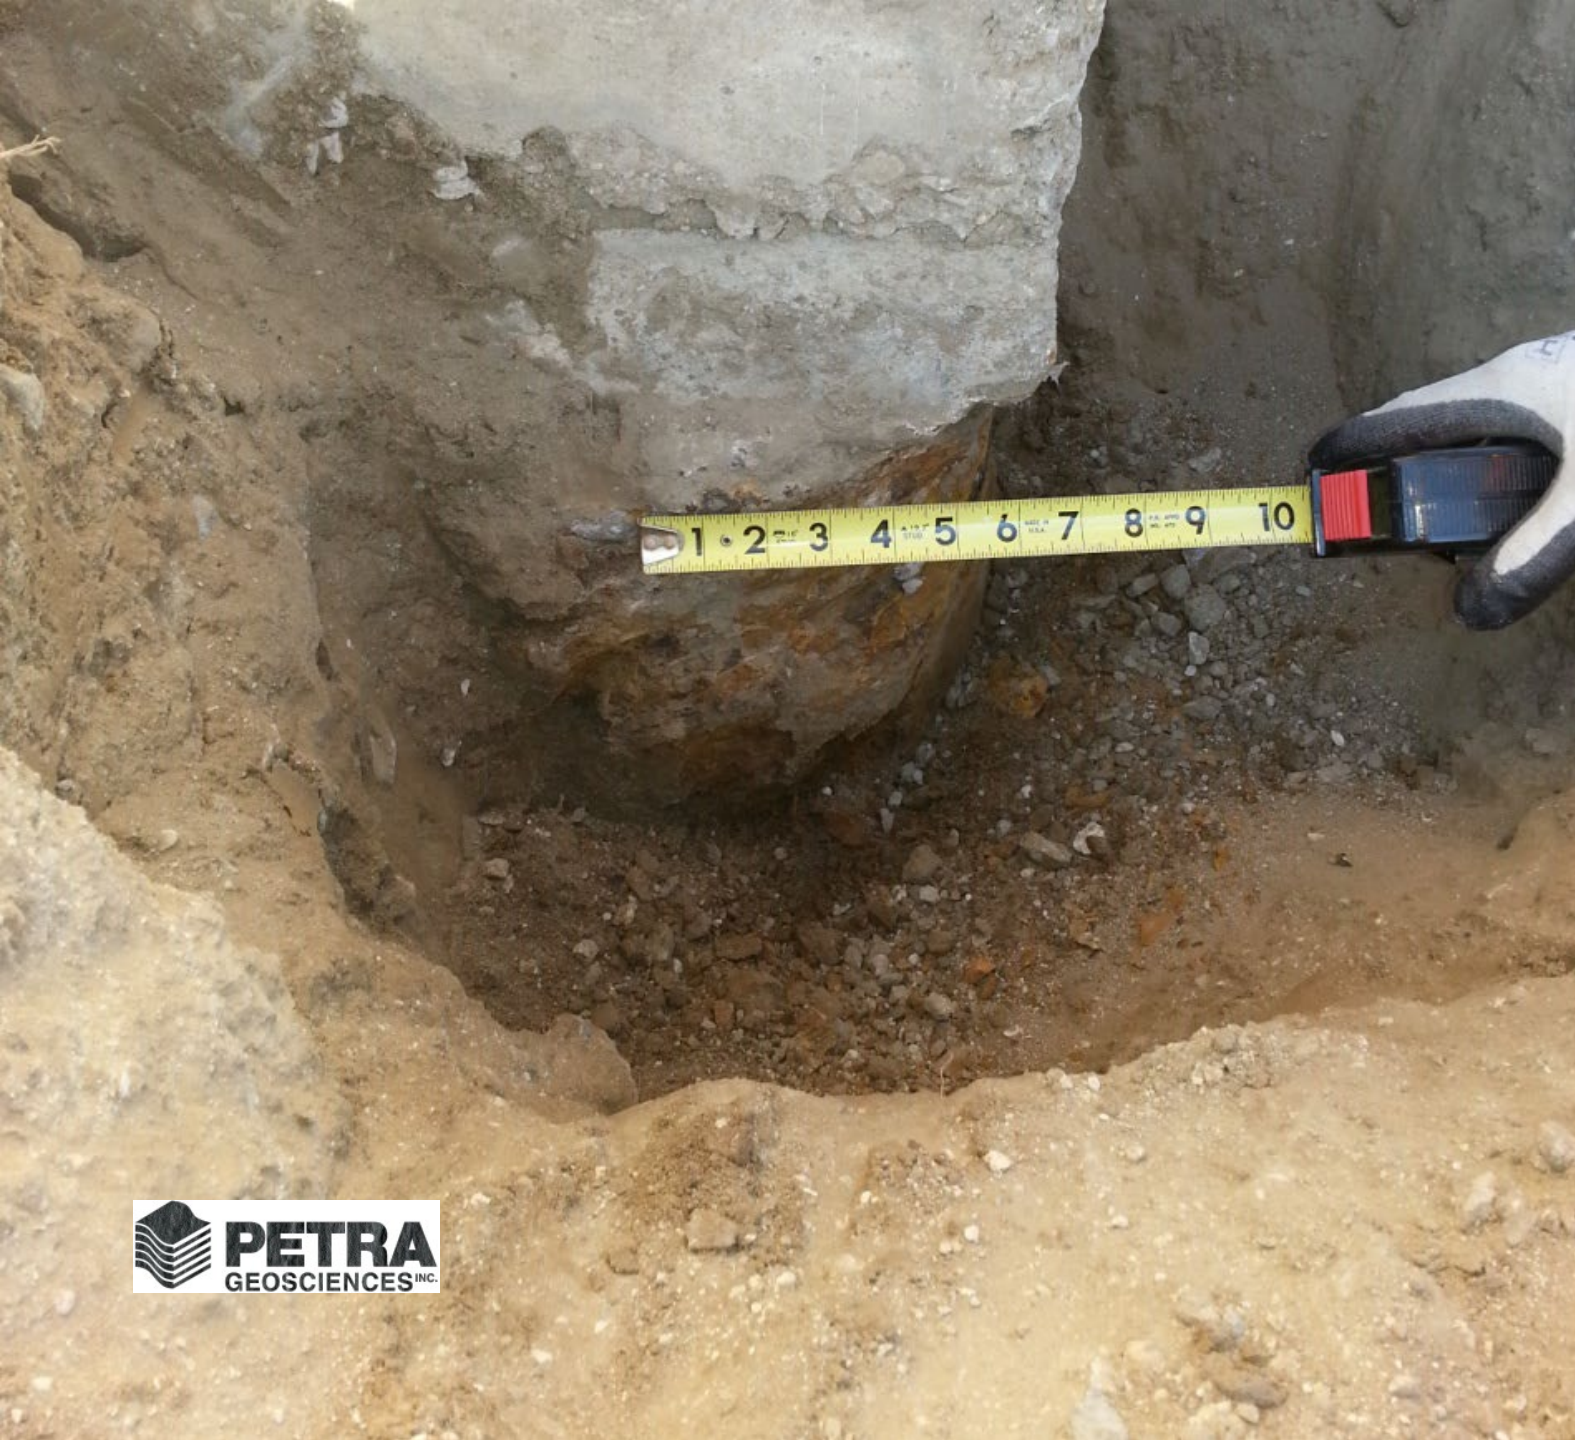
MICROPILE INSTALLATION AT WARNER MS – WESTMINSTER SD

- Micropiles were installed at Warner MS to underpin an existing building to mitigate liquefaction hazards.
- Upgrade was part of AB 300 program.
- The micropiles were 244 mm (9-5/8 inch) diameter.
- Installed through predominately silty and clayey strata with intermittent sand lenses and drilled to a gravel layer approximately 21.3 m (70 ft) below the ground surface.
- The regulatory agency (DSA) required that verification tests be conducted under combined lateral and axial loading.

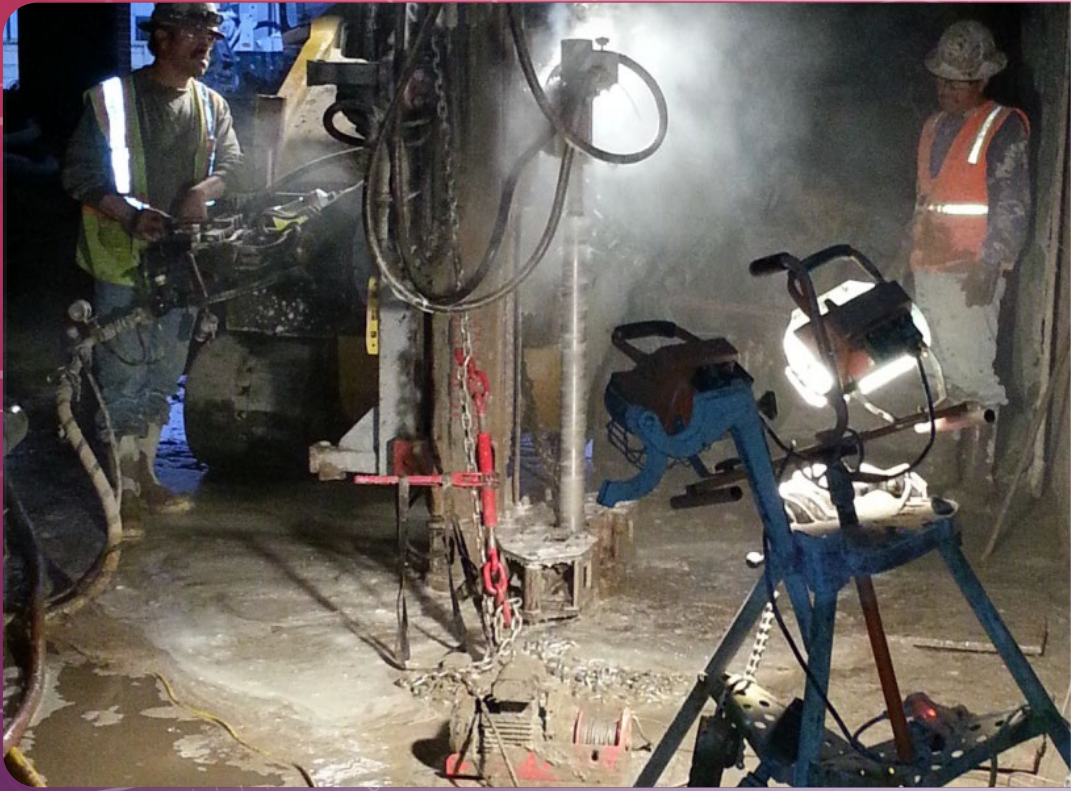
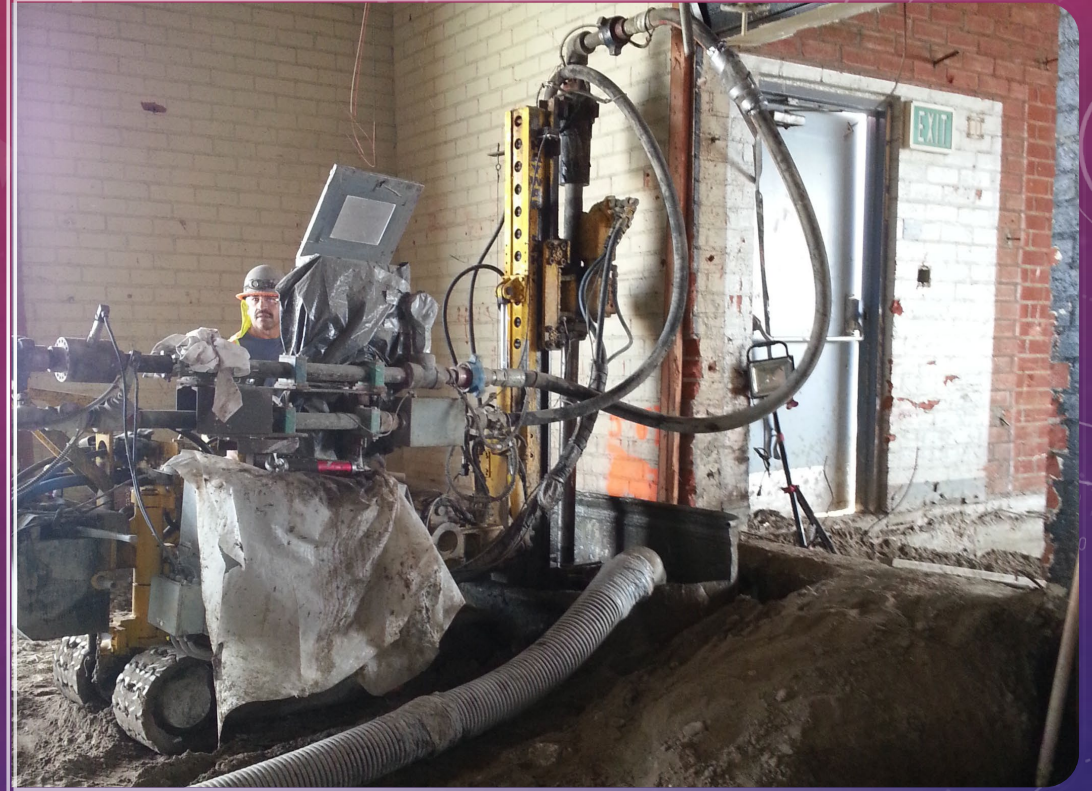
JET GROUT CONSTRUCTION

CONSTRUCTION OF JET GROUT ENCASUREMENT WITH LIMITED ACCESS RIG.

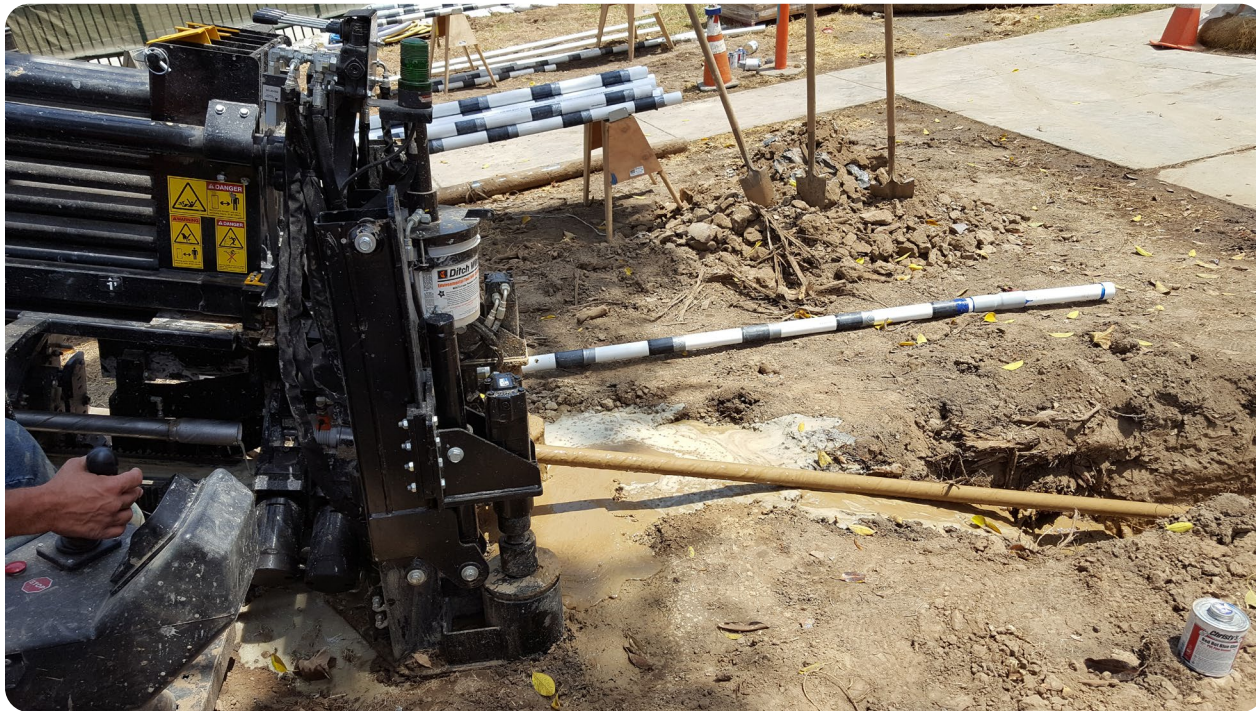
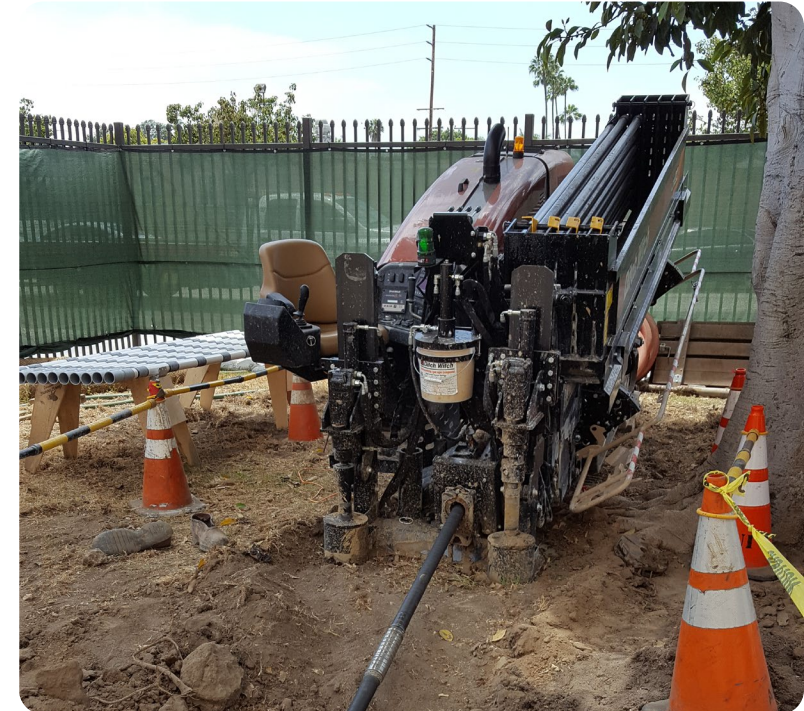
HORIZONTAL DRILLING TO INSTALL PERMEATION GROUTING LIQUEFACTION MITIGATION

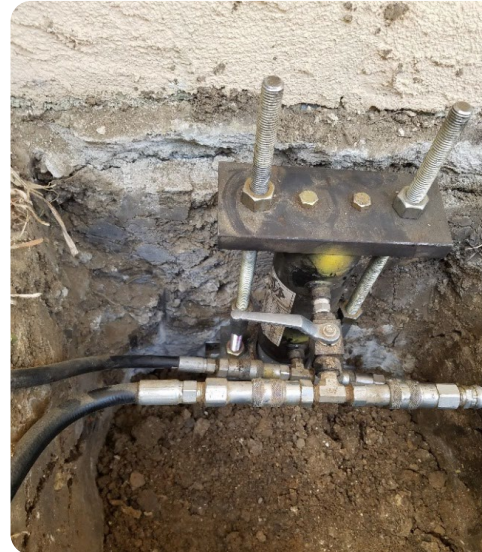
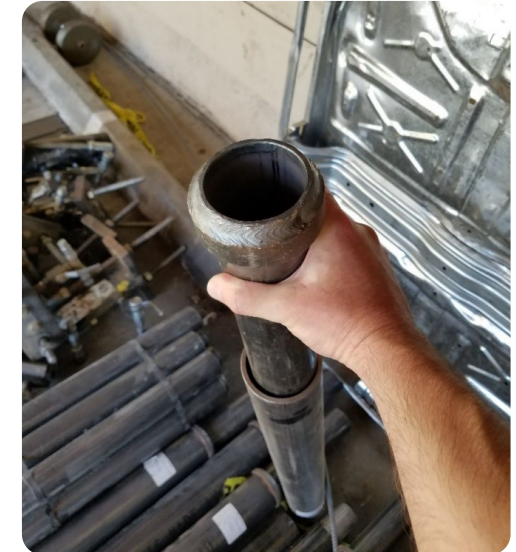
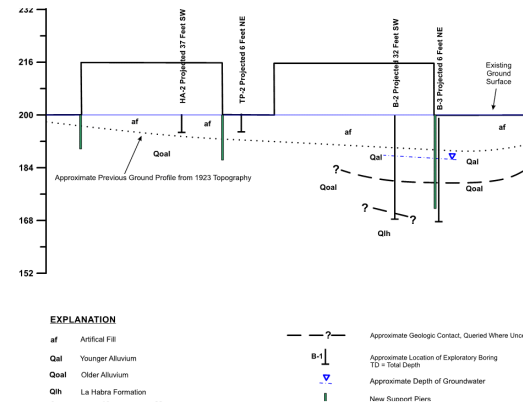
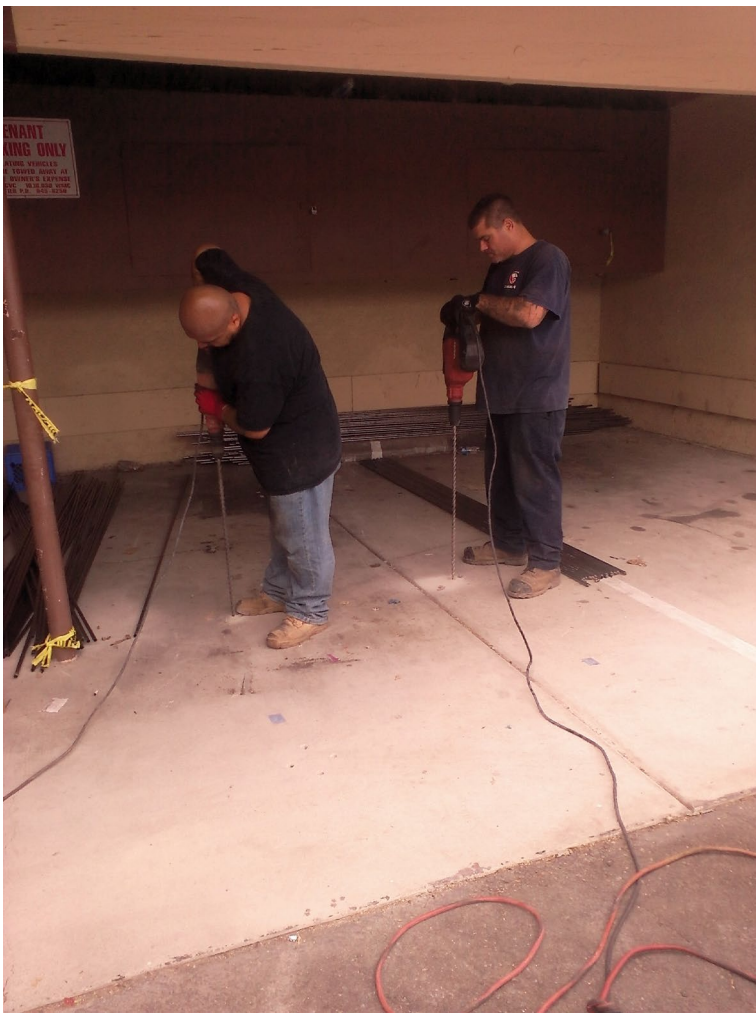
DISTRESSED APARTMENT COMPLEX PROJECT IN WHITTIER

- Distress caused by fill settlement, expansive soils, and liquefaction during the 1987 Whittier Narrows Earthquake.
- Rehabilitated with Jacked Push Piers and Foam Injection

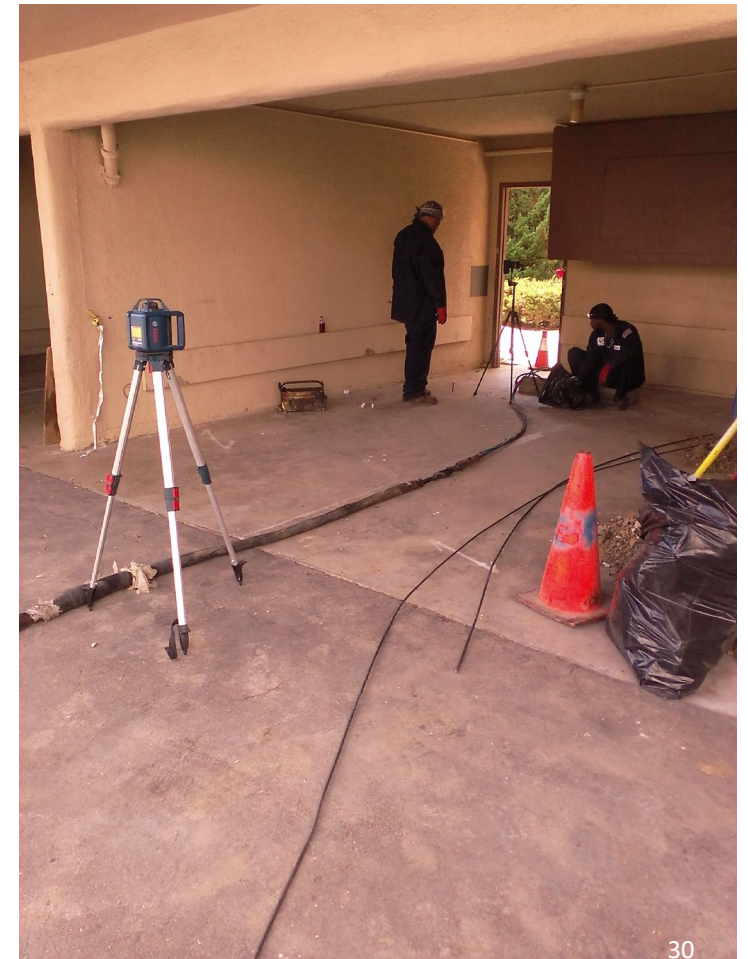
Foam Injection is a less intrusive process only requiring 5/8-inch diameter holes drilled through existing slabs.

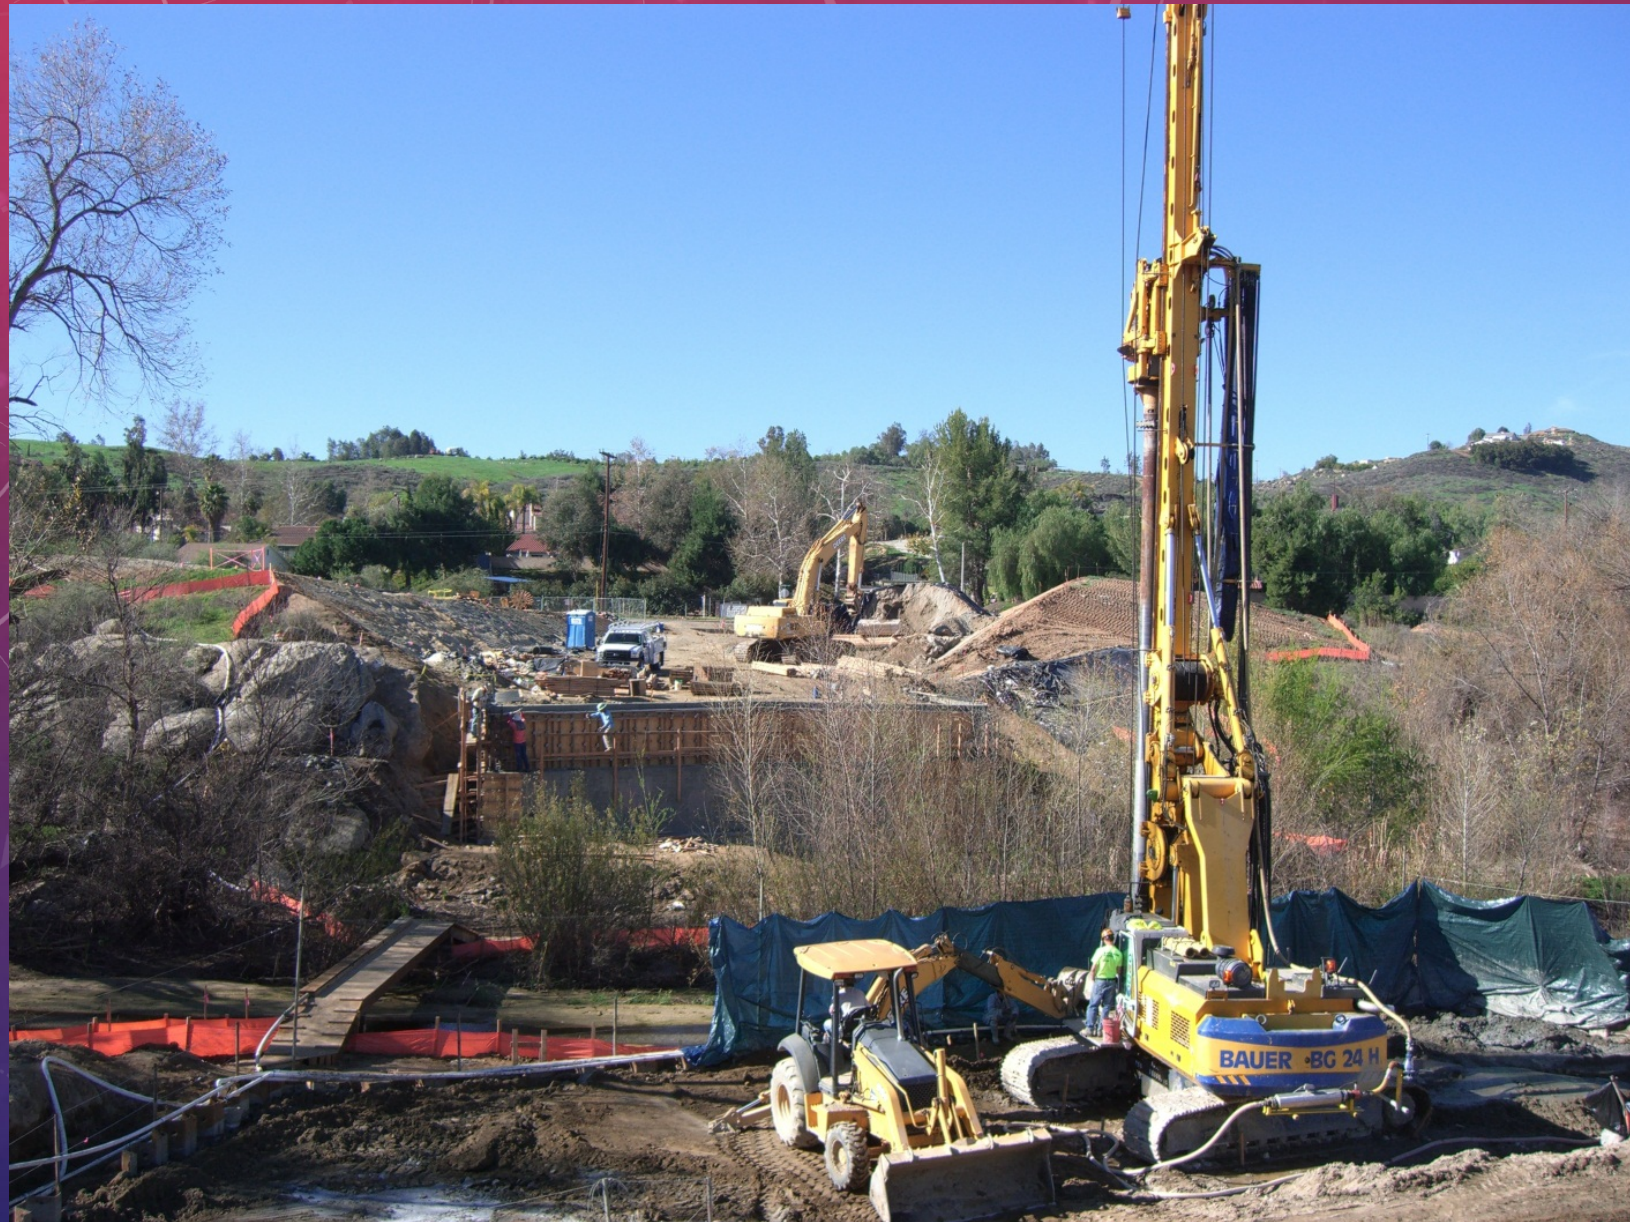
DEEP SOIL MIXING FOR BRIDGE ABUTMENT

GROUND IMPROVEMENT PROGRAM FOR BRIDGE PROJECT IN RIVERSIDE

LIQUEFACTION AND SCOUR MITIGATION OF NORTH ABUTMENT DOWN TO 50 FEET, SUBSTANTIAL IMPROVEMENT IN BEARING CAPACITY
