Long Range Facility Audit 2009-2019

Clovis Unified School District • August 2009

Fancher Creek Elementary School

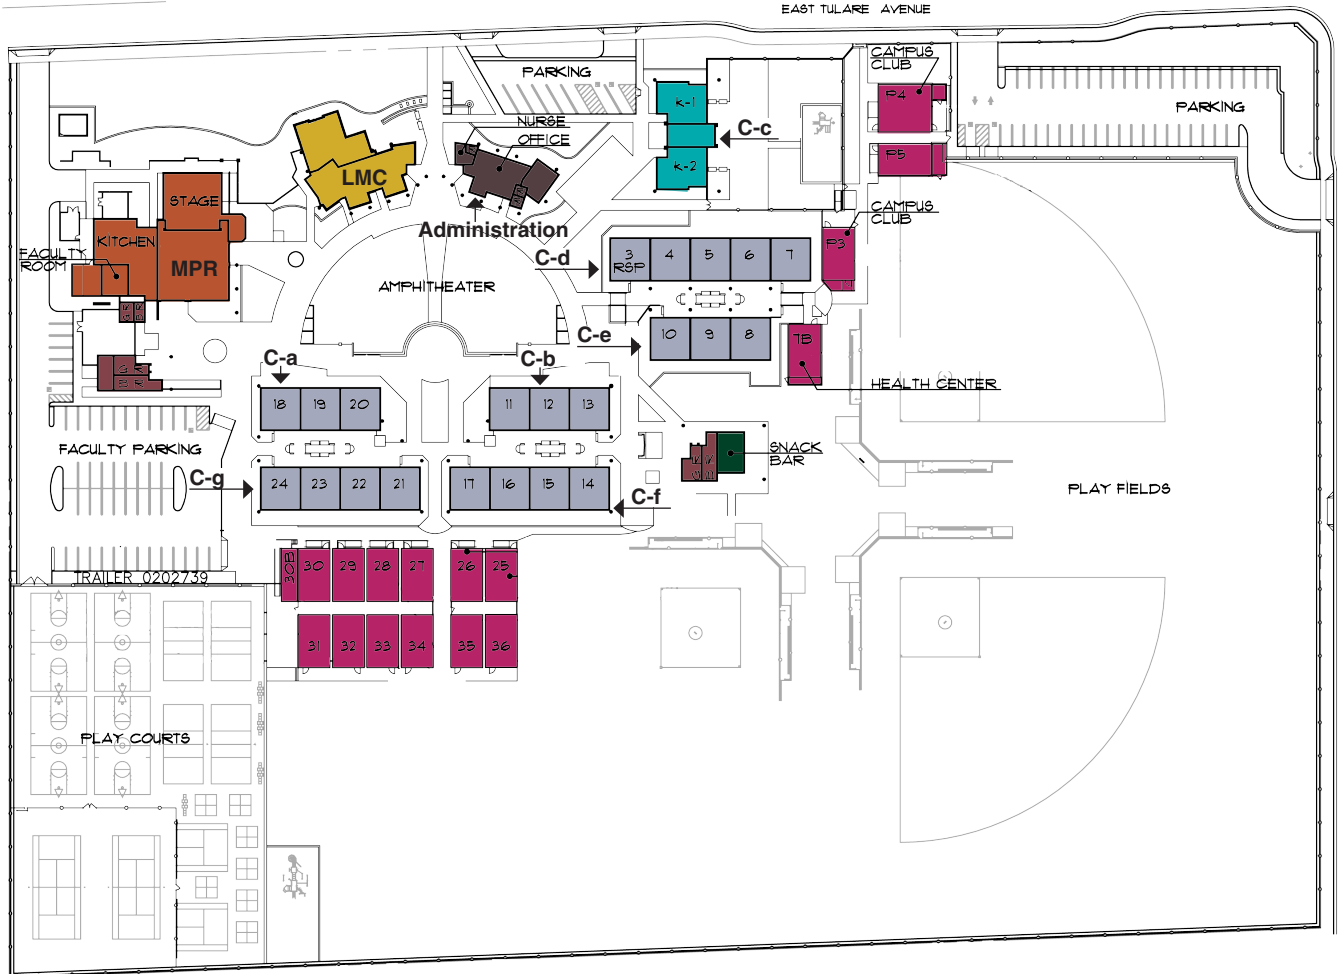
Site Plan

Observations: The concrete condition is good. There are locations of minor cracking and trip hazards. The curb ramps do not meet ADA requirements. The accessible stall signage and striping require minor changes. ADA detectable warning surface is required in various locations. Walk gates do not meet ADA requirements. Some drinking fountains do not meet ADA requirements.

Observations: The storm drain system is in good working condition, but there is evidence of standing water between the portables and in the playfields at the backstops.

Recommendations: Reconstruct concrete improvements to eliminate trip hazards and comply with ADA curb ramp requirements. • Add accessible stall signage and striping as required. • Add ADA detectable warning surface at various locations. • Replace walk gates with ADA compliant gate hardware. • Replace drinking fountains with ADA compliant drinking fountains.

Recommendations: Reconstruct concrete improvements where slope can be improved. • Add additional storm drain inlets to prevent standing water.
