Pre-Feasibility Study

Fuller Middle School and Farley Building
Framingham Public Schools

Framingham, Massachusetts

February 27, 2013

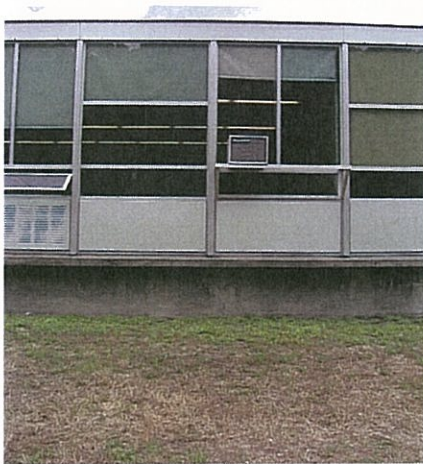
Typical storefront

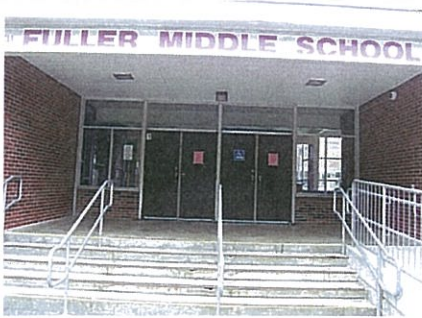
The doors are operational and in serviceable conditions. The surfaces of many doors show distortion or impact damage. Some doors need final adjustment.

Typical entry doors

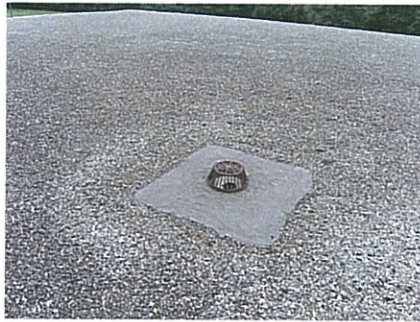
Drain at gym roof

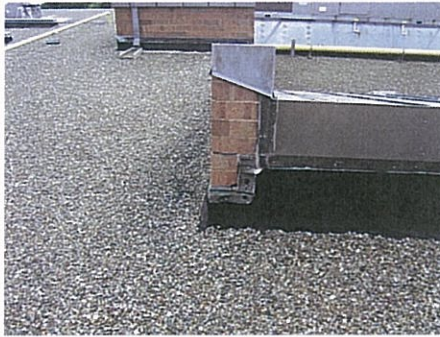
Flashing repairs supported and identified

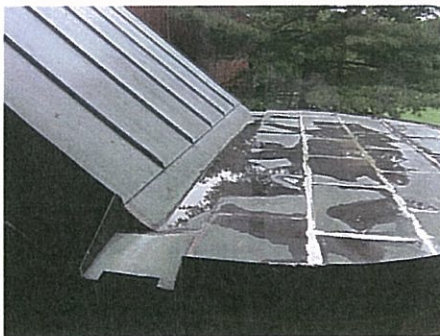
Condition of pool area roof – typical
