MILL VALLEY SCHOOL DISTRICT FACILITIES ASSESSMENT 2018

MILL VALLEY MIDDLE SCHOOL

FACILITY CONDITION ASSESSMENT

Mill Valley Middle School
425 Sycamore Avenue
Mill Valley, California 94941

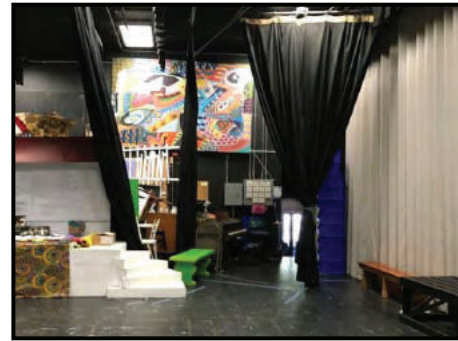
**PHOTO - 3
GYM STAGE**

The Gym stage has become the de facto space for music and drama programs

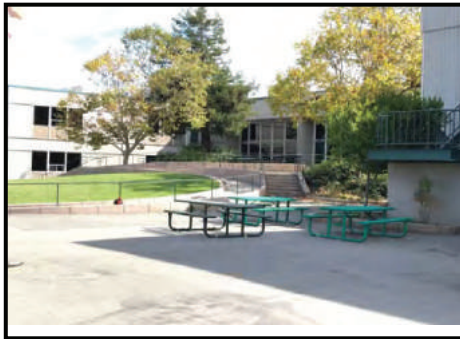
**PHOTO - 5
OUTDOOR AREA**

The outdoor area has few permanent shade structures

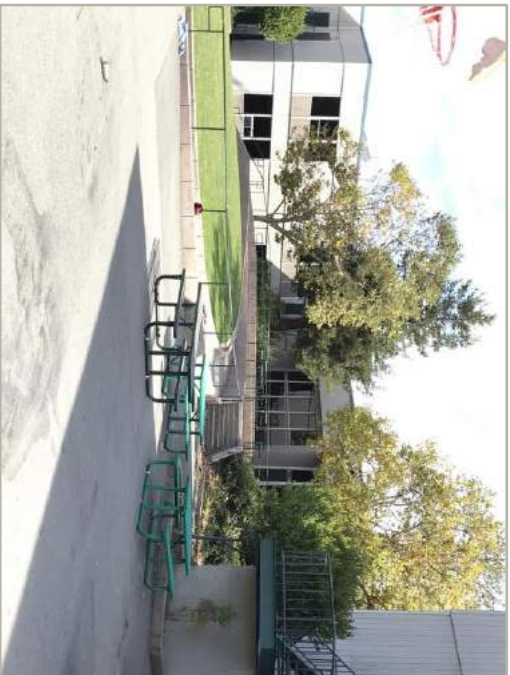
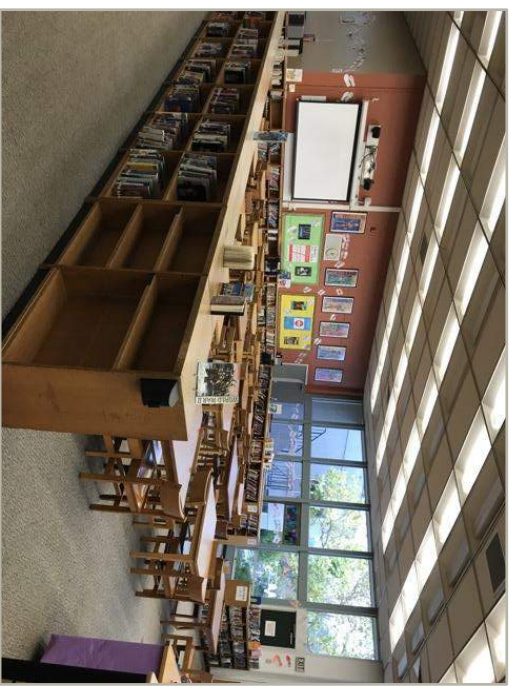
2. Main Building Summary

Main Building Information		
Address	425 Sycamore Avenue, Mill Valley, CA	
Constructed/ Renovated	1972/1996	
Building Size	91,875 SF	
Number of Stories	Two	
System	Description	Condition
Structure	Sections of the building are steel framed, other sections use load bearing cast in place concrete both areas have concrete-topped metal decks	Fair
Facade	Painted T-111 with aluminum windows	Fair
Roof	Primary: Flat construction with modified bituminous finish Secondary: Gable construction with metal finish	Poor
Interiors	Walls: Painted gypsum board, wood and vinyl Floors: Carpet, VCT, ceramic tile Ceilings: Painted gypsum board, ACT	Fair
Elevators	Hydraulic: 1 car serving all 3 levels Wheelchair lifts	Fair
Plumbing	Copper supply and cast-iron waste and venting Gas domestic water heater	Fair

Main Building Information		
HVAC	Individual air handlers with gas heating units on the roof Supplemental components: Computer room air conditioning unit (CRAC) All HVAC equipment is controlled by building management system	Fair
Fire Suppression	Wet-pipe sprinkler system (limited); hydrants, fire extinguishers,	Fair
Electrical	Source and Distribution: Main switchboard panel with copper wiring Interior Lighting: LED Emergency: None	Good
Fire Alarm	Alarm panel, smoke detectors, alarms, strobes, pull stations, back-up emergency lights, and exit signs	Fair
Equipment/Special	Commercial kitchen equipment	Fair
Key Issues and Findings	Repair water heater flue pipe, Install insulation for Data center air conditioner refrigeration lines, The roof needs replacement T-111 siding needs replacement

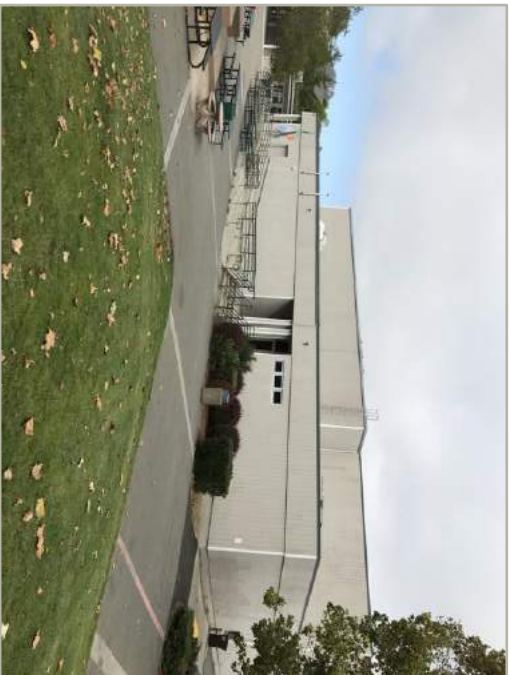
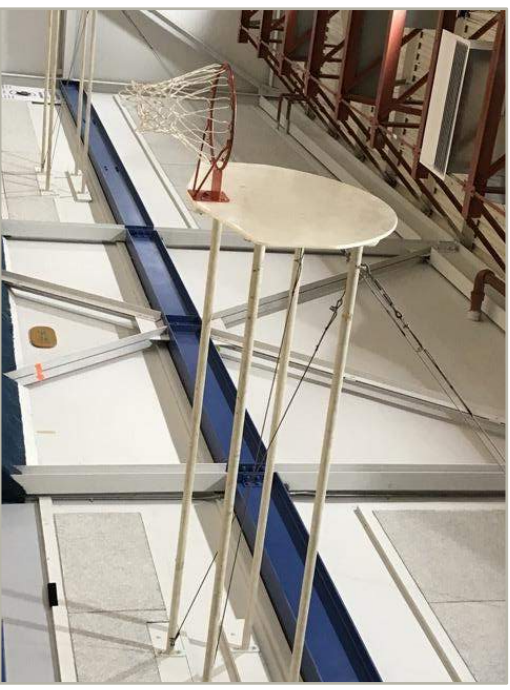
3. Gym Building Summary

Gym Building Information		
Address	425 Sycamore Avenue, Mill Valley, CA	
Constructed/ Renovated	1972/1996	
Building Size	15,500 SF	
Number of Stories	One	
System	<i>Description</i>	<i>Condition</i>
Structure	Steel frame with concrete-topped metal decks	Fair
Façade	Painted T-111 with steel windows	Fair
Roof	Primary: Flat construction with modified bituminous finish	Fair
Interiors	Walls: Painted gypsum board and CMU, vinyl Floors: Carpet, VCT, ceramic tile, maple sports floor Ceilings: Painted gypsum board, ACT exposed	Fair
Elevators	None	--
Plumbing	Copper supply and cast-iron waste and venting Electric domestic water heater	Fair

Gym Building Information		
HVAC	Individual unit heaters units Make-up air unit	Poor Fair
Fire Suppression	Wet-pipe sprinkler system (limited); hydrants, fire extinguishers,	Fair
Electrical	Source and Distribution: Fed from Main building to distribution panel with copper wiring Interior Lighting: LED Emergency: None	Fair
Fire Alarm	Alarm panel, smoke detectors, alarms, strobes, pull stations, back-up emergency lights, and exit signs	Fair
Equipment/Special	None	--
Key Issues and Findings	Roof ladder access missing, Antiquated and damaged unit heaters, T-11 siding is warping and rotting, Steel window frames are rusting

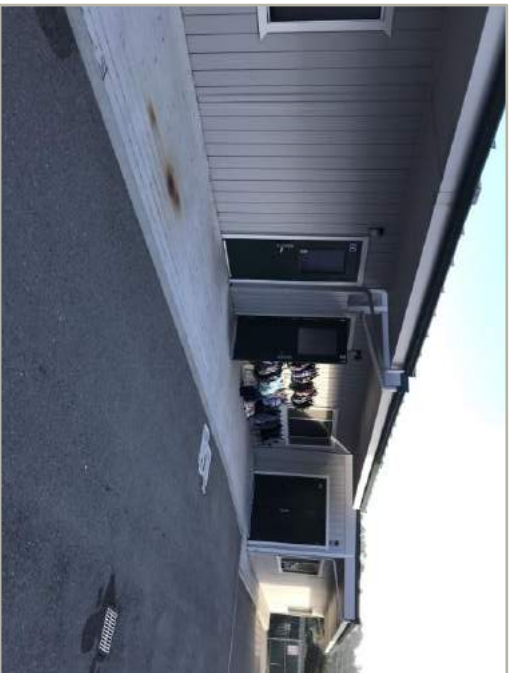
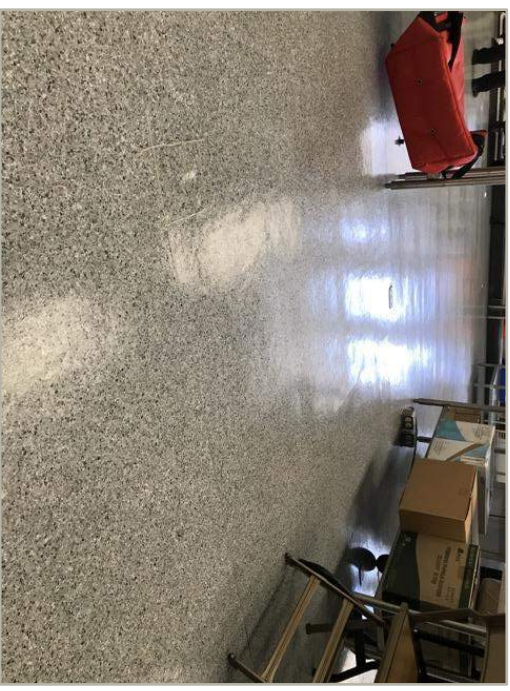
4. Portables 78-82 Summary

Portables 78-82 Information		
Address	425 Sycamore Avenue, Mill Valley, CA	
Constructed/ Renovated	1999	
Building Size	6,240 SF	
Number of Stories	One	
System	Description	Condition
Structure	Light gauge steel framing on a concrete perimeter footing	Fair
Facade	Painted T-111 with aluminum windows	Fair
Roof	Primary: Flat construction with metal finish	Fair
Interiors	Walls: Vinyl covered gypsum board Floors: Carpet, Sheet Vinyl Ceilings: ACT	Fair
Elevators	None	--
Plumbing	Copper supply and cast iron waste and venting Electric domestic water heaters	Fair

Portables 78-82 Information	
HVAC	Individual heat pump Supplemental components: Unit heater Fair
Fire Suppression	Hydrants, fire extinguishers Fair
Electrical	Source and Distribution: Main panel with copper wiring Interior Lighting: LED Emergency: None Fair
Fire Alarm	Alarm panel, smoke detectors, alarms, strobes, pull stations, back-up emergency lights, and exit signs Fair
Equipment/Special	None --
Key Issues and Findings	Dry rotted and warped siding, it needs replacement

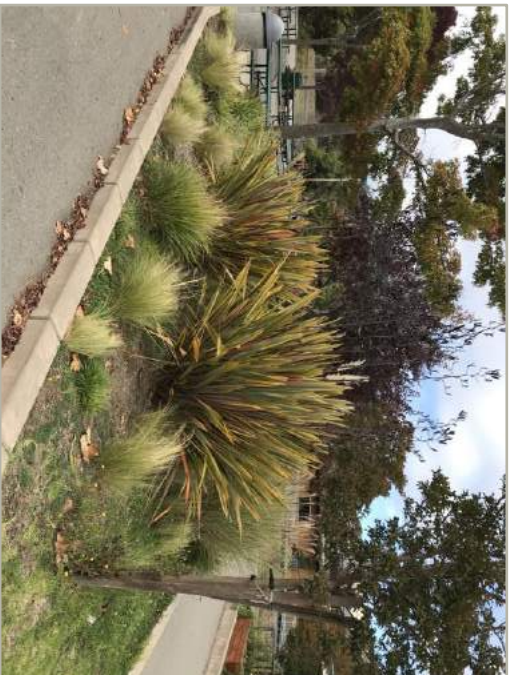
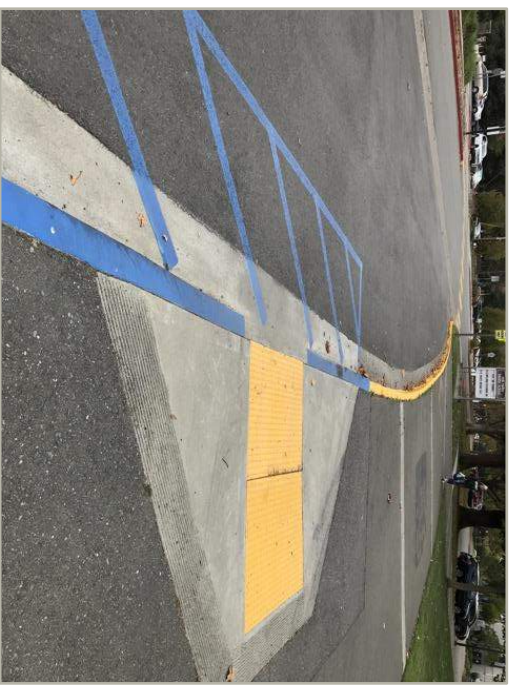
7. Site Summary

Site Information	
Key Issues and Findings	The site is landfill, next to San Francisco Bay, and has historically experienced significant subsiding. Some subsidence was seen in the parking lot directly in front of the school along Sycamore Avenue, more can be anticipated. The Expected Useful Life of the hard surface areas, sidewalks, parking lots and play areas will be less than at a site that has firm subsoil. The parking lots and walkways were substantially improved and replaced in 2014.

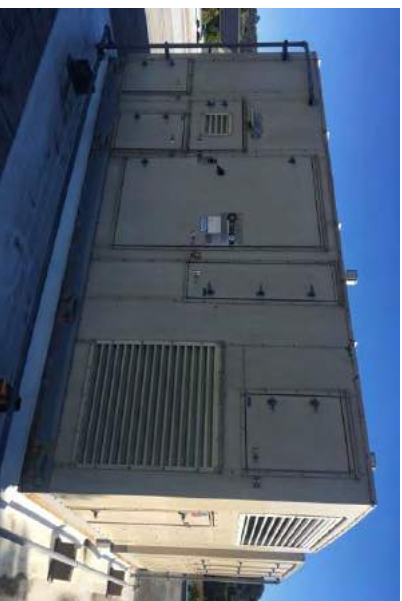
#39	WATER HEATER, GAS
-----	-------------------

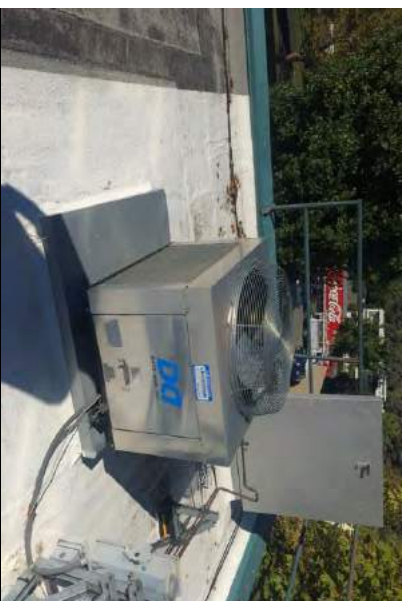
#43	MAKE-UP AIR UNIT
-----	------------------

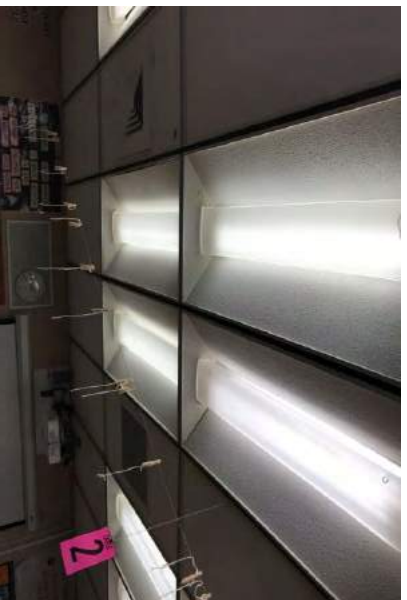
#52 LED LIGHTING FIXTURE
