MILL VALLEY  
SCHOOL DISTRICT  
FACILITIES  
ASSESSMENT  
2018

# OLD MILL ELEMENTARY SCHOOL

# FACILITY CONDITION ASSESSMENT

Old Mill Elementary School  
352 Throckmorton Avenue  
Mill Valley, California 94941

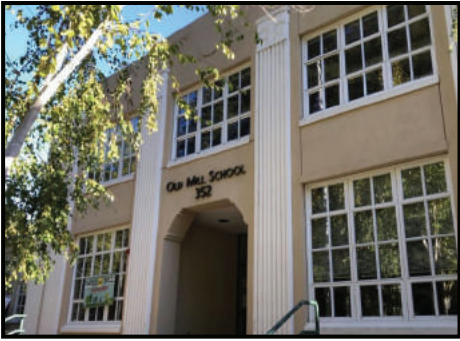
PHOTO - 1  
ENTRANCE

Main entrance to school retains historic and art deco feel and is welcoming

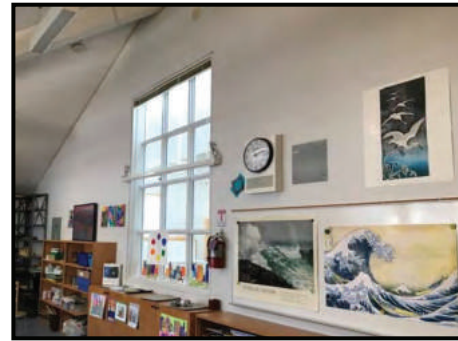
PHOTO - 3  
ART ROOM

Art is often overheated due to it's kiln and second floor location

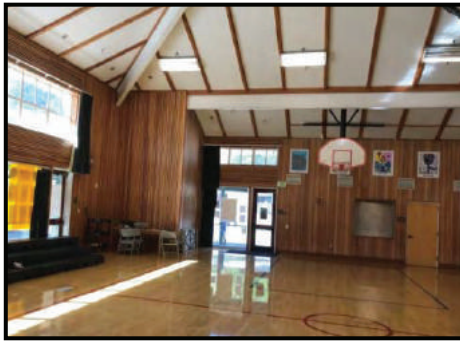
PHOTO - 5  
MPR

MPR is used by PE, music, and drama classes

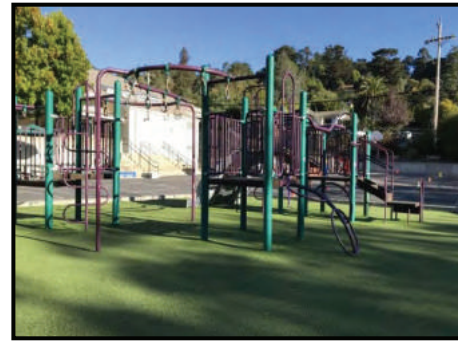
PHOTO - 7  
PLAYSTRUCTURE

Grades 1-2 playstructure would be more appropriate in the location of the grades 3-5 playstructure

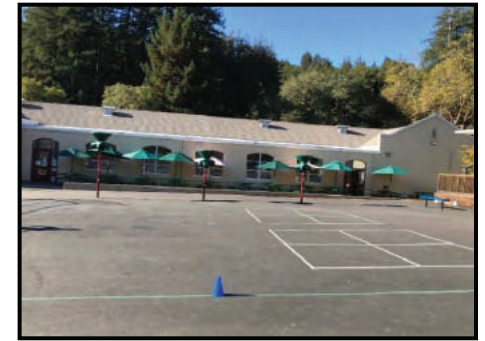
PHOTO - 8  
PLAY YARD

The outdoor area has no permanent shade structures; the existing shade structures are umbrellas

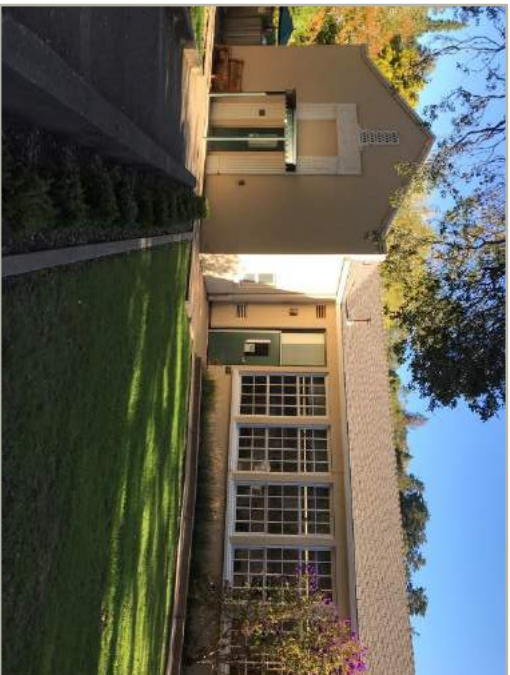
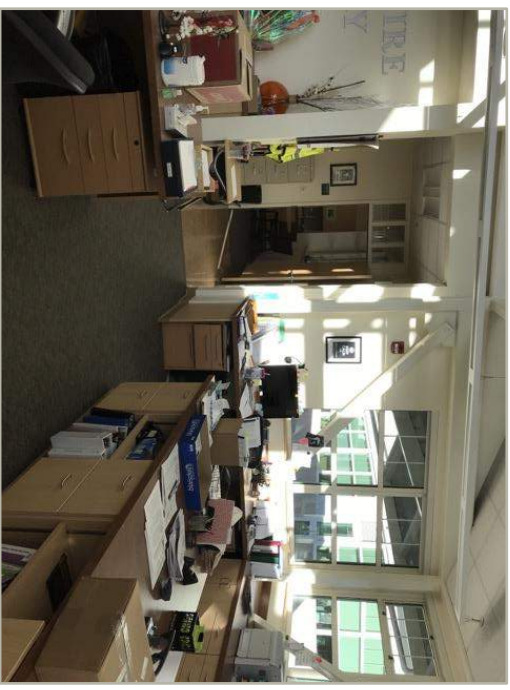
Main Building Information		
Address	352 Throckmorton, Mill Valley, California	
Constructed/ Renovated	1918/2010	
Building Size	17,900 SF	
Number of Stories	One	
System	Description	Condition
Structure	Conventional wood frame structure with raised floor and wood framed roof	Good
Facade	Stucco with aluminum windows	Good
Roof	Primary: Gable construction with asphalt shingles Secondary: Flat construction with modified bituminous finish	Good
Interiors	Walls: Painted gypsum board, sound board, vinyl, wood paneling, ceramic tile Floors: Carpet, sheet vinyl, ceramic tile Ceilings: Painted gypsum board, ACT	Good

Main Building Information	
Elevators	Hydraulic: One car serving both floors Wheelchair lift
Plumbing	Copper supply and cast iron waste and venting, some galvanized Electric water heaters
HVAC	Individual furnaces Supplemental components: ductless split-systems
Fire Suppression	Wet-pipe sprinkler system; hydrants, fire extinguishers
Electrical	Source and Distribution: Main switchgear with copper wiring Interior Lighting: LED Emergency: None
Fire Alarm	Alarm panel, smoke detectors, alarms, strobes, pull stations, back-up emergency lights, and exit signs
Equipment/Special	None
Key Issues and Findings	The age, condition and extent of the galvanized water supply line needs to be determined. The classrooms have no air conditioning.

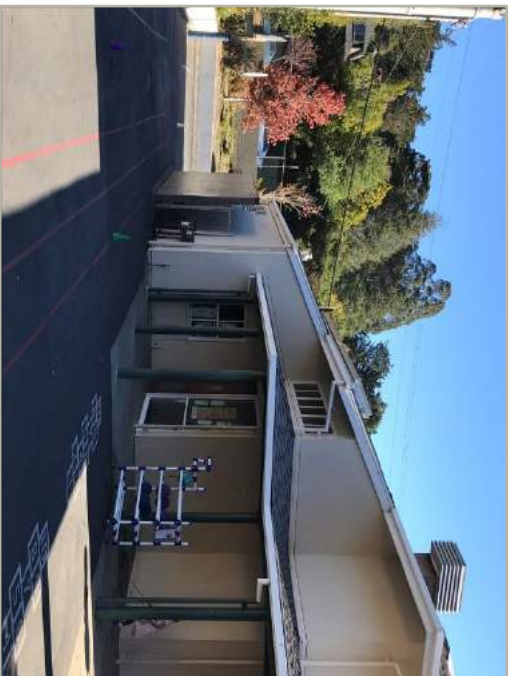
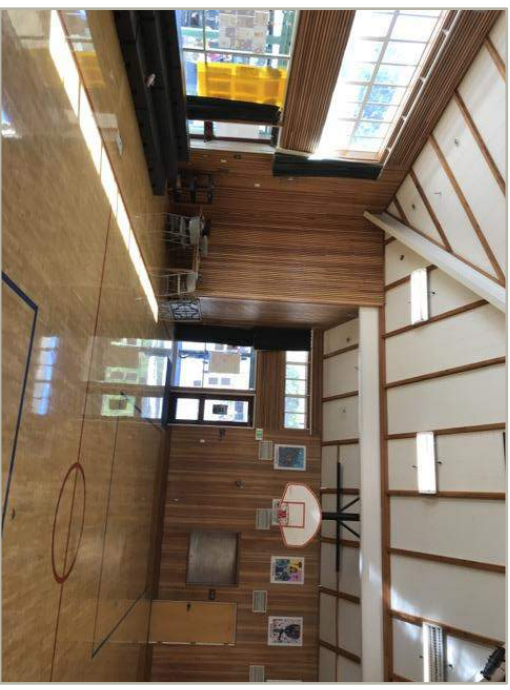
Multipurpose Building Information		
Address	352 Throckmorton, Mill Valley, California	
Constructed/ Renovated	1918/2010	
Building Size	4,179 SF	
Number of Stories	One	
System	Description	Condition
Structure	Steel frame structure on concrete slab	Good
Facade	Stucco with aluminum windows	Good
Roof	Primary: Hip construction with asphalt shingles	Fair
Interiors	Walls: Painted gypsum board and wood siding Floors: VCT, Maple sports floor, quarry tile Ceilings: Painted gypsum board, ACT	Fair
Elevators	Wheelchair lift	Fair
Plumbing	Copper supply and cast iron waste and venting Electric water heater	Fair

Multipurpose Building Information		
HVAC	Central system furnaces	Fair
Fire Suppression	Wet-pipe sprinkler system; hydrants, fire extinguishers	Good
Electrical	Source and Distribution: Main panel with copper wiring Interior Lighting: LED Emergency: None	Fair
Fire Alarm	Alarm panel, smoke detectors, alarms, strobes, pull stations, back-up emergency lights, and exit signs	Fair
Equipment/Special	None	--
Key Issues and Findings	One of the two furnaces does not work, the building does not have air conditioning

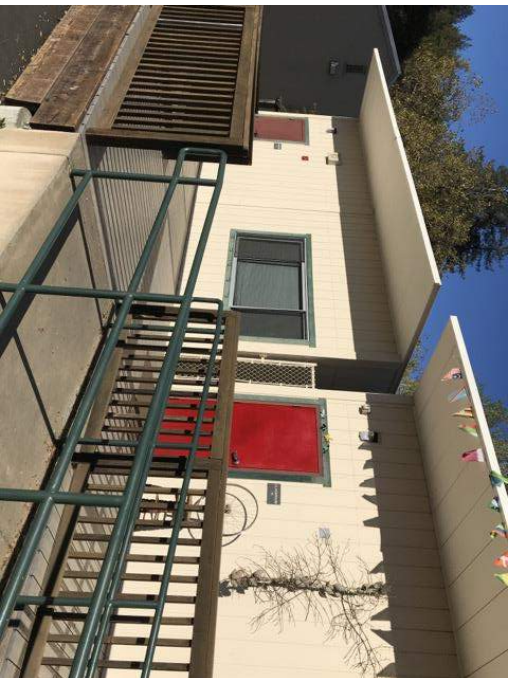
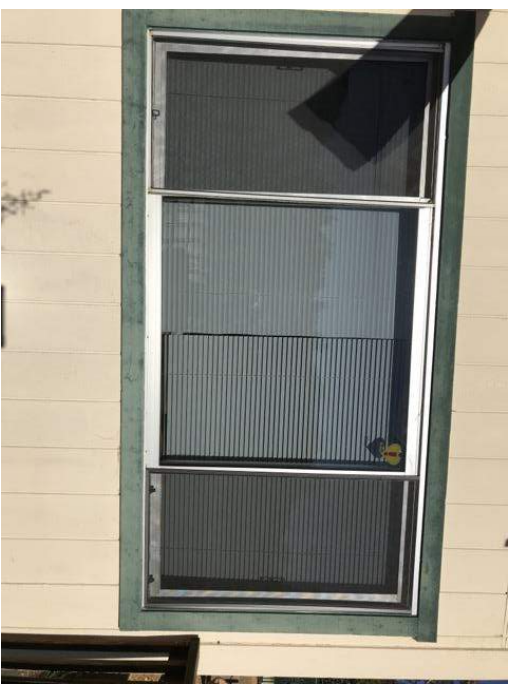
Portables Information		
Address	352 Throckmorton, Mill Valley, California	
Constructed/ Renovated	1997	
Building Size	1,920 SF	
Number of Stories	One	
System	<i>Description</i>	<i>Condition</i>
Structure	Light weight metal frame structure on T-footing	Fair
Facade	Painted T-111 with aluminum windows	Fair
Roof	Primary: Flat construction with metal finish	Fair
Interiors	Walls: Vinyl finished sound board Floors: Carpet Ceilings: ACT	Fair
Elevators	None	--
Plumbing	Copper supply and cast iron waste and venting No hot water	Fair

Portables Information		
HVAC	Individual package units	Fair
Fire Suppression	Dry-pipe / Wet-pipe sprinkler system; hydrants, fire extinguishers, hose cabinets, kitchen hood system	--
Electrical	Source and Distribution: Main panel with copper wiring Interior Lighting: LED Emergency: None	Fair
Fire Alarm	Alarm panel, smoke detectors, alarms, strobes, pull stations, back-up emergency lights, and exit signs	Good
Equipment/Special	None	--
Key Issues and Findings	The exterior T-111 is warping and beginning to deteriorating

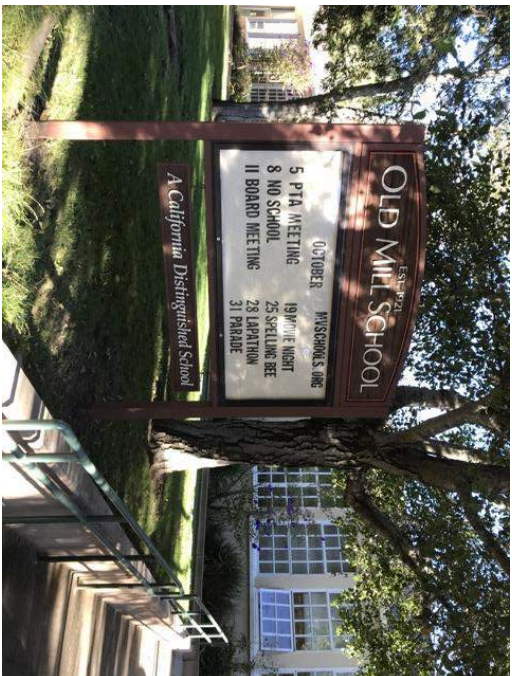
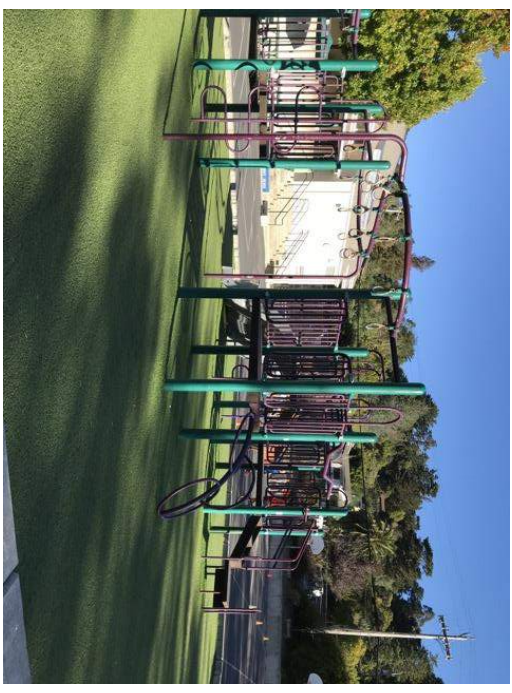
Site Information		
Lot Size	2.5 acres (estimated)	
Parking Spaces	No off street parking provided	
System	Description	Condition
Pavement/Flatwork	Asphalt play areas with areas of concrete and concrete sidewalks, curbs, ramps, and stairs	Good
Site Development	Property entrance signage, chain link fencing, chain link dumpster enclosures Moderately furnished park benches, picnic tables, trash receptacles Moderate landscaping features Irrigation present	Good
Landscaping and Topography	Reinforced concrete and pressure treated wood retaining walls Severe site slopes along west and north boundary	Fair
Utilities	Municipal water and sewer Local utility-provided electric and natural gas	Good
Site Lighting	Pole-mounted: None Building-mounted: LED	Good
Ancillary Structures	None	--
Key Issues and Findings	The west play area appears to drain into the main building. Added catch basin.

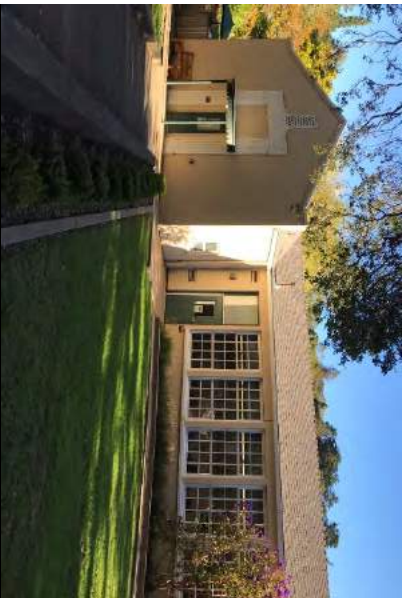
#1  
PARTIAL FRONT ELEVATION,  
MAIN BUILDING

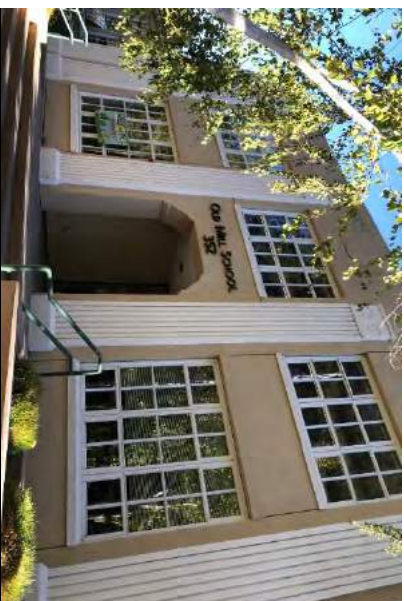
#2  
PARTIAL FRONT ELEVATION,  
MAIN BUILDING

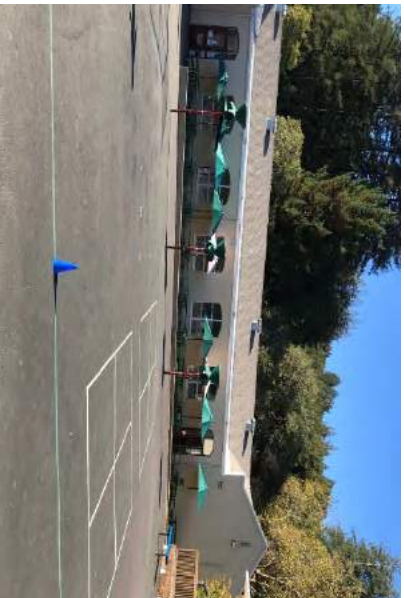
#3  
REAR ELEVATION, MAIN  
BUILDING

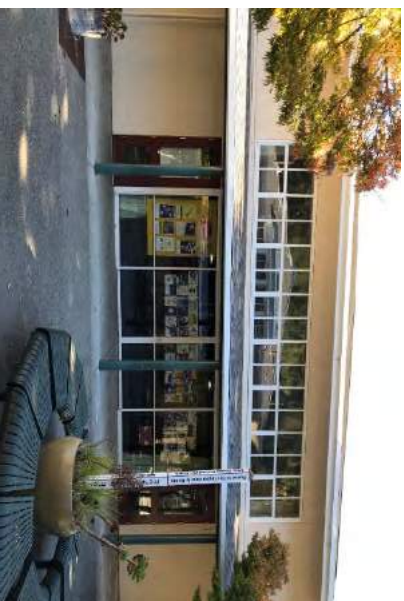
#4  
FRONT ELEVATION  
MULTIPURPOSE BUILDING

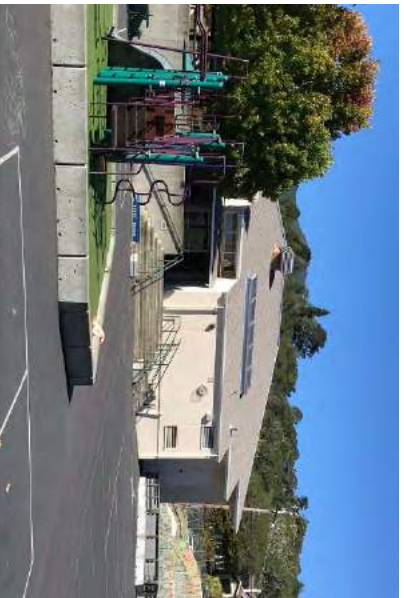
#5  
SIDE ELEVATION  
MULTIPURPOSE BUILDING

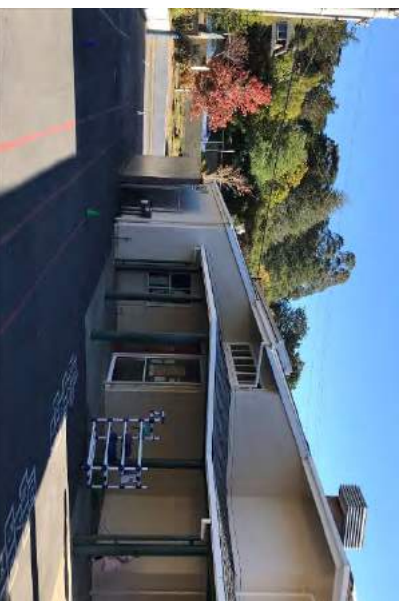
#6  
SIDE ELEVATION  
MULTIPURPOSE BUILDING

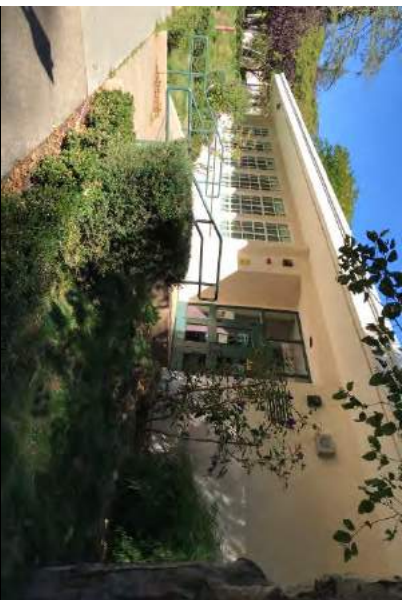
#7  
FRONT ELEVATION, LOWER LEVEL

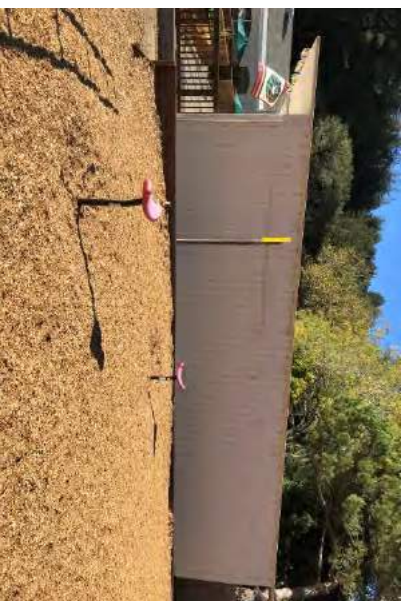
#10  
SIDE ELEVATION, PORTABLES

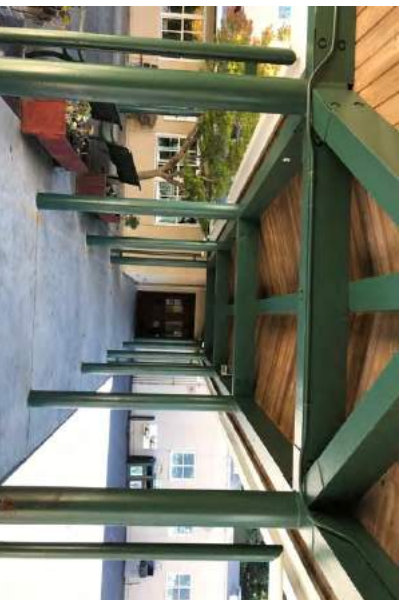
#11  
EXTERIOR COVERED WALKWAY

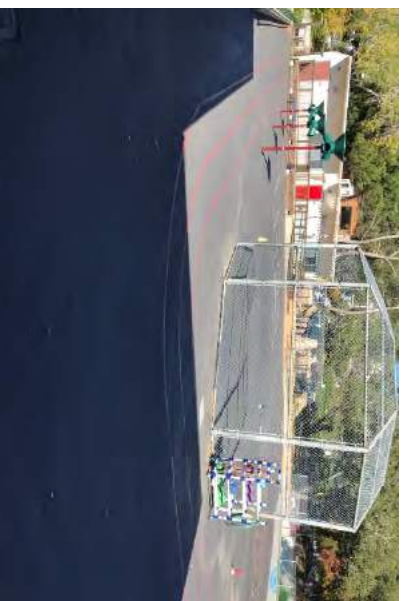
#12  
PLAY AREA

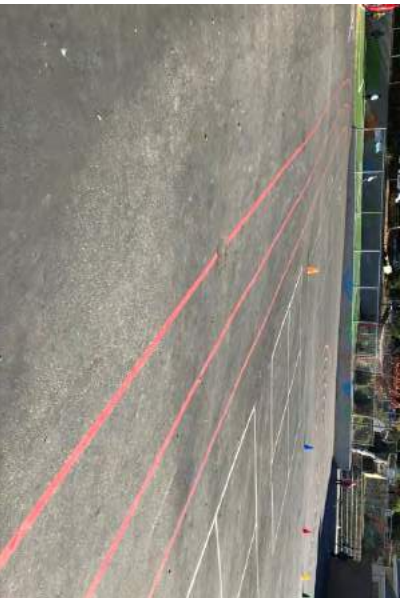
#13

PLAY SURFACES

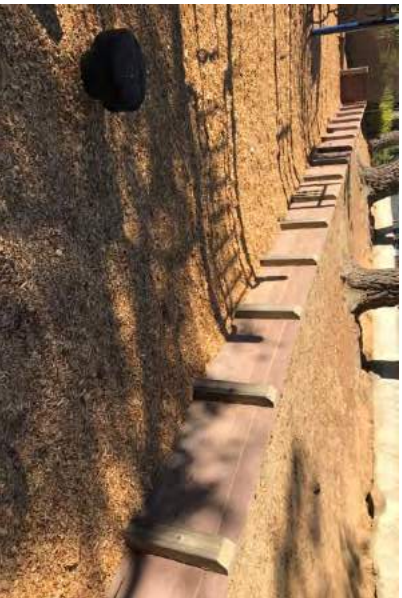
#15

RETAINING WALL, TREATED  
TIMBER

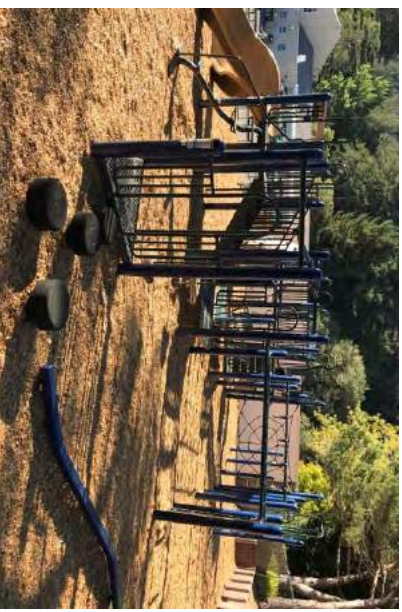
#16

PLAY STRUCTURE

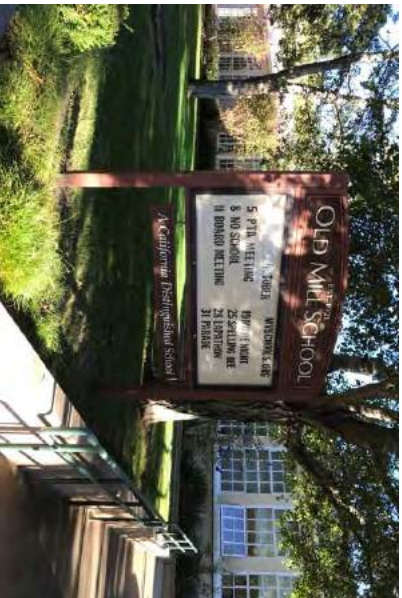
#17

BUILDING SIGNAGE

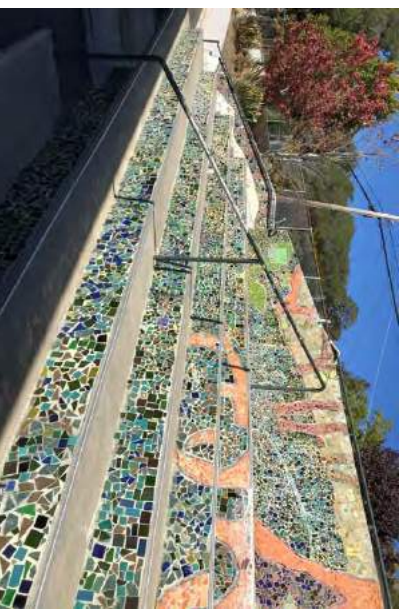
#18

MOSAIC STEPS

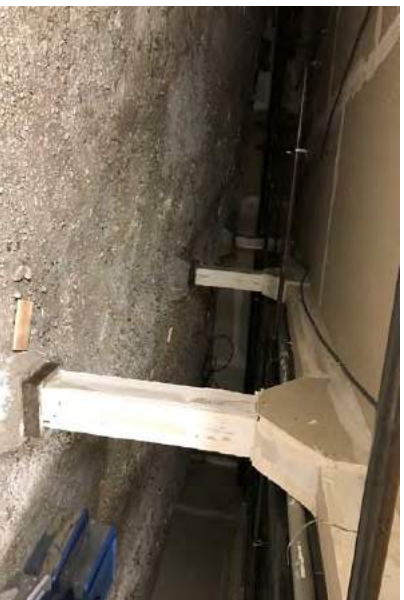
#19  
STRUCTURE UNDER THE MAIN BUILDING

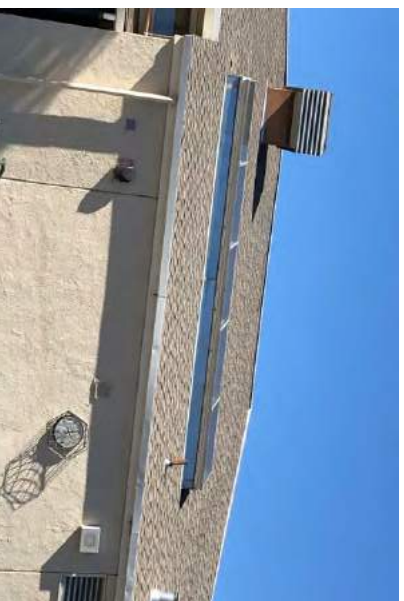
#22  
MULTIPURPOSE BUILDING ROOF

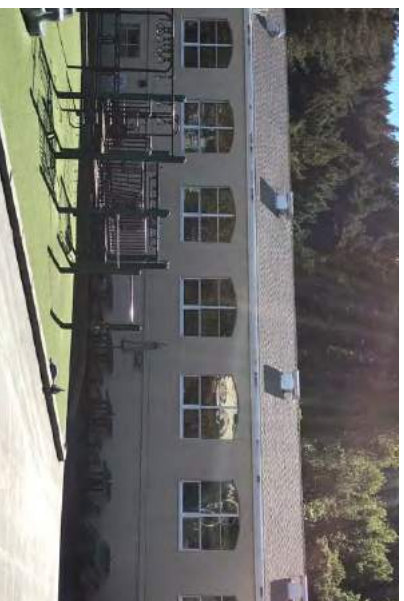
#24  
STUCCO WALLS

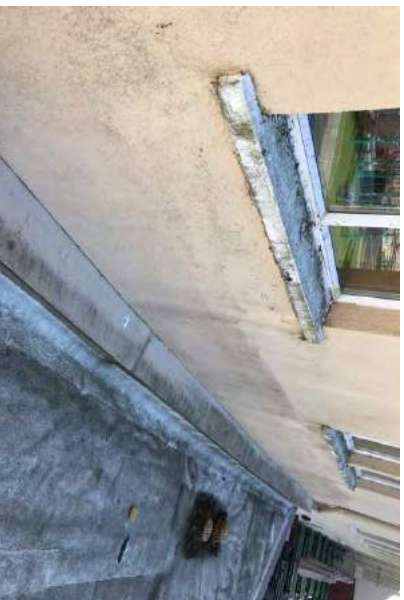
#25

STUCCO WALLS

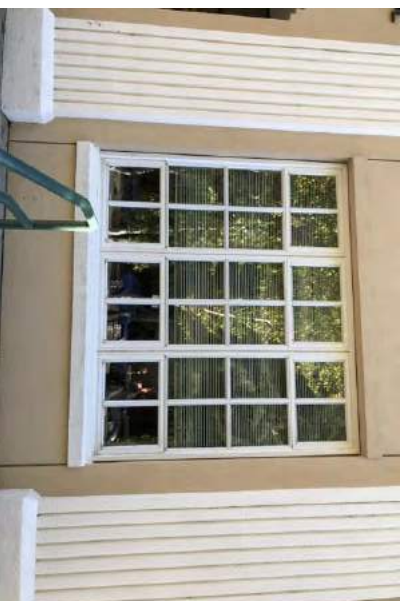
#26

WINDOWS

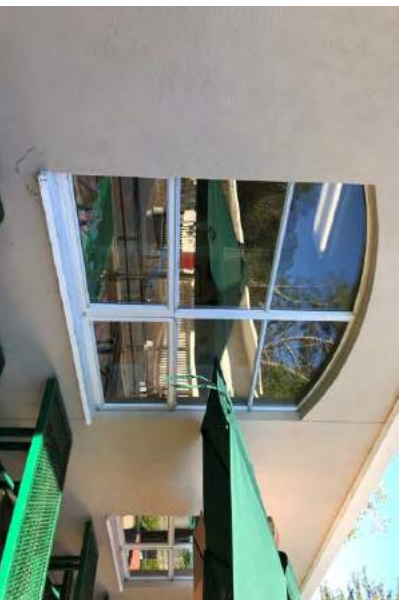
#27

WINDOWS

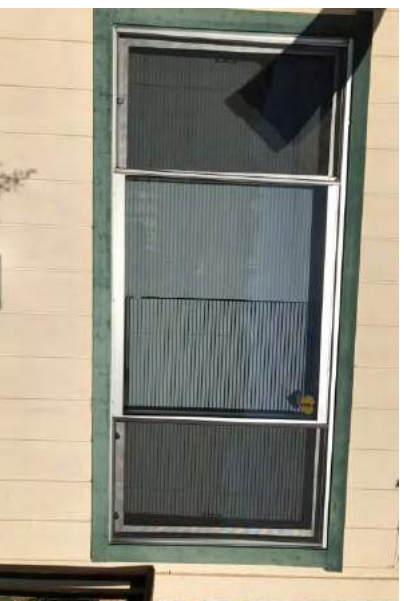
#28

WINDOWS AT PORTABLES

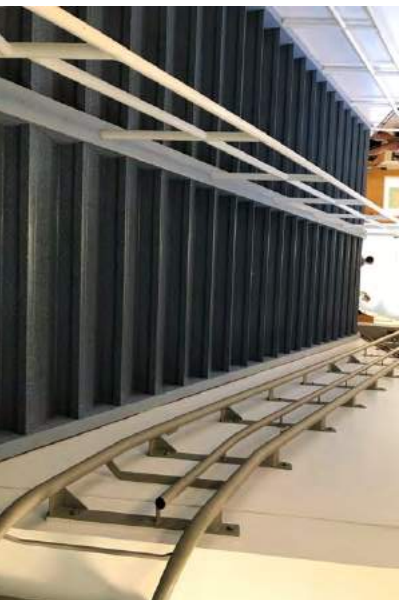
#29

INTERIOR STAIRS

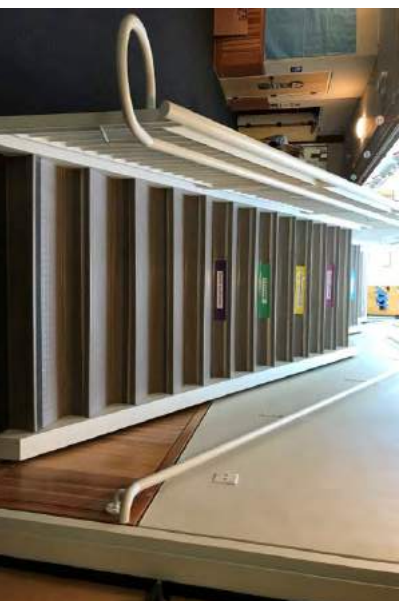
#30

INTERIOR STAIRS

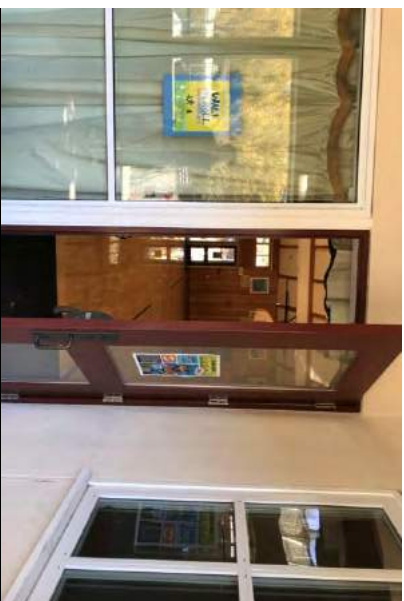
#32

EXTERIOR DOOR, STEEL WITH SAFETY GLASS

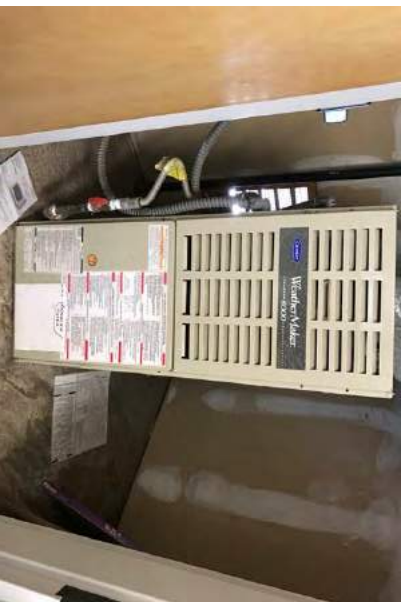
#33

FURNACE, GAS AT CLASSROOMS

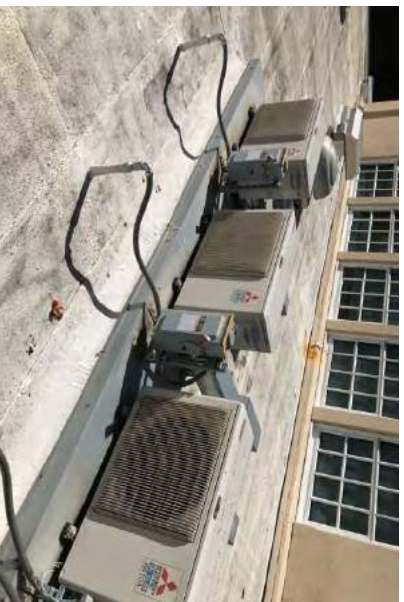
#35

MINI SPLITS, LOWER LEVEL

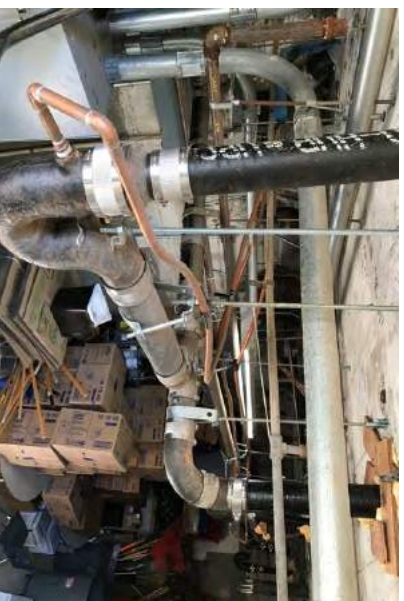
#36

PLUMBING

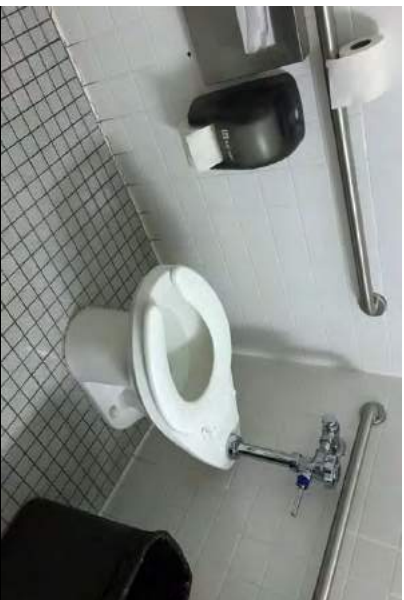
#37

TOILET, TANKLESS

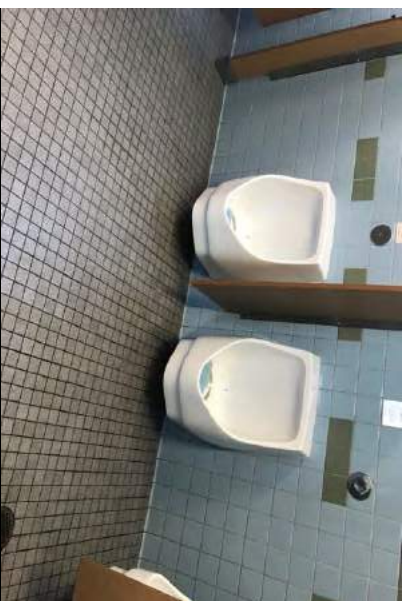
#38

URINAL, WATERLESS

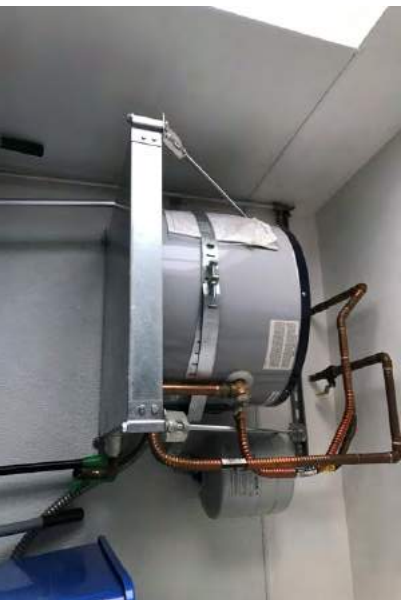
#39

WATER HEATER

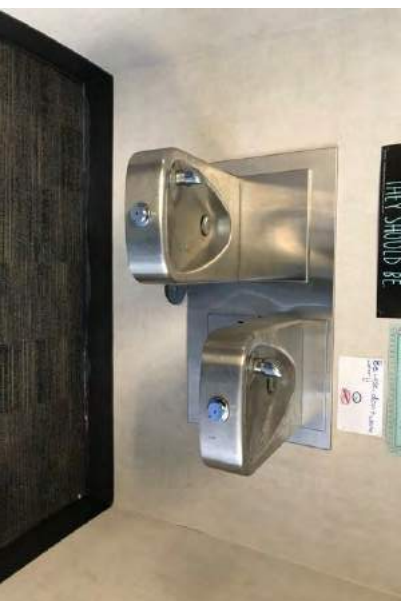
#40

DRINKING FOUNTAIN

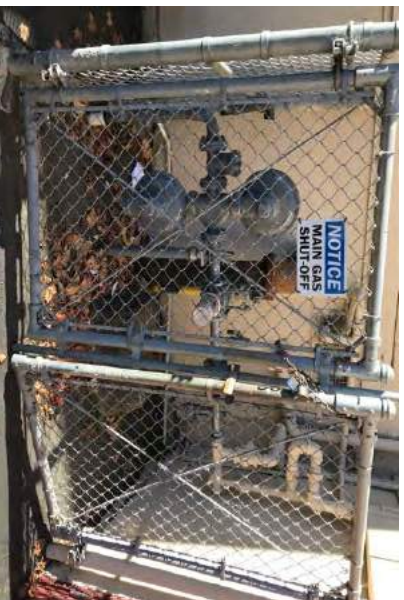
#41

GAS SUPPLY

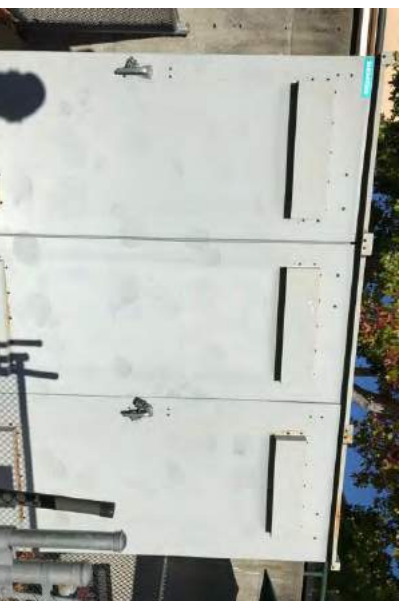
#42

MAIN SWITCHGEAR

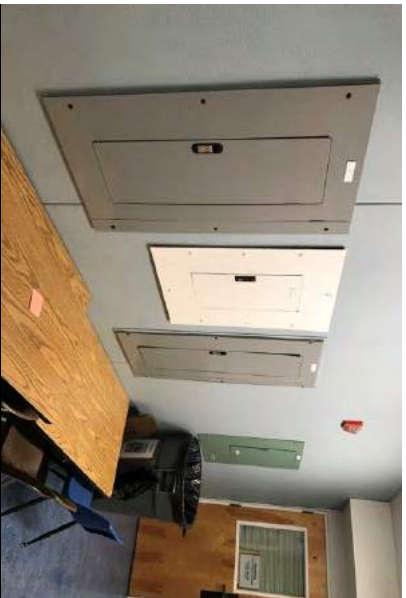
#43

ELECTRICAL DISTRIBUTION

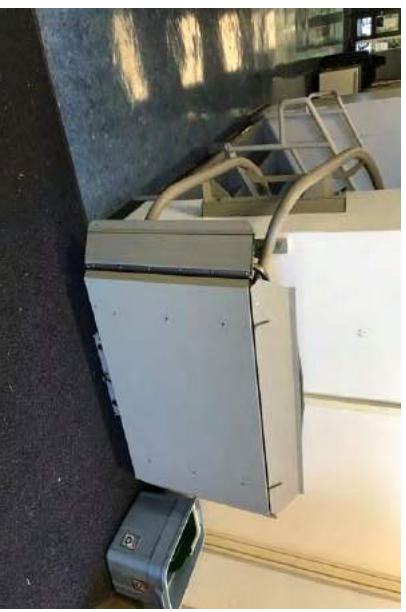
#45

PUBLIC ADDRESS SYSTEM

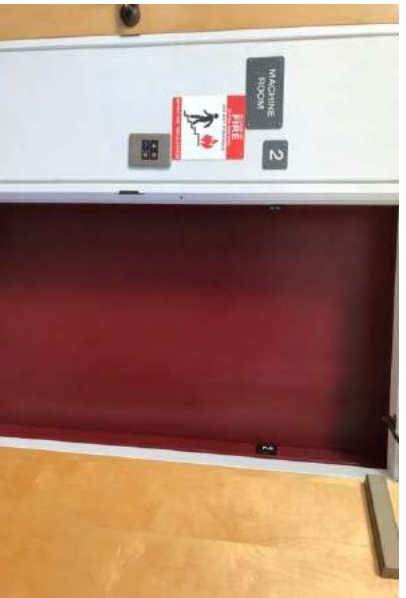
#46

STAIR LIFT, LOWER LEVEL TO  
MAIN BUILDING

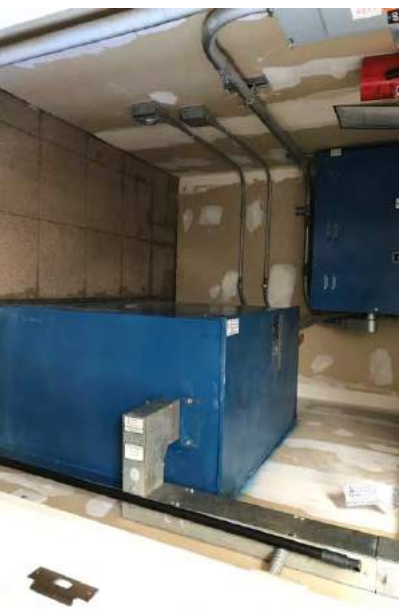
#47

ELEVATOR

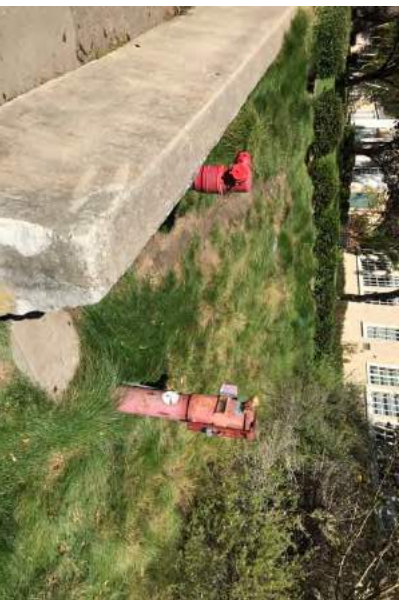
#49

FIRE SPRINKLER STANDPIPE

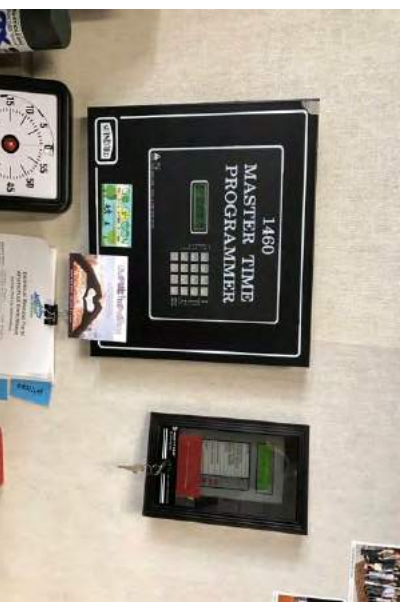
#53

OFFICE

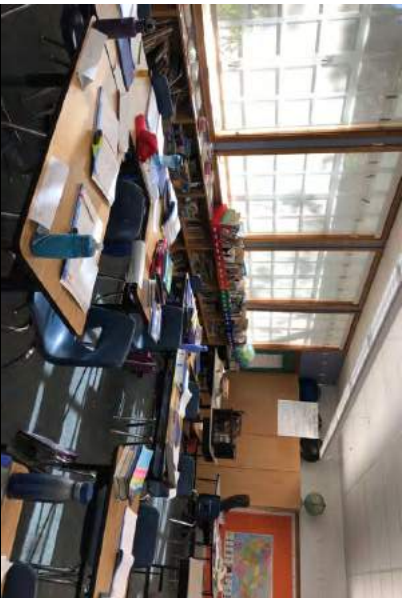
#54

ART CLASSROOM

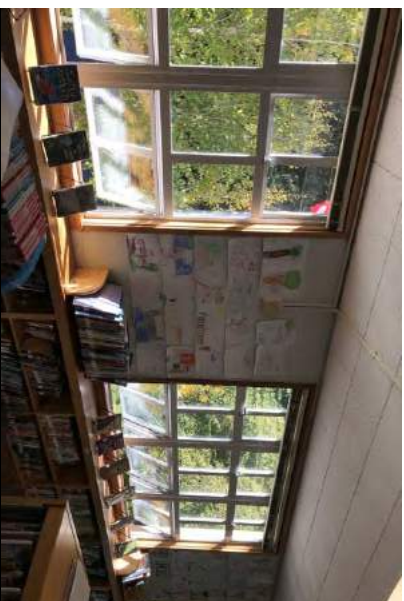
#55

CLASS ROOM

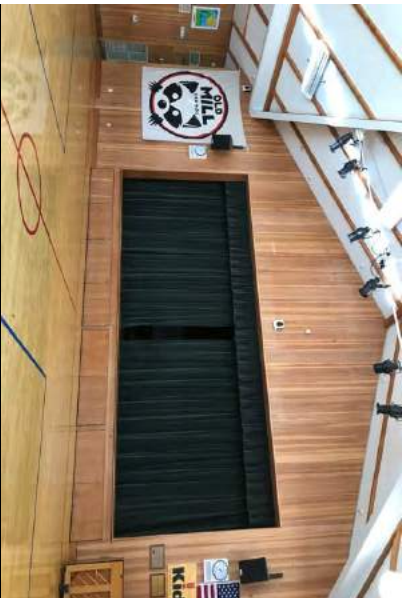
#58

MULTIPURPOSE BUILDING

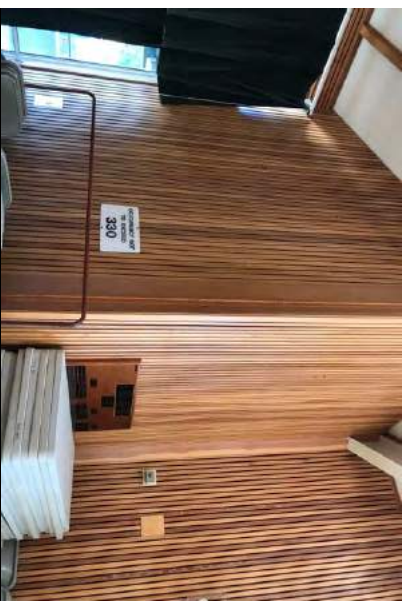
#59

MULTIPURPOSE BUILDING
