MILL VALLEY SCHOOL DISTRICT FACILITIES ASSESSMENT 2018

PARK ELEMENTARY SCHOOL

FACILITY CONDITION ASSESSMENT

Park Elementary School
360 East Blithedale Avenue
Mill Valley, California 94941

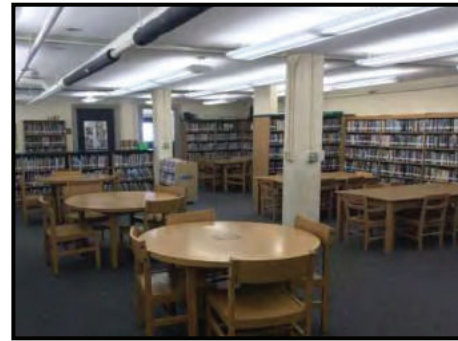
PHOTO - 3
LIBRARY

Although the Library is adequately sized, it is modeled on a more traditional, less multi-media model. It is intersected by several columns.

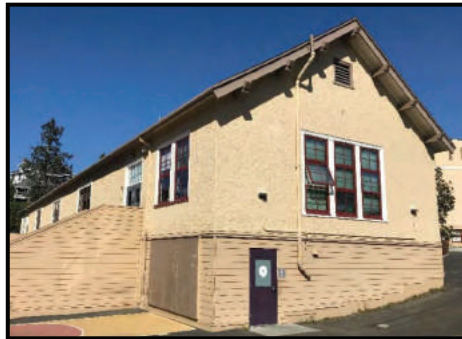
PHOTO - 5
SITE

The site is sloping and uneven in certain areas

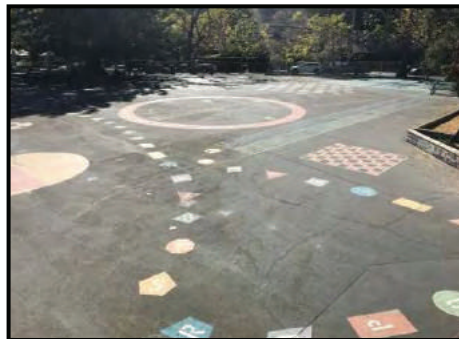
PHOTO - 6
PLAY AREA

The campus features a generous, though largely uncovered, outdoor play area.

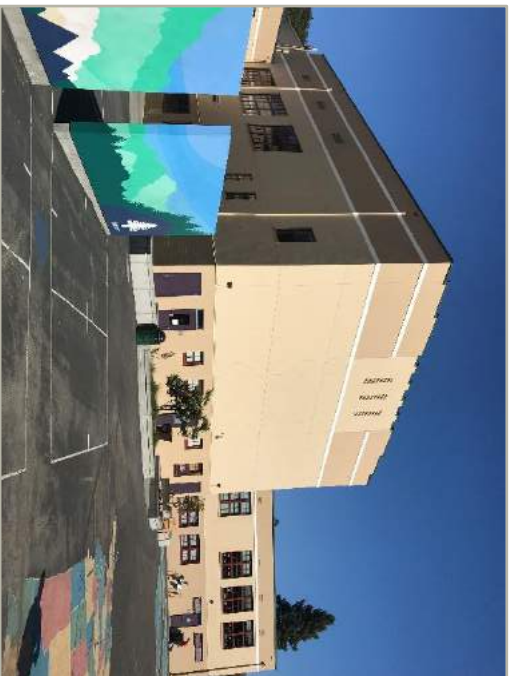
Main Building Information		
Address	360 East Blithedale Avenue, Mill Valley California 94941	
Constructed/ Renovated	1938 / 2012	
Building Size	29,787 SF (estimated)	
Number of Stories	Two	
System	Description	Condition
Structure	Conventional wood frame structure on concrete slab Masonry bearing walls and wood-framed roofs	Good
Façade	Stucco with aluminum windows	Fair
Roof	Primary: Flat construction with modified bituminous finish Secondary: Flat construction with single-ply TPO/PVC membrane Tertiary: Mansard construction with clay/concrete tiles	Fair
Interiors	Walls: Painted gypsum board, CMU, wood wainscoting Floors: Carpet, linoleum, VCT, ceramic tile, wood strip Ceilings: Painted gypsum board, Glue-on ACT	Fair
Elevators	Hydraulic: One car serving both floors Wheelchair lift	Fair
Plumbing	Copper supply and cast iron waste and venting Gas water heater and instant water heaters	Fair

Main Building Information		
HVAC	Central system with boiler, hydronic radiators Supplemental components: ductless split-systems, suspended gas unit heaters	Fair
Fire Suppression	Wet-pipe sprinkler system; hydrants, fire extinguishers	Fair
Electrical	Source and Distribution: Main switchboard with copper wiring Interior Lighting: LED Emergency: None	Fair
Fire Alarm	Alarm panel, smoke detectors, alarms, strobes, pull stations, back-up emergency lights, and exit signs	Fair
Equipment/Special	None	--
Key Issues and Findings	Water leaking into two rooms from windows or siding, failed roof membranes in isolated locations, leaking boiler piping, antiquated HVAC system, missing fire system backflow, antiquated emergency lighting, fire sprinkler heads appear aged

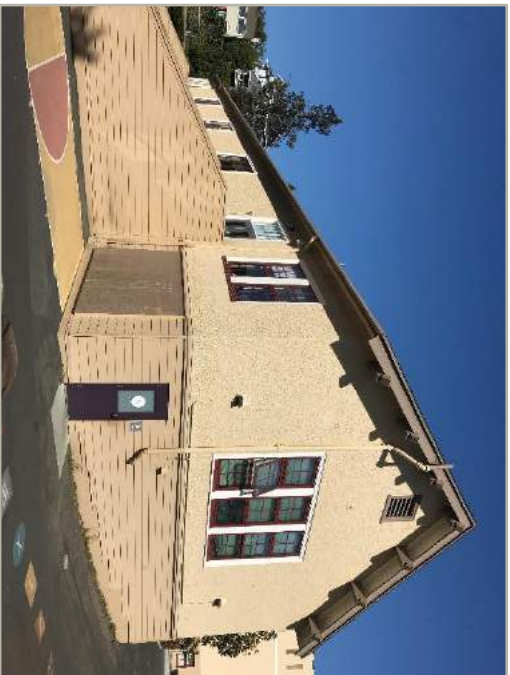
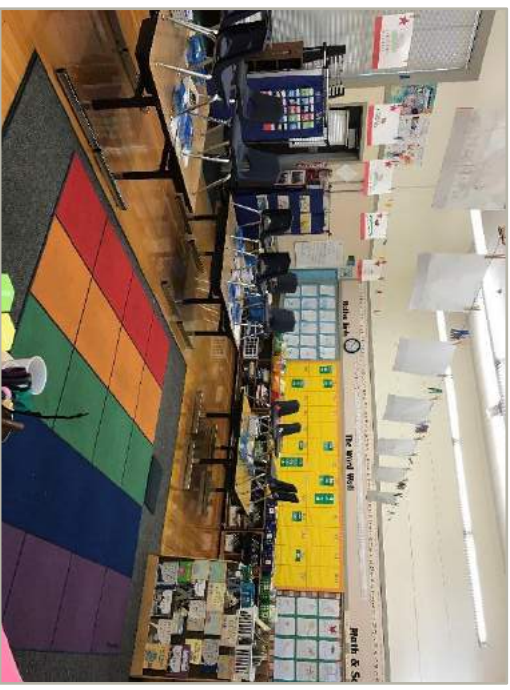
Annex Building Information		
Address	360 East Blithedale Avenue, Mill Valley California	
Constructed/ Renovated	1934 / 2012	
Building Size	6,491 SF (estimated)	
Number of Stories	2	
System	Description	Condition
Structure	Conventional wood frame structure with raised floor Wood-framed roof	Good
Facade	Stucco and wood siding with aluminum windows	Good
Roof	Gable construction with asphalt shingles	Fair
Interiors	Walls: Painted gypsum board, wood wainscoting, ceramic tile Floors: Carpet, ceramic tile, epoxy coating, wood strip Ceilings: Painted gypsum board, glue-on ACT	Fair
Elevators	None	--
Plumbing	Copper supply and cast iron waste and venting Instant water heaters	Fair

Annex Building Information	
HVAC	Hydronic radiators Fair
Fire Suppression	Wet-pipe sprinkler system; hydrants, fire extinguishers Fair
Electrical	Source and Distribution: Fed from Main Building with copper wiring Interior Lighting: LED Emergency: None Fair
Fire Alarm	Smoke detectors, alarms, strobes, back-up emergency lights, and exit signs Fair
Equipment/Special	None --
Key Issues and Findings	A few asphalt roof tiles are missing or damaged, antiquated HVAC system, antiquated emergency lighting, fire sprinkler heads appear aged

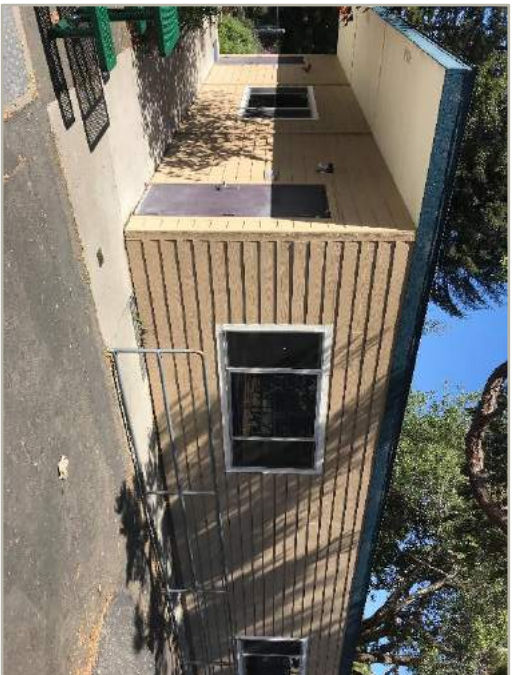
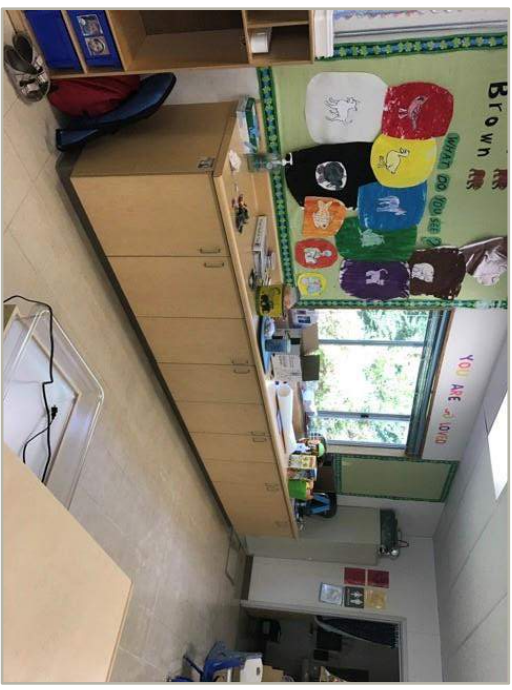
Modular Building Information		
Address	360 East Blithedale Avenue, Mill Valley California	
Constructed/ Renovated	2005	
Building Size	1,400 SF (estimated)	
Number of Stories	One	
System	Description	Condition
Structure	Modular wood frame structure on concrete slab	Fair
Facade	Wood siding with aluminum windows	Fair
Roof	Primary: Flat construction with metal finish	Fair
Interiors	Walls: Vinyl Floors: VCT Ceilings: ACT	Fair
Elevators	None	--
Plumbing	Copper supply and cast iron waste and venting No hot water	Fair

Modular Building Information		
HVAC	Heat pump	Fair
Fire Suppression	Hydrants, fire extinguishers	Fair
Electrical	Source and Distribution: Fed from Main Building with copper wiring Interior Lighting: LED Emergency: None	Fair
Fire Alarm	Smoke detectors, alarms, strobes	Fair
Equipment/Special	None	--
Key Issues and Findings	Wood rot on window trim, building lacks fire sprinklers

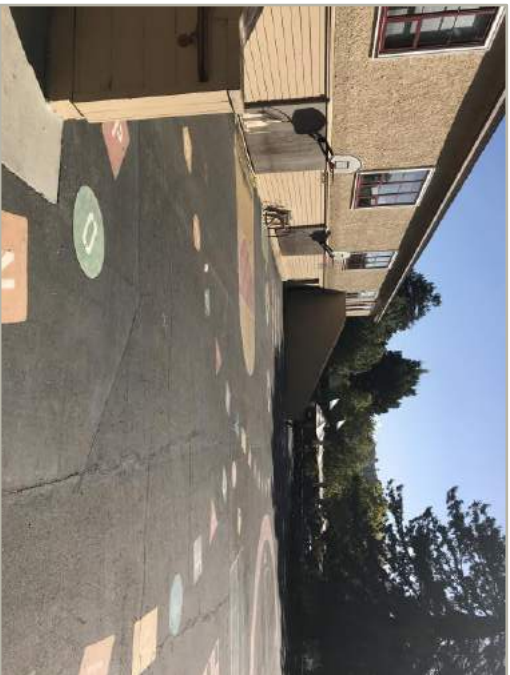
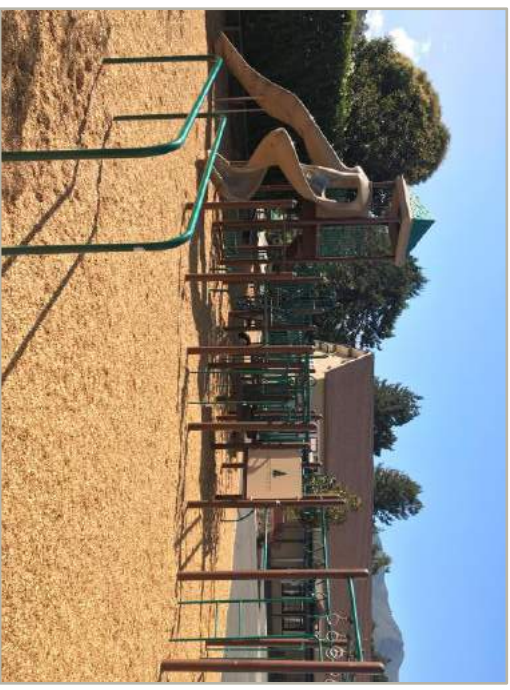
5. Site Summary

Site Information		
Lot Size	3.14 acres (estimated)	
Parking Spaces	31 total spaces all in open lots; 2 of which are accessible	
System	Description	Condition
Pavement/Flatwork	Asphalt lots with areas of concrete and concrete sidewalks, curbs, ramps, and stairs	Fair
Site Development	Building-mounted and property entrance signage, chain link fencing Playgrounds Limited park benches, picnic tables, trash receptacles	Fair
Landscaping and Topography	Limited landscaping features Irrigation present Concrete and CMU retaining walls Moderate site slopes throughout	Fair
Utilities	Municipal water and sewer Local utility-provided electric and natural gas	Good
Site Lighting	Building-mounted: LED Pedestrian walkway lighting	Good
Ancillary Structures	Pre-fabricated storage shed, ISO shipping containers	Fair
Key Issues and Findings	Pavement cracking and uneven surfaces for playground games, deteriorated retaining walls

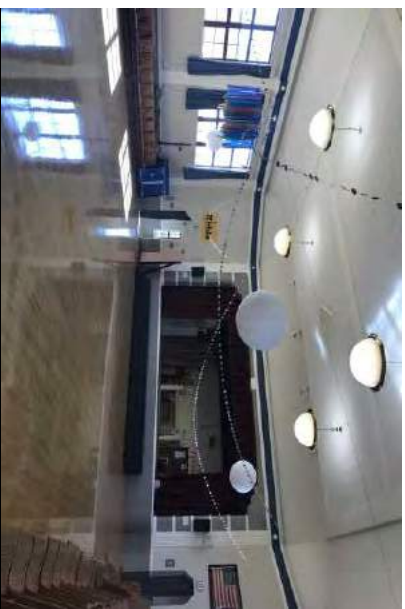
#19 ROOF STRUCTURE

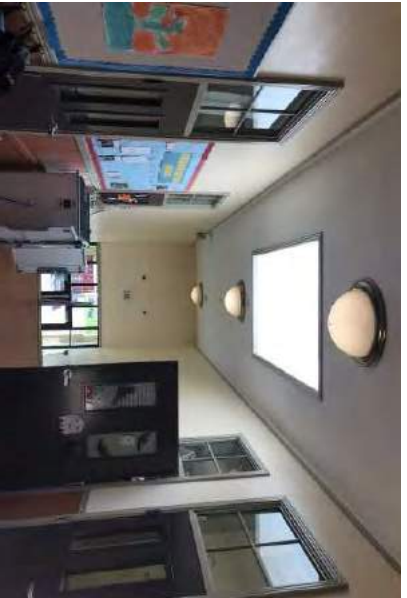
#22 CORRIDOR

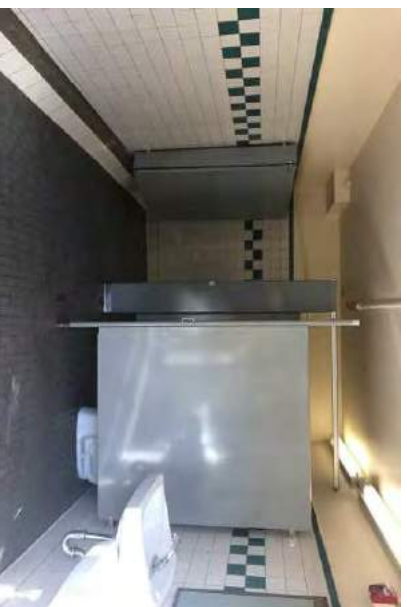
#29	RESTROOM
-----	----------

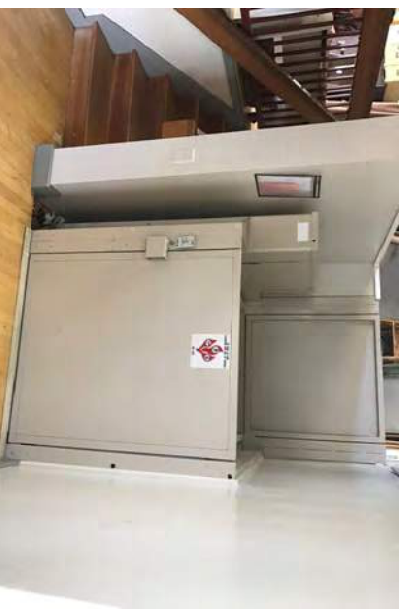
#31	ELEVATOR
-----	----------

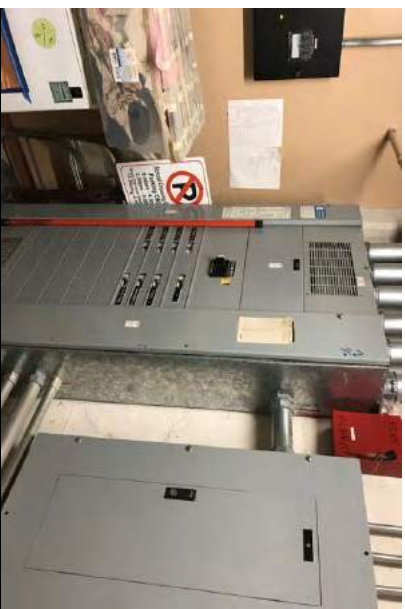
#49
1,200 AMP SWITCHBOARD

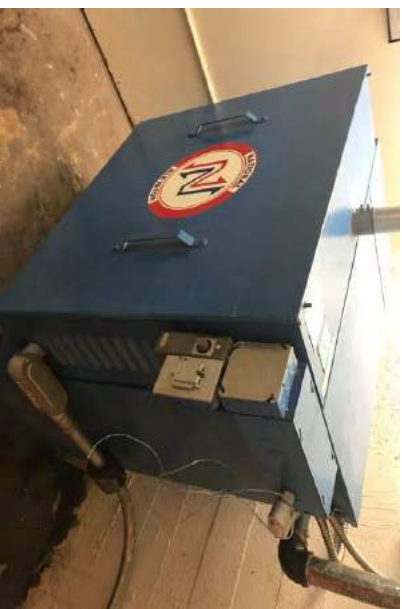
#51
ELEVATOR CONTROLS

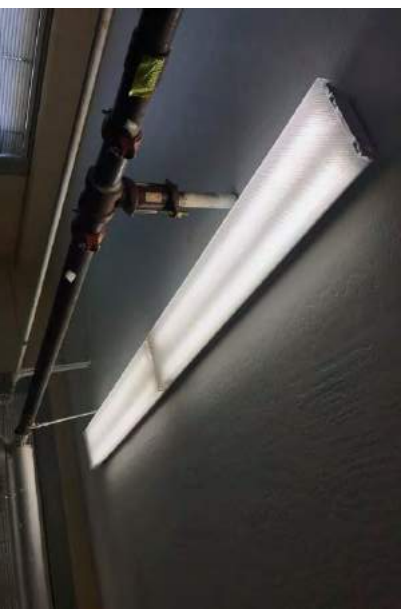
#54
LED LIGHTING

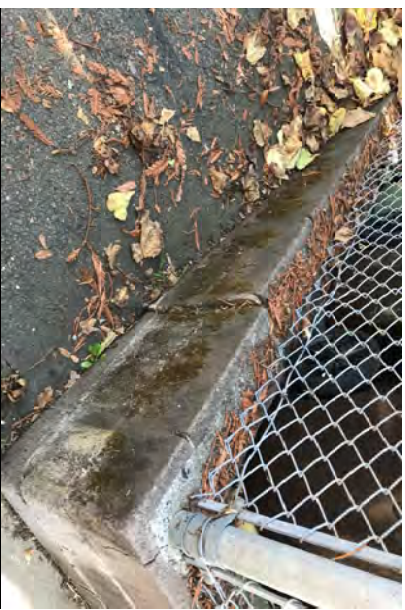
#62

RETAINING WALL

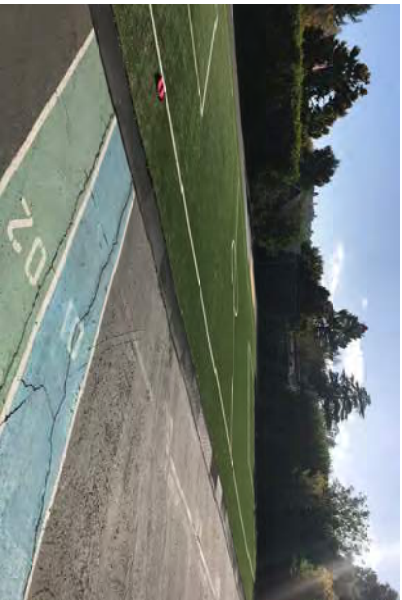
#63

ARTIFICIAL TURF

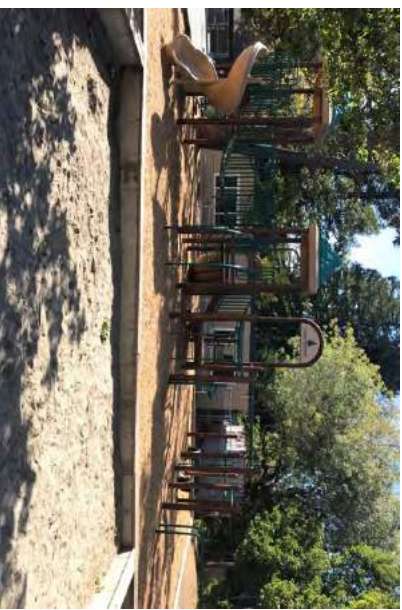
#64

PLAY STRUCTURE

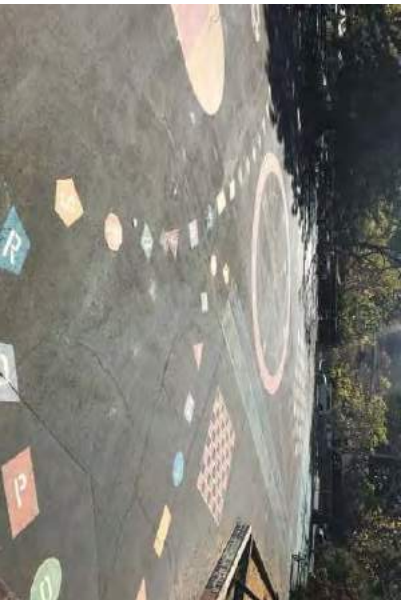
#65

ASPHALT PLAYGROUND
