# MILL VALLEY SCHOOL DISTRICT FACILITIES ASSESSMENT 2018

# PARK ELEMENTARY SCHOOL

# FACILITY CONDITION ASSESSMENT

Park Elementary School  
360 East Blithedale Avenue  
Mill Valley, California 94941

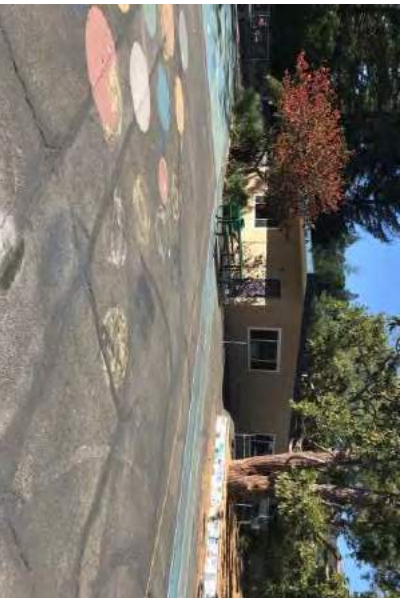
#3 MODULAR BUILDING

Modular Building Information		
HVAC	Heat pump	Fair
Fire Suppression	Hydrants, fire extinguishers	Fair
Electrical	Source and Distribution: Fed from Main Building with copper wiring Interior Lighting: LED Emergency: None	Fair
Fire Alarm	Smoke detectors, alarms, strobes	Fair
Equipment/Special	None	--
Key Issues and Findings	Wood rot on window trim, building lacks fire sprinklers

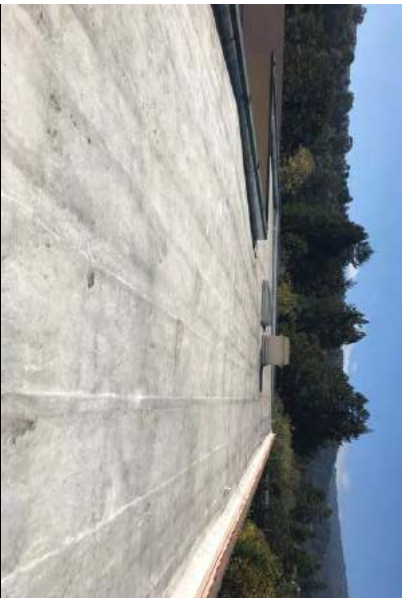
#13  
MODIFIED BITUMINOUS ROOF  
WITH REFLECTIVE COATING

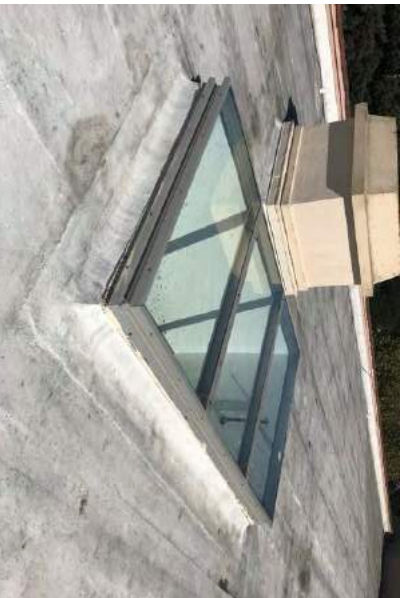
#15  
SKYLIGHT

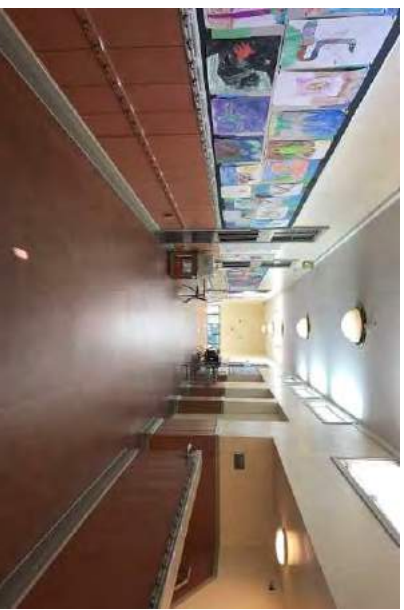
#22 CORRIDOR

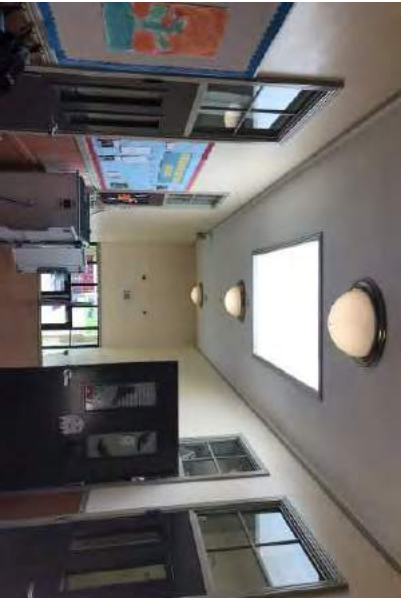
#23 CORRIDOR

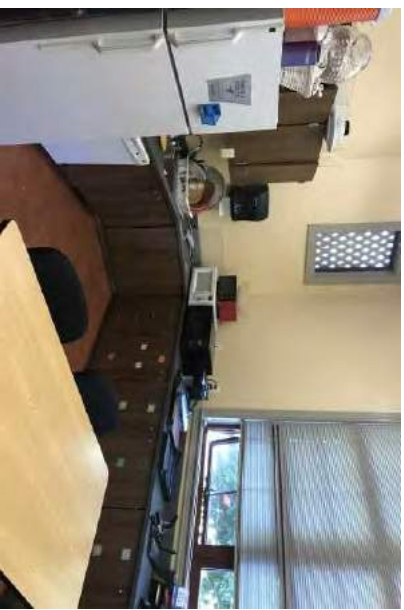
#24 KITCHEN

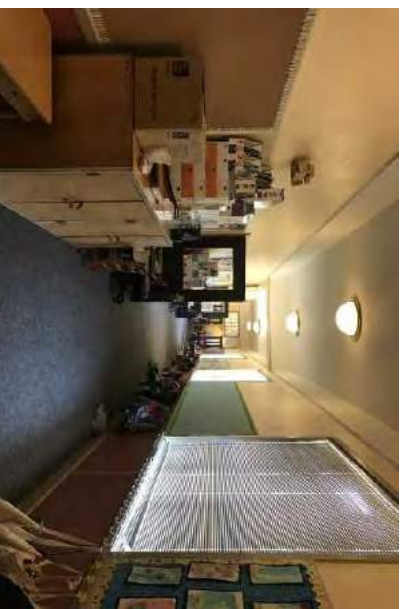
#26

ANNEX BUILDING CORRIDOR

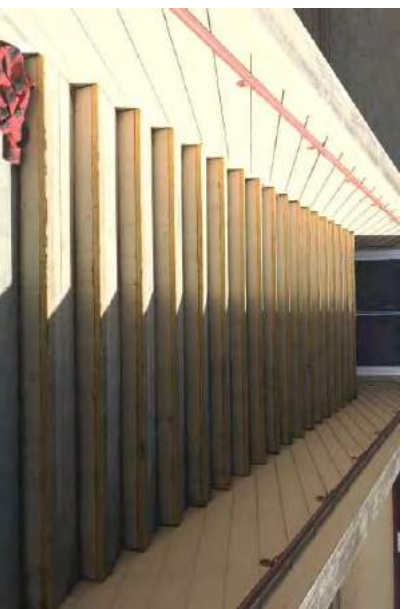
#28

EXTERIOR STAIRS ANNEX BUILDING

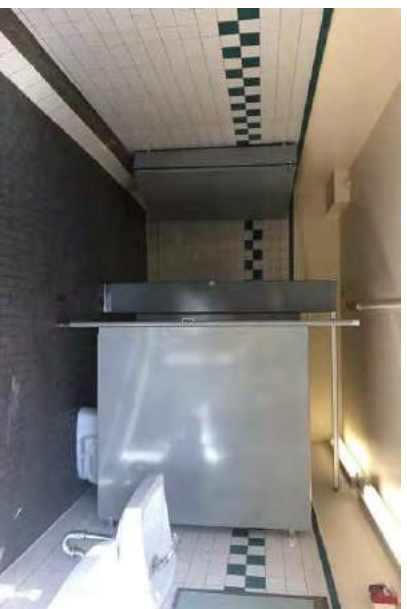
#30

RESTROOM

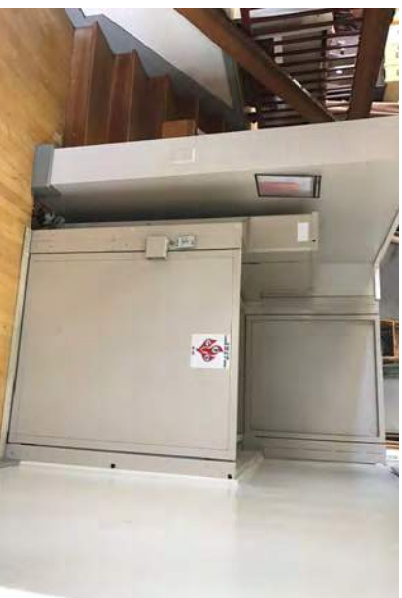
#32	WHEELCHAIR LIFT
-----	-----------------

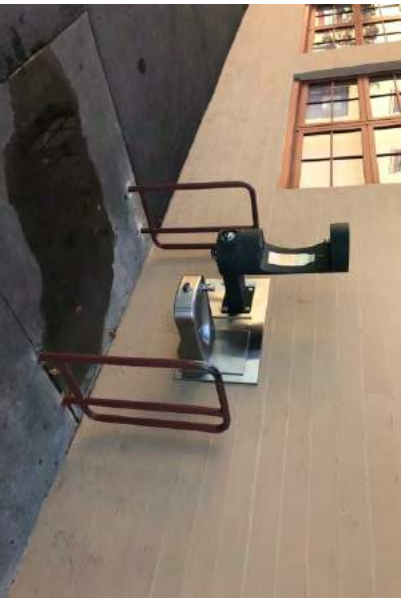
#47 DRINKING FOUNTAIN

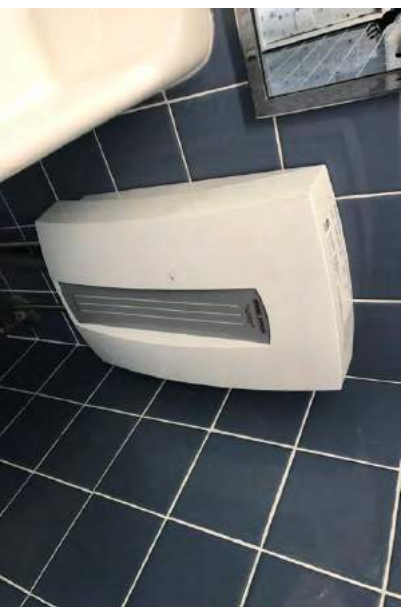
#48 INSTANT HOT WATER HEATER

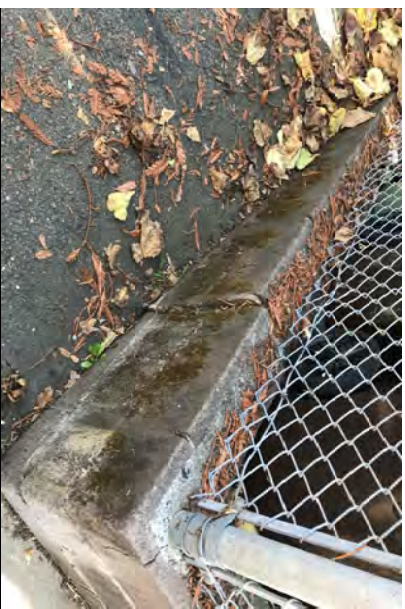
#62  
RETAINING WALL

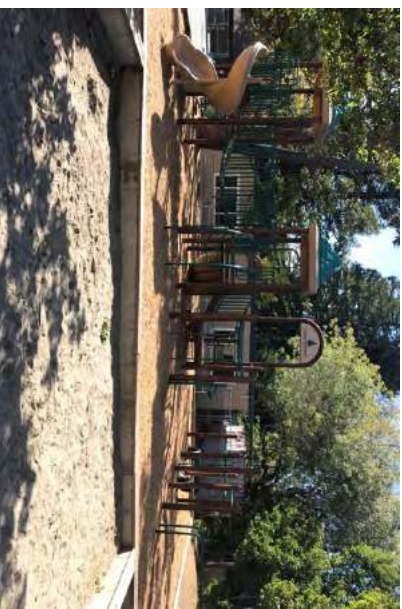
#64  
PLAY STRUCTURE
