MILL VALLEY SCHOOL DISTRICT FACILITIES ASSESSMENT 2018

TAM VALLEY ELEMENTARY

TAM VALLEY ELEMENTARY : PRE-PLANNING SURVEY

FACILITY CONDITION ASSESSMENT

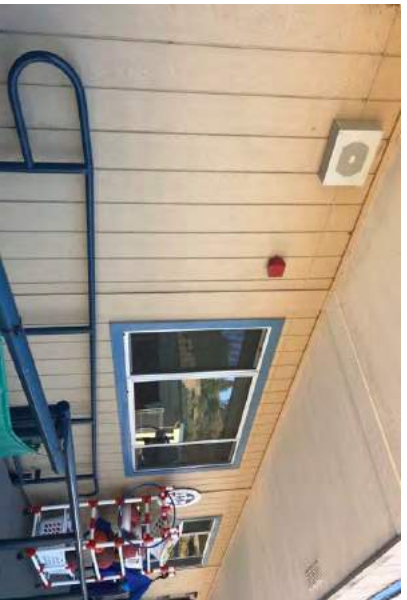
#5

E-K SIDING AND WINDOW

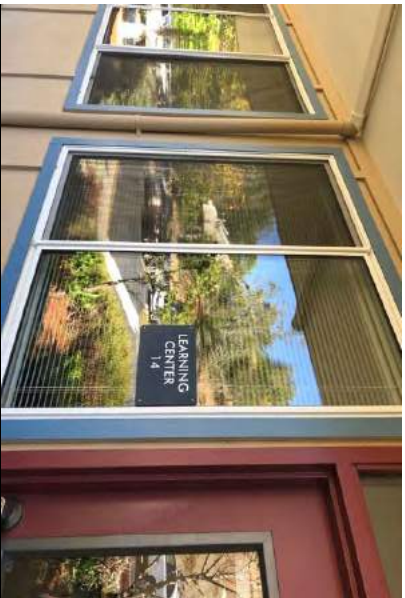
#7
C-D WINDOWS

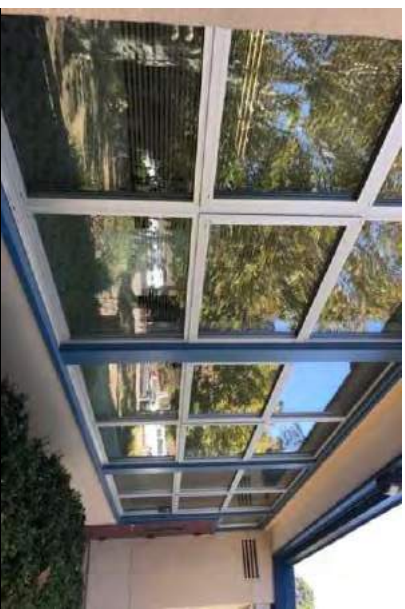
#8
A-B ALUMINUM DOUBLE-GLAZED WINDOWS

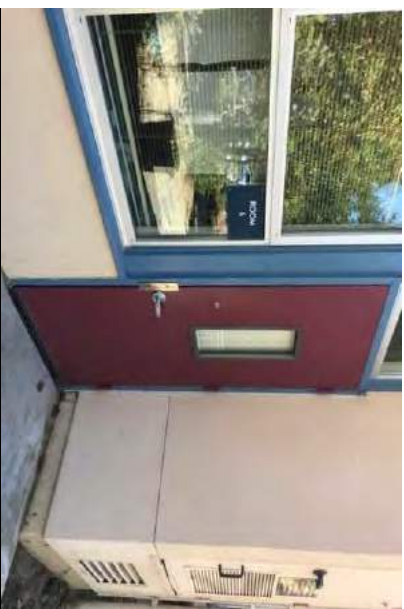
#10
A-B EXTERIOR DOORS STEEL WITH SAFETY GLASS

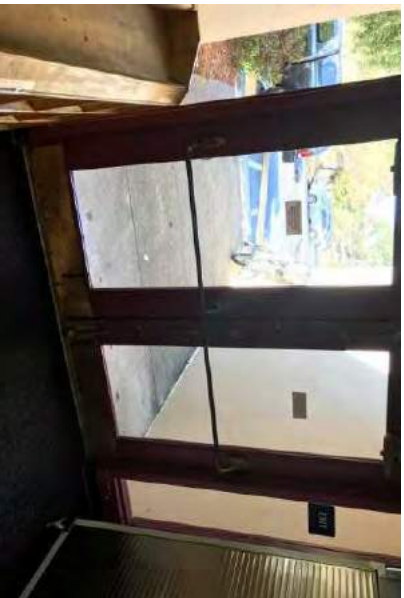
#11
A-B DOOR HARDWARE AGED AND STICKING

- As outlined by EMG in their report, consideration should be given to the following: roof repair and door hardware repair at Buildings A-D; replacement of interior wall finishes at select locations, an investigation of previous fire damage to the electric room; cooling capability in the Buildings A-D classrooms; an electrical distribution system upgrade at Buildings A & B; replacing all the galvanized plumbing supply lines with copper; replacing plumbing sanitary waste lines at Buildings C-K; regular maintenance of Building C-K roof gutters; redirection of Building A & B downspouts away from doors; the addition of a Backflow Preventer.

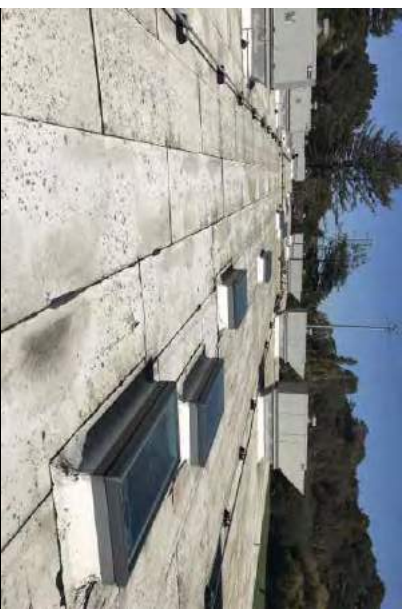
#22

C-D MODIFIED BITUMINOUS ROOF

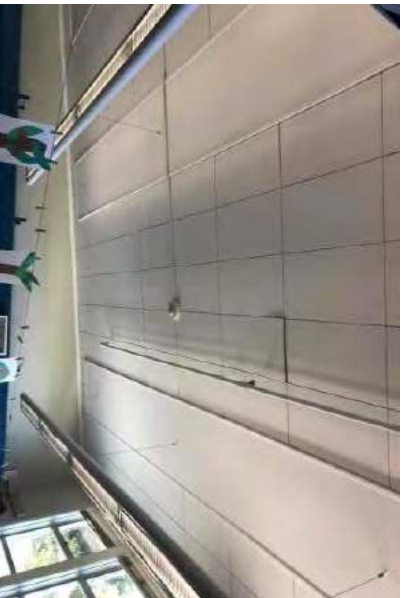
#33 GLUE-ON ACOUSTICAL TILE (ACT) CEILING

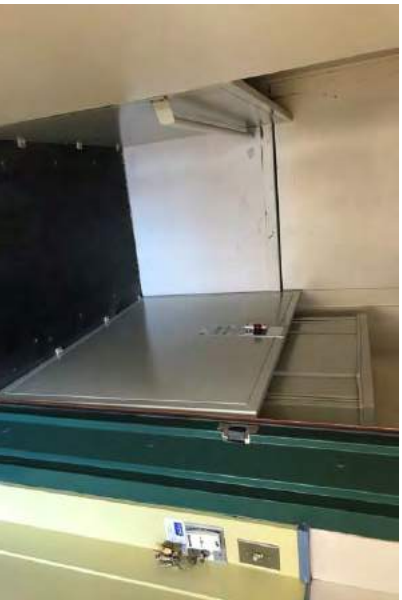
#37
WHEELCHAIR LIFT

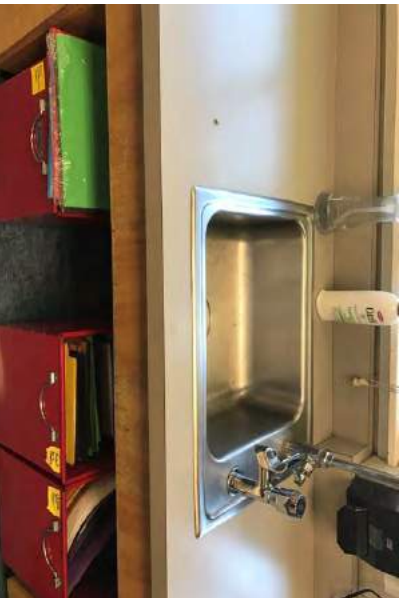
#43
STAINLESS STEEL CLASSROOM
SINK

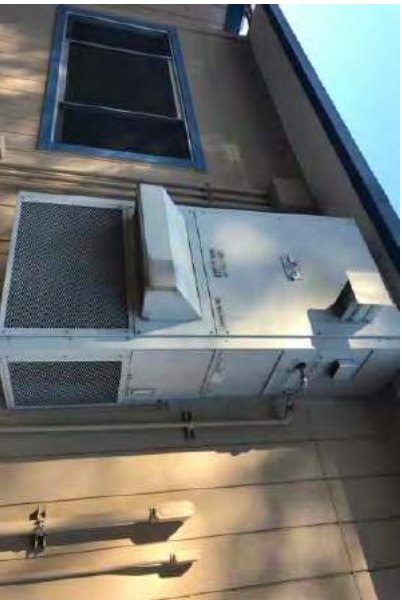
#57	E-K PACKAGE UNIT
-----	------------------

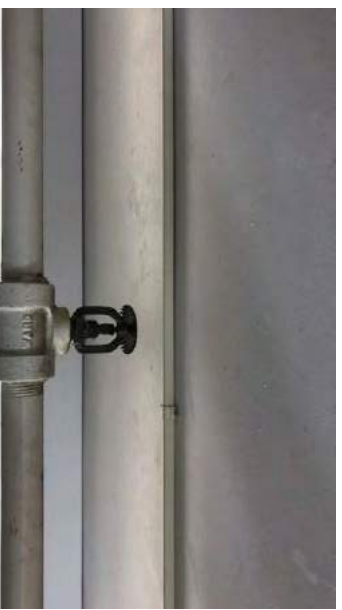
#60	SPRINKLER HEADS
-----	-----------------

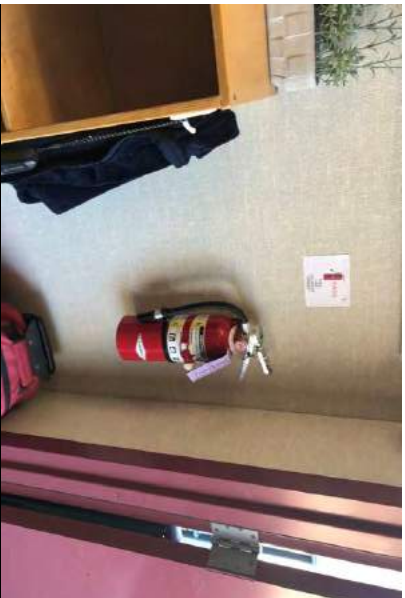
#61	FIRE EXTINGUISHER
-----	-------------------

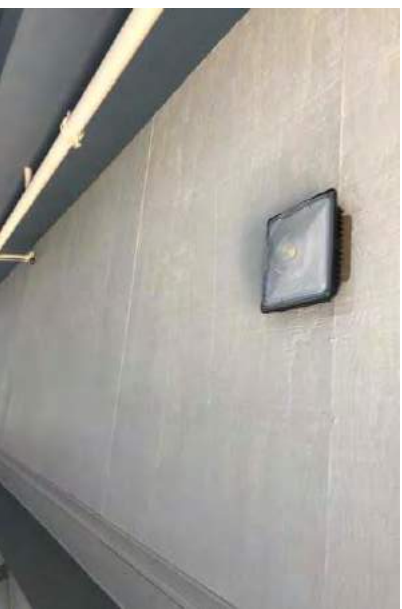
#70
EXTERIOR LIGHTING

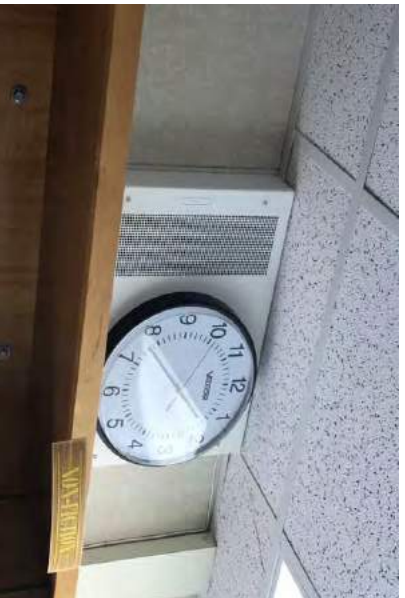
#71
PUBLIC ADDRESS SYSTEM

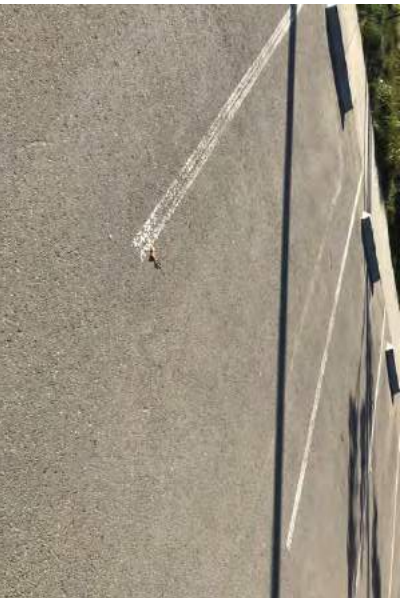
#75 ASPHALT PARKING LOTS SEAL & STRIPE

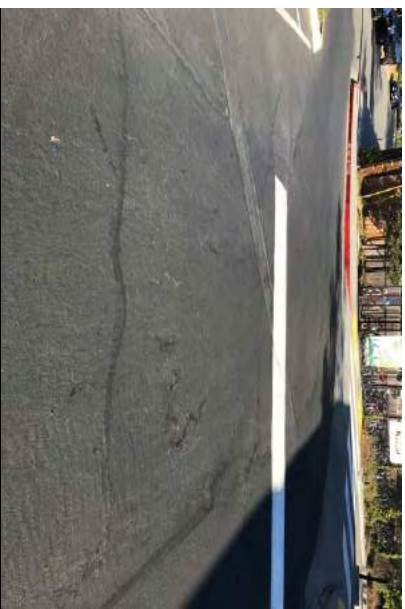
#74 ASPHALT PARKING LOTS MILL & OVERLAY

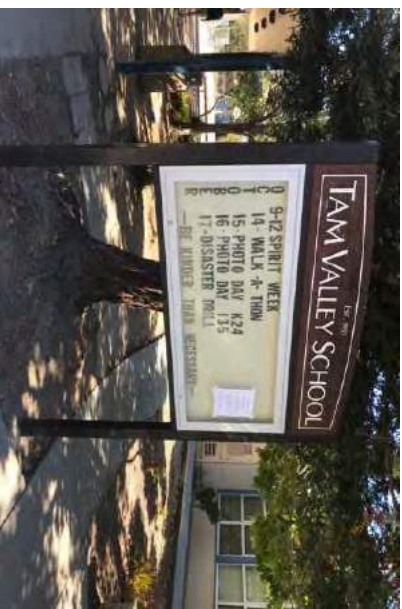
#76 PROPERTY SIGNAGE

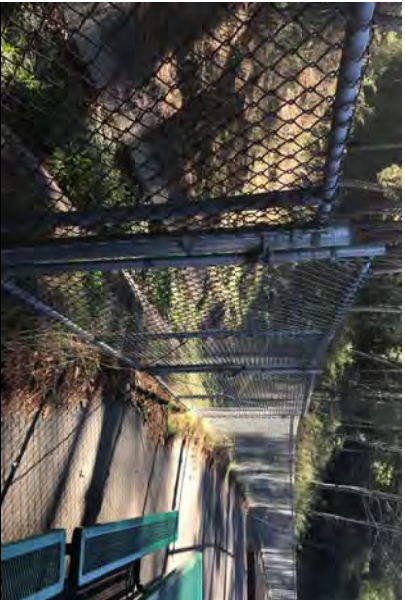
#79	CHAIN-LINK FENCE
-----	------------------

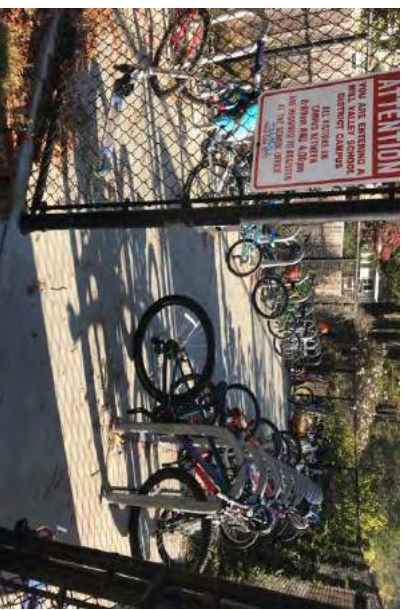
#82	BIKE RACKS
-----	------------

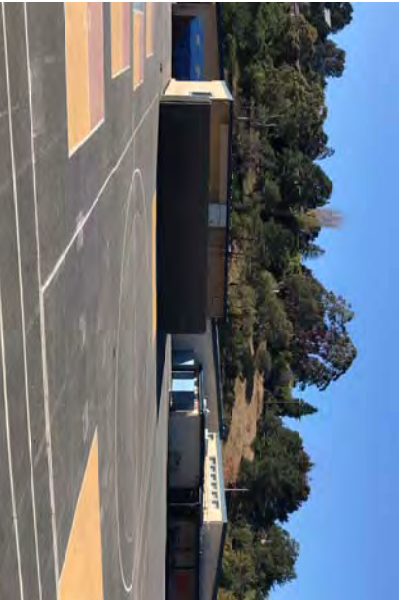
#83	ASPHALT PLAYGROUND
-----	--------------------

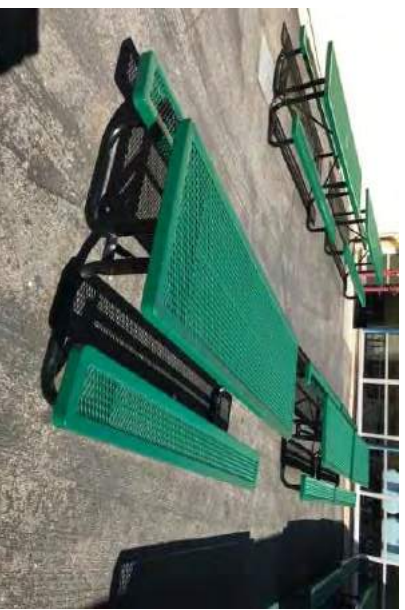
#84	PICNIC TABLES
-----	---------------

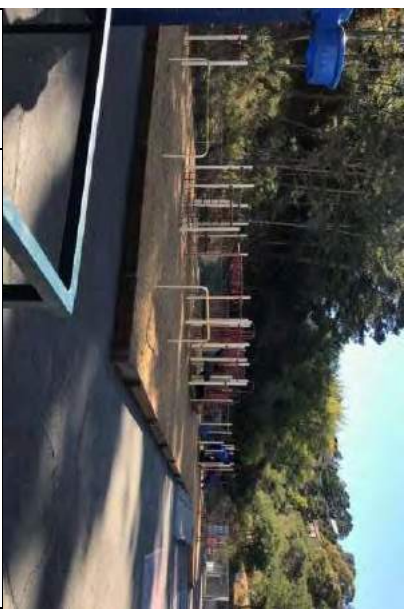
#86

LARGE PLAY STRUCTURE

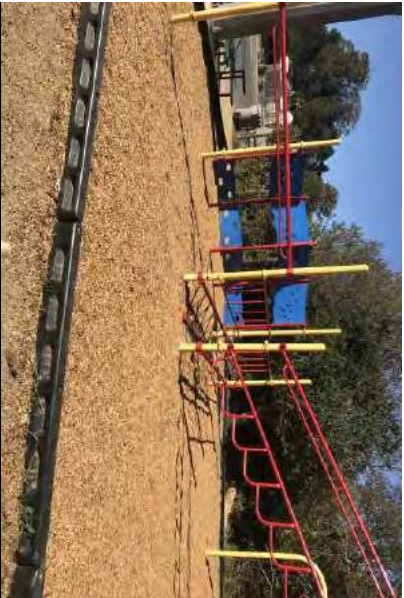
#87

MEDIUM PLAY STRUCTURE

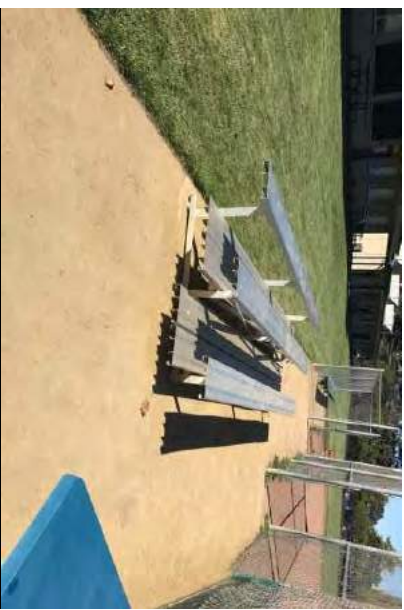
#88

BLEACHERS

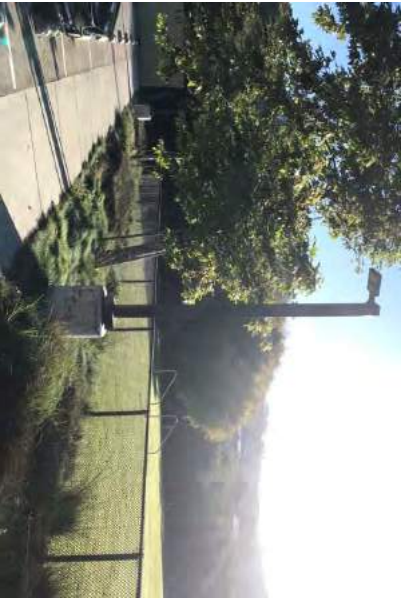
#89

LED POLE LIGHTING
